Date Mon 12/04/2023

Name	Description
Cavins Environmental	Cavins Group inspected all equipment and containments and changed all air scrubber filters. Humidity and temperature readings were checked on all three floors in the main area and one exterior reading. Remediation of 305 Pioneer continued—continued cleaning and documentation of SO 115.
Total

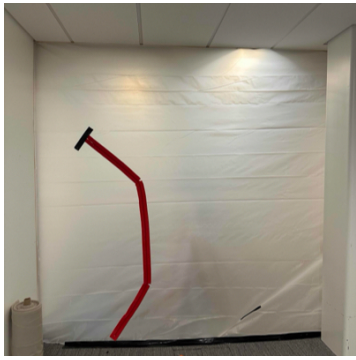
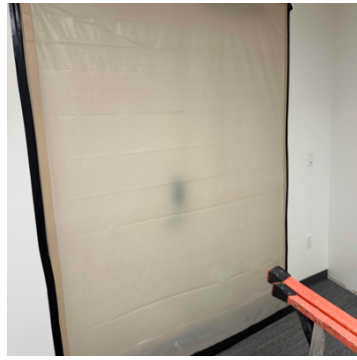
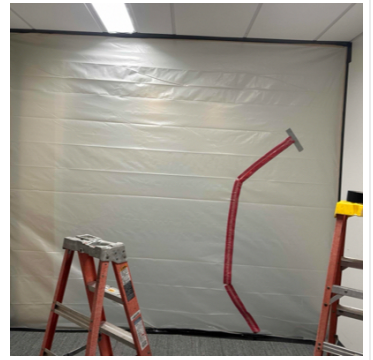
**20. Storage Room 303: Containment Expansion**

The containment of 305 Pioneer was expanded due to additional mold growth discovered during the remediation process.

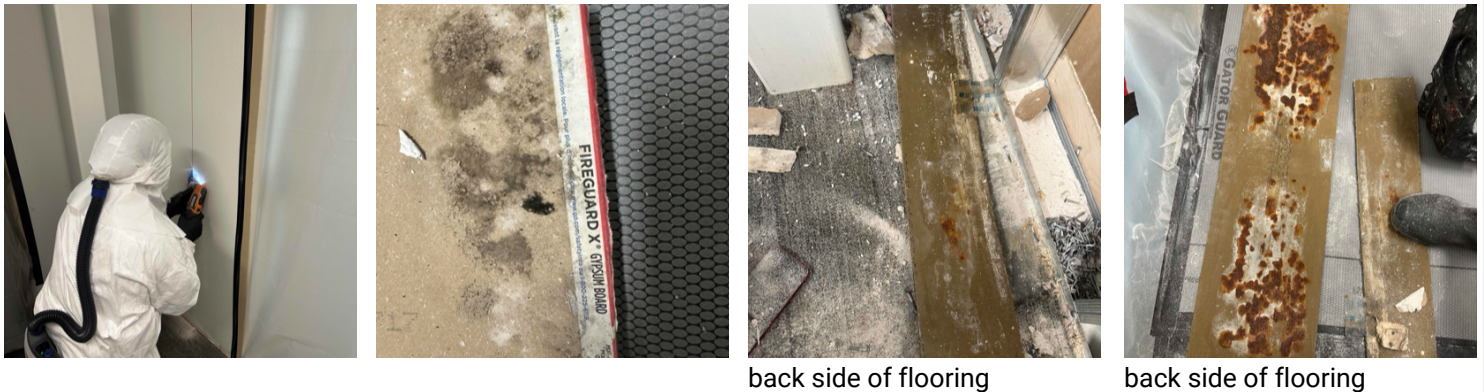
**38. Storage Room 303: Start Mold Remediation**

Mold growth was found on various materials, including the carpet, trim, drywall, and insulation. The carpet tiles had to be removed because of mold growth. The subfloor was dismantled to gain access to the sheetrock in the floor plenum.

back side of flooring

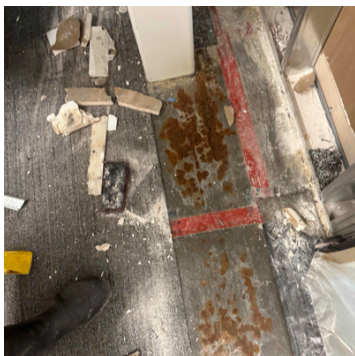
rust under carpet

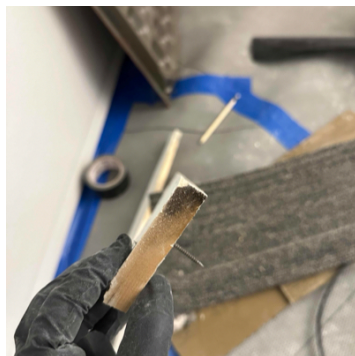
mold growth on wood trim
