Date Tue 12/05/2023

Work Logs

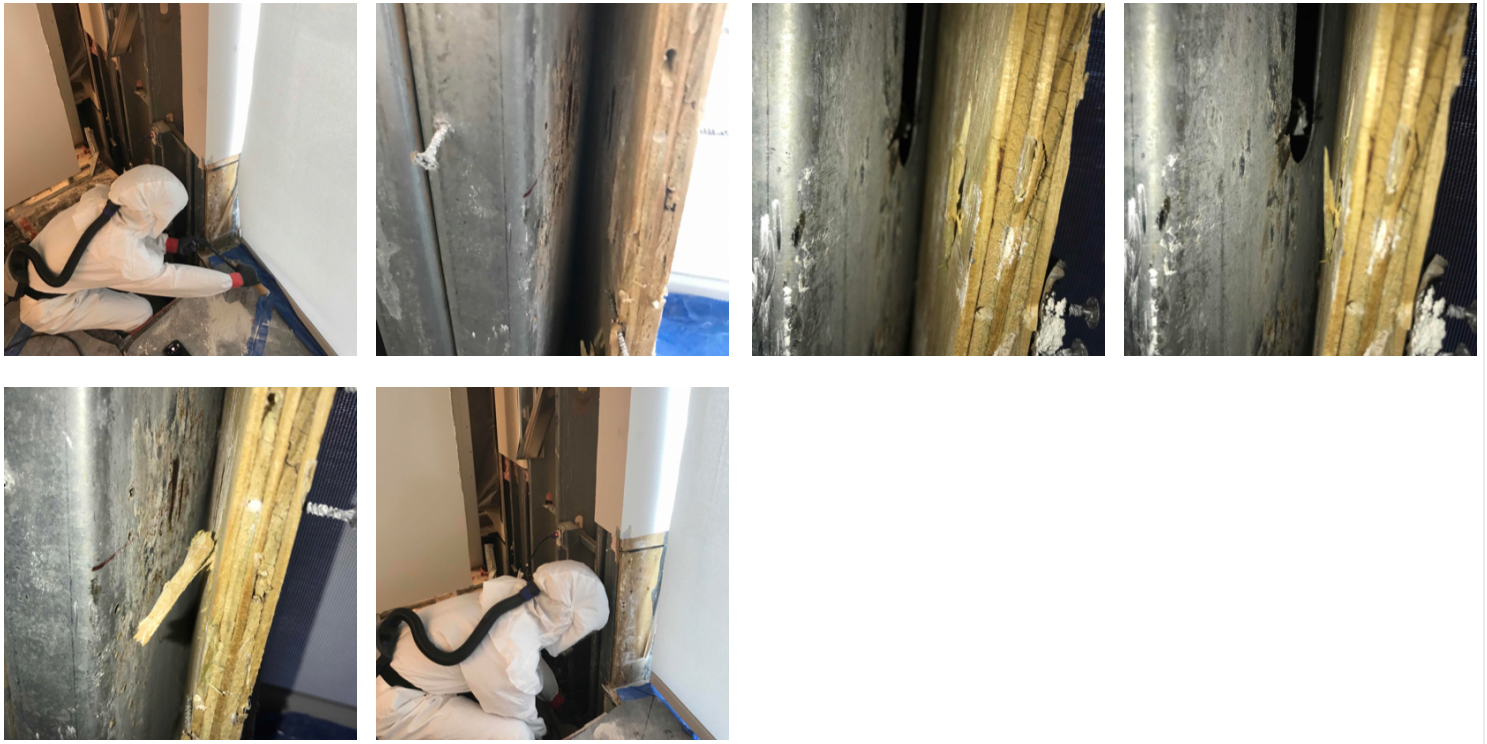
21. 305 - Pioneer: Mold Investigation

Further mold was found between the plywood and metal studs beside the window frame. There is a visible light gap through the flashing.
