Date Sun 12/03/2023

Name	Description
Cavins Environmental	Cavins Group inspected all equipment and containments and changed all air scrubber filters. Humidity and temperature readings were checked on all three floors in the main area and one exterior reading.
Total

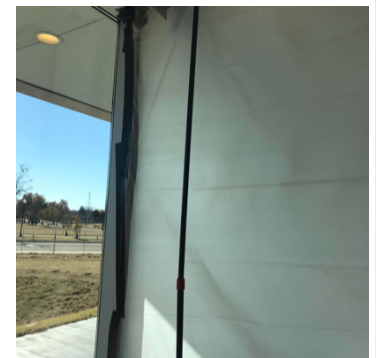
4. First Floor - 149 Storytime: Equipment On-site

- 2 - Air scrubbers
- 5 - Zip Posts

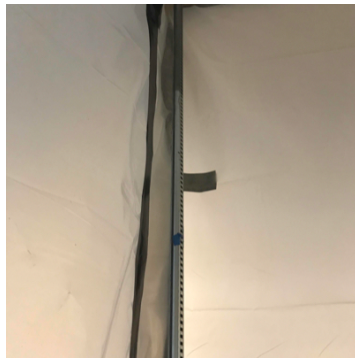
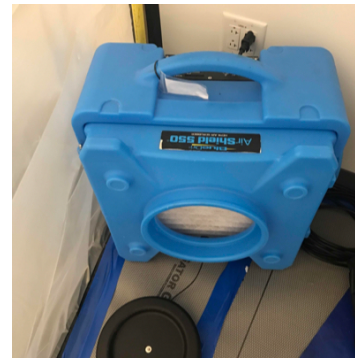
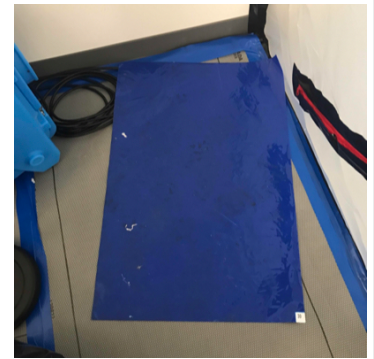
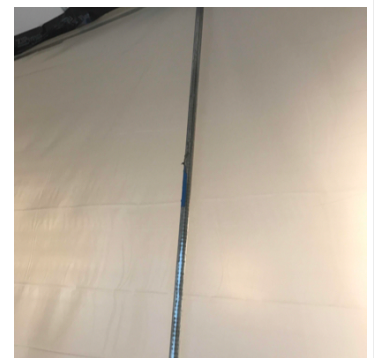
7. SO 201A: Equipment On-site

- 7 - Zip Posts
- 2 - Air Scrubbers

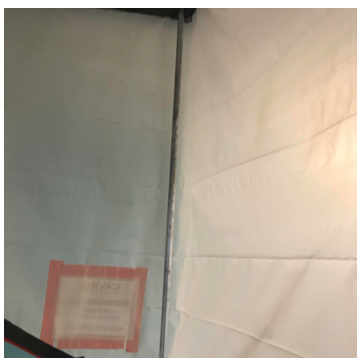
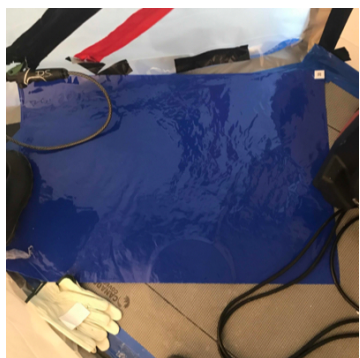
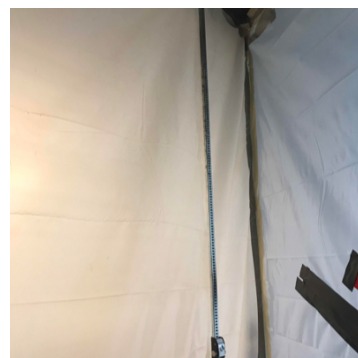
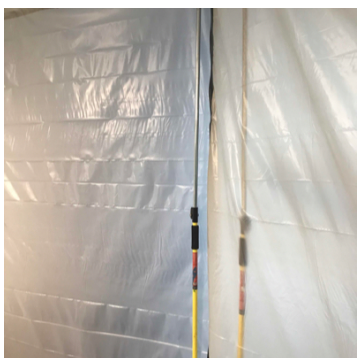
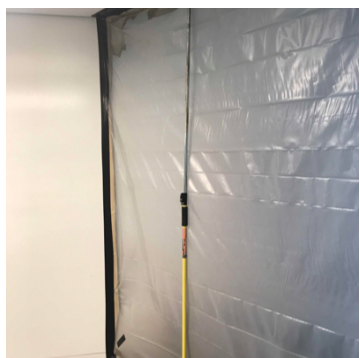
11. 305 Pioneer: Equipment On-site

- 4 - Zip Posts
- 2 - Air Scrubbers

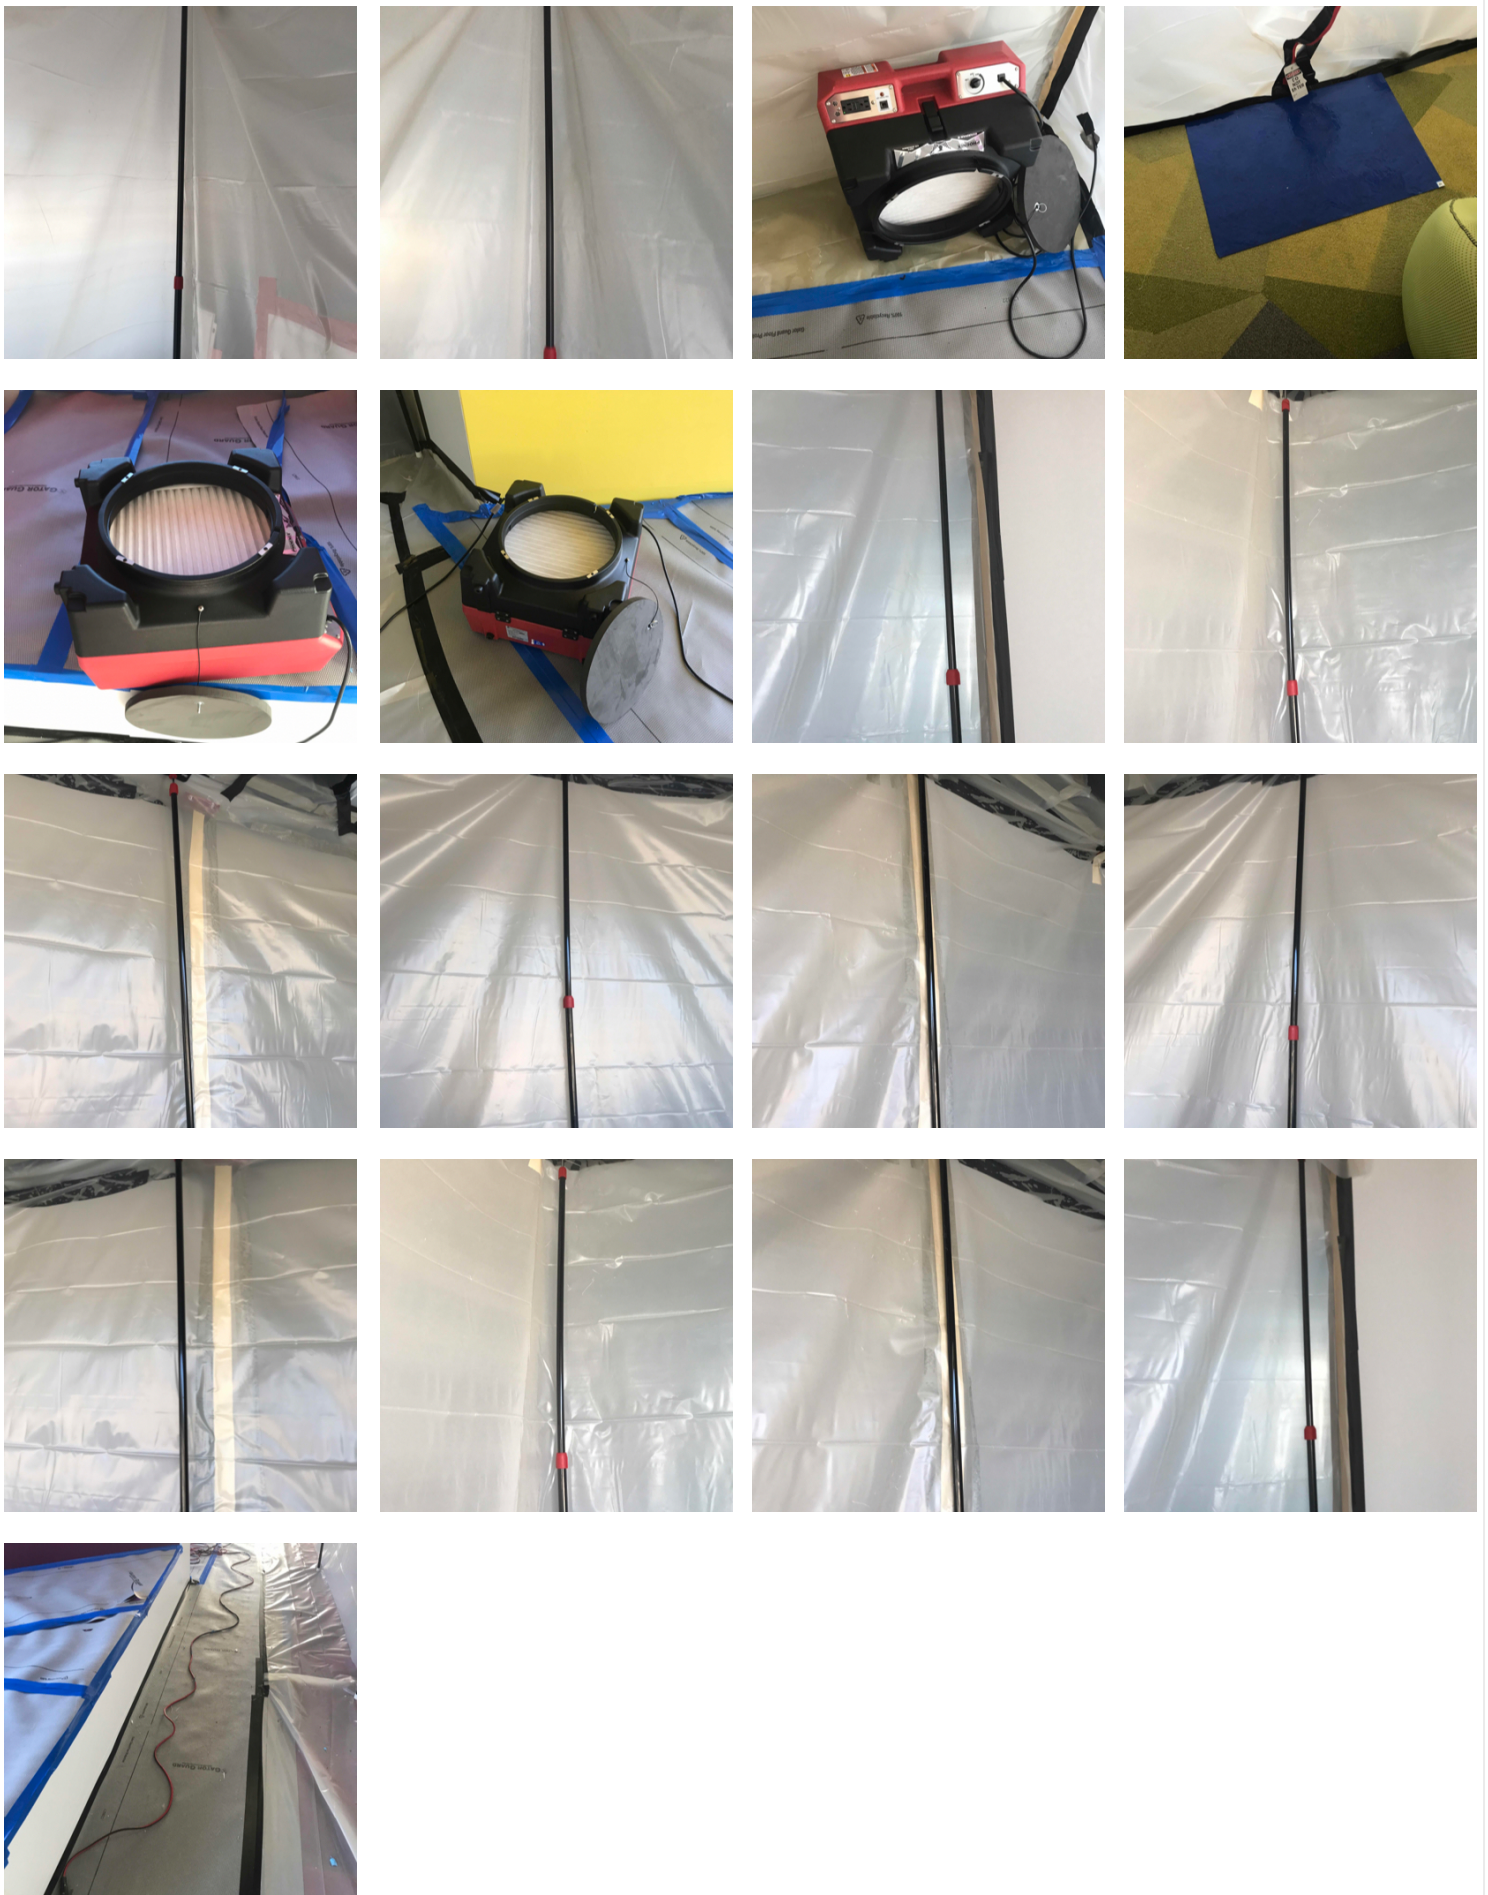
16. First Floor - Bay Windows (Children's Area): Equipment On-site

- 12 - Zip Posts
- 3 - Air Scrubbers
- 1 - 50' Extension Cord

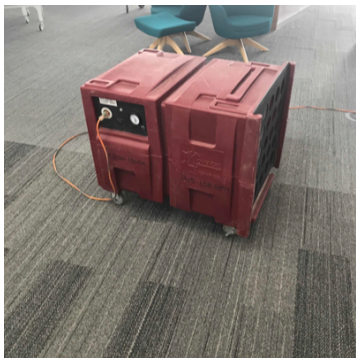
23. Second Floor - Main Area: Equipment On-site

1 - Air Scrubber

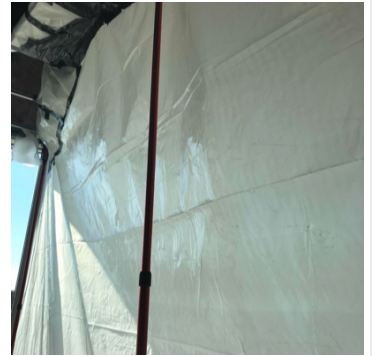
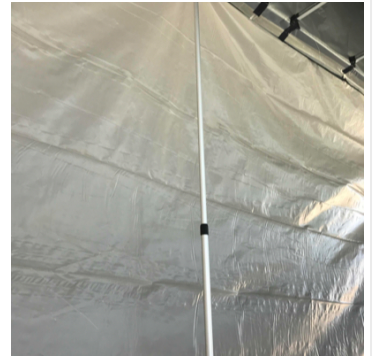
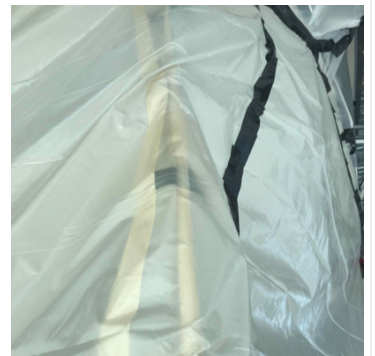
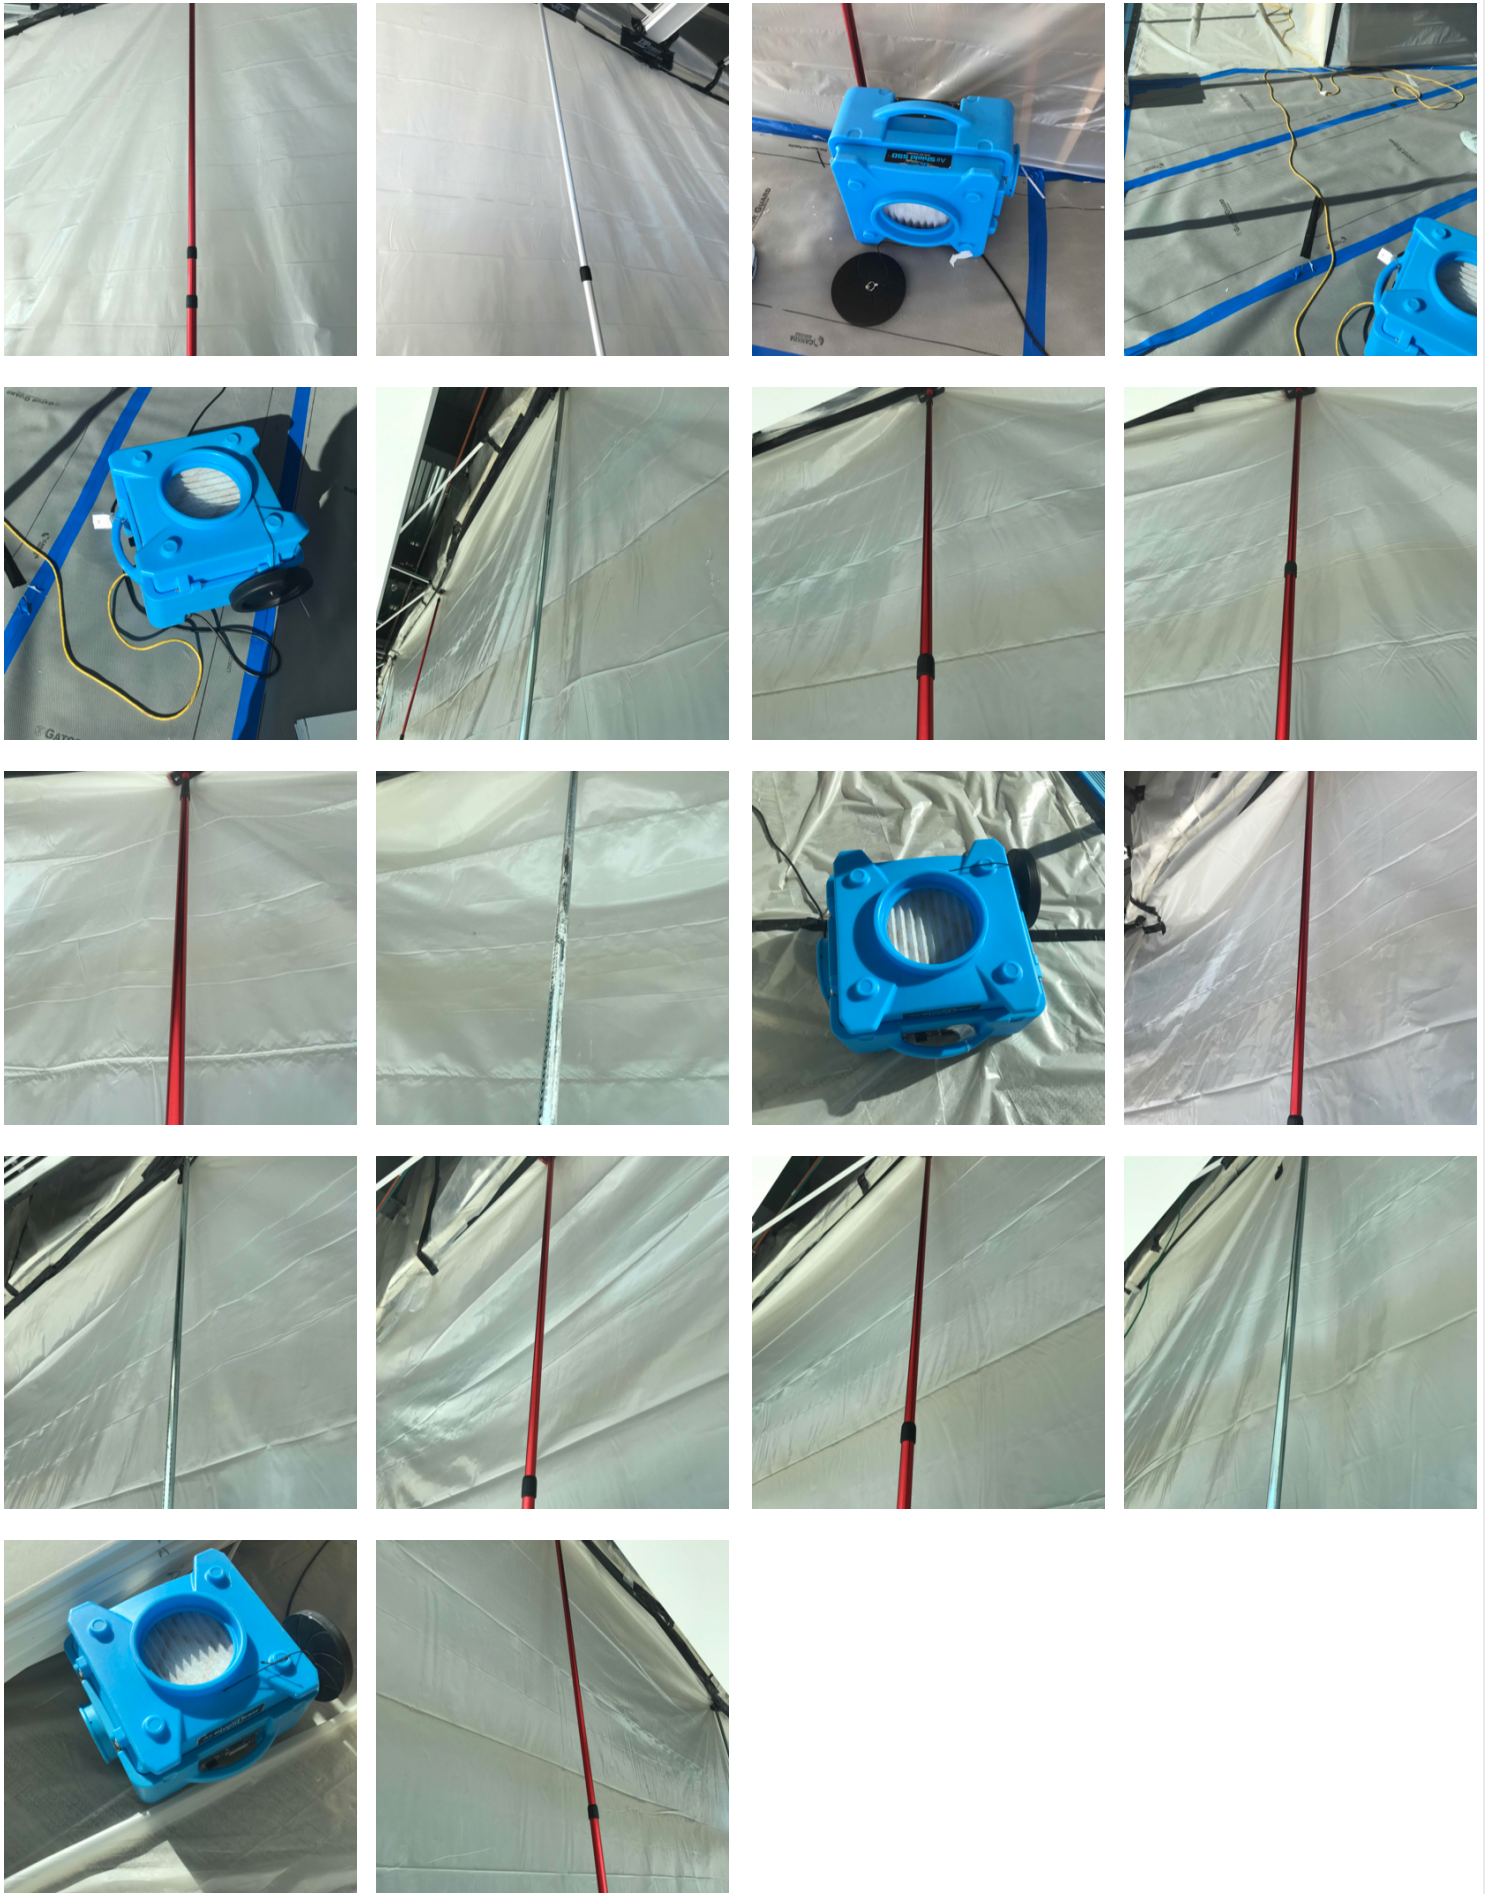
25. Second Floor - Southeast Corner: Equipment On-site

- 22 - Zip Posts
- 6 - Medium Air Scrubbers
- 1 - 25' yellow extension cord

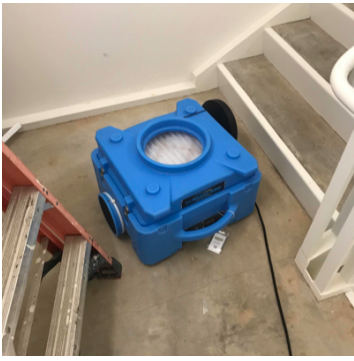
26. Southwest Exit Stairwell: Equipment On-site

1 - Air Scrubber

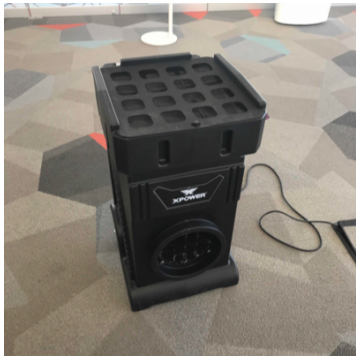
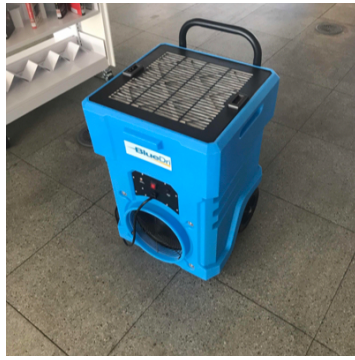
29. First Floor - Main Area Equipment On-site

2 - Air Scrubbers

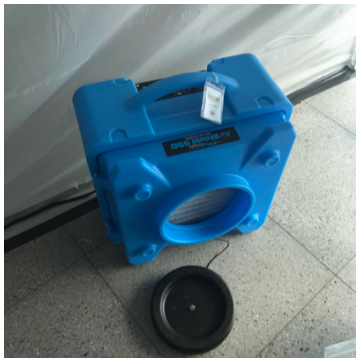
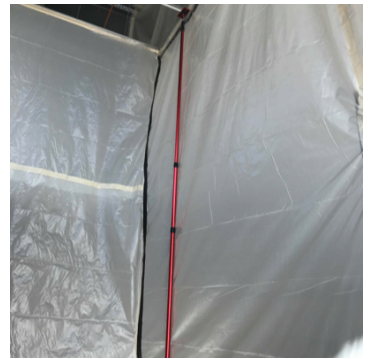
31. First Floor - Southwest Vestibule: Equipment On-site

- 2 - Air Scrubbers
- 2 - Zip Posts

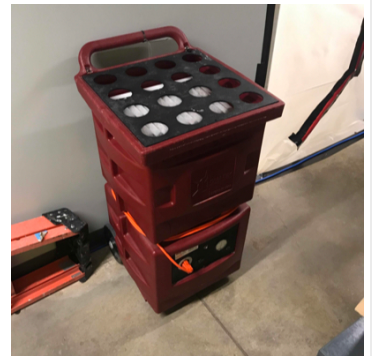
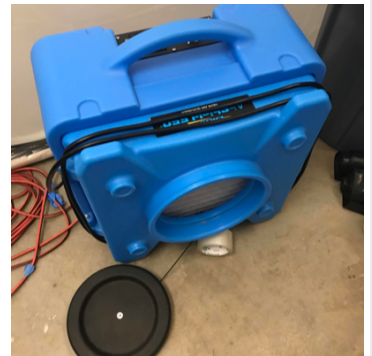
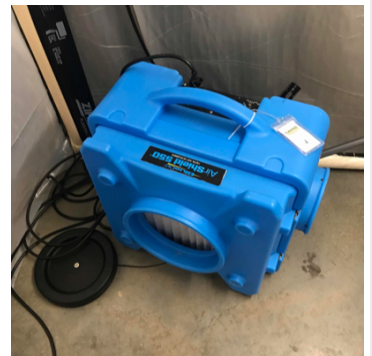
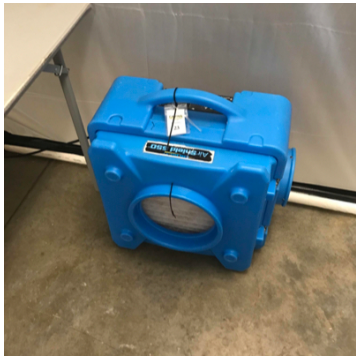
34. Garage: Equipment On-site

- 4 - Air Scrubbers
- 2 - 50' Extension Cord
- 2 - 25' Extension Cords

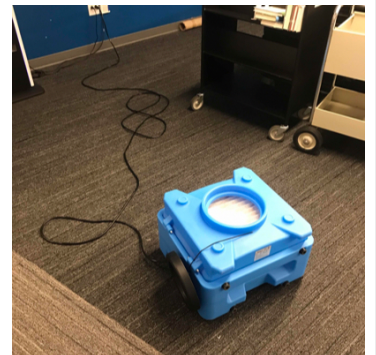
37. SO 115: Equipment On-site

3 - Air Scrubbers
