Norman Public Library Central - Mold

103 W Acres St Norman, OK 73069

Date Sat 12/02/2023

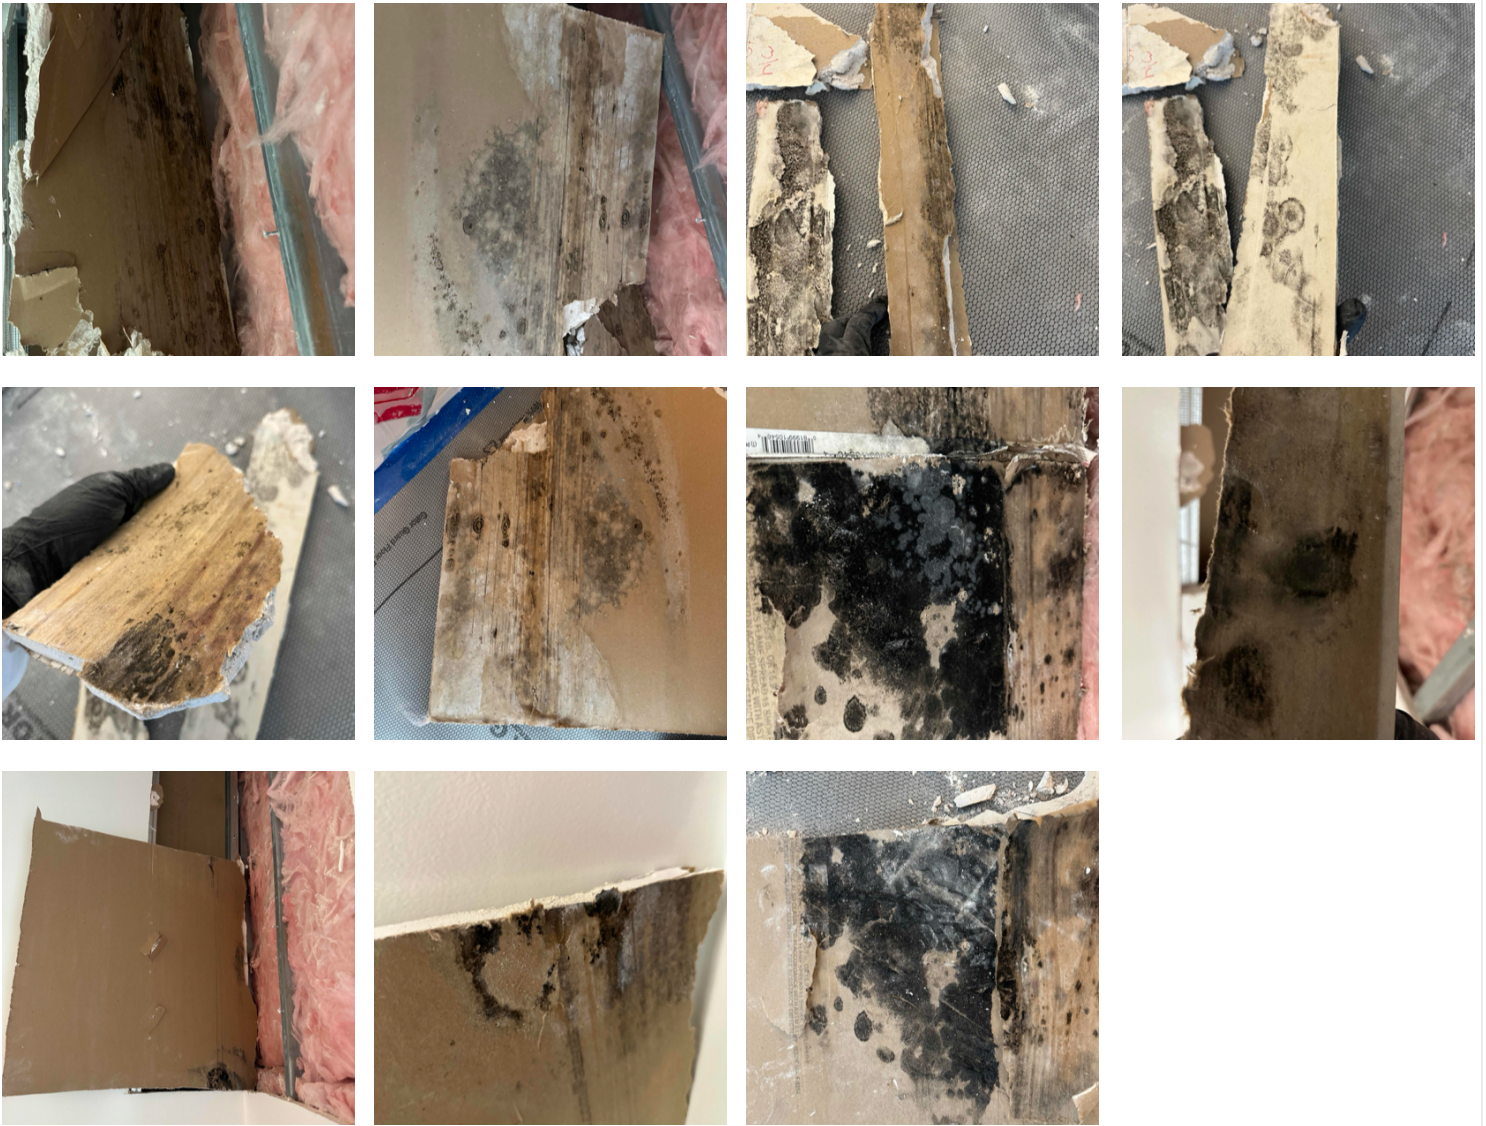
42. 305 Pioneer: Microbial Growth

During demolition, microbial growth was found on a variety of surfaces, including sheetrock and insulation.

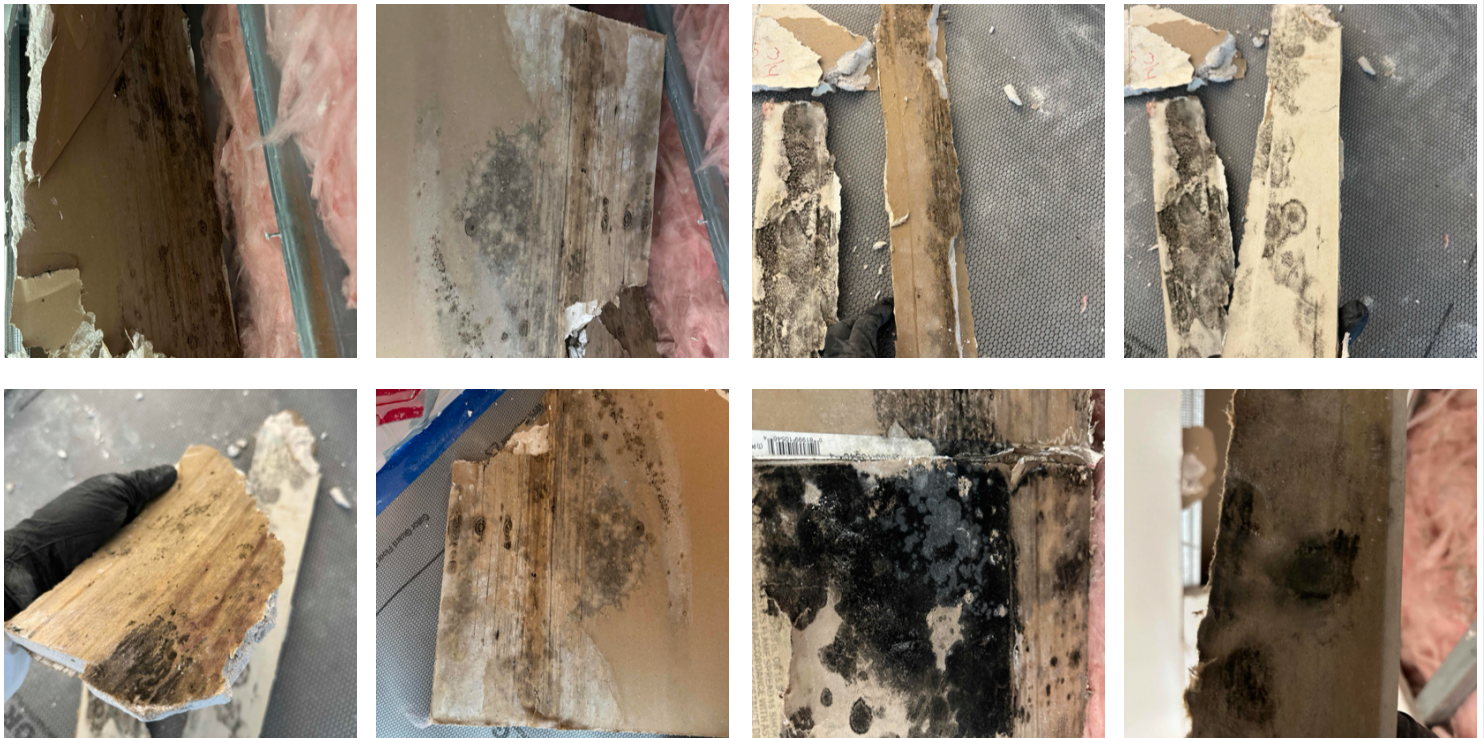
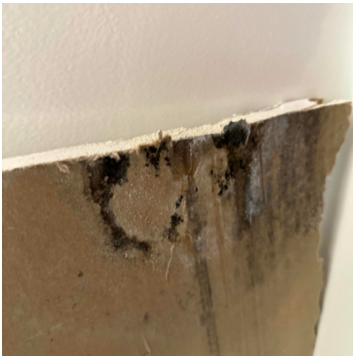
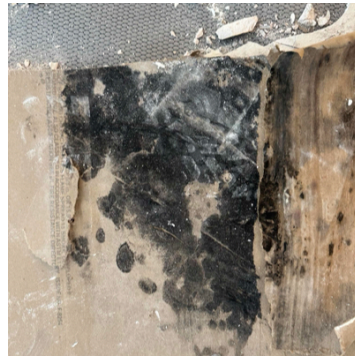
46. 305 Pioneer: Remediation

Upon removing sheetrock in the 305 Pioneer room, the microbial growth has spread into the adjacent storage room 303; additional containment will need to be set to be remediated alongside 305 Pioneer. The microbial growth has spread between the floors, requiring further demolition for remediation.

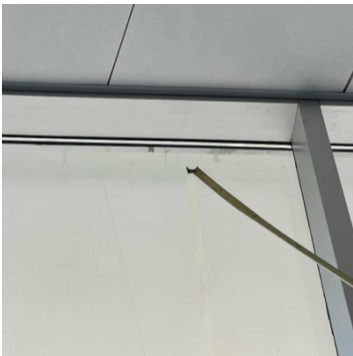
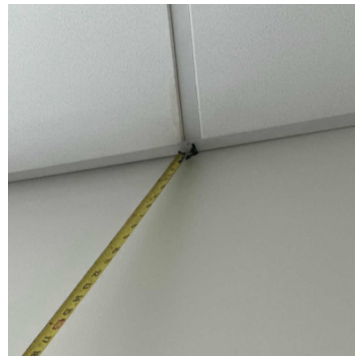
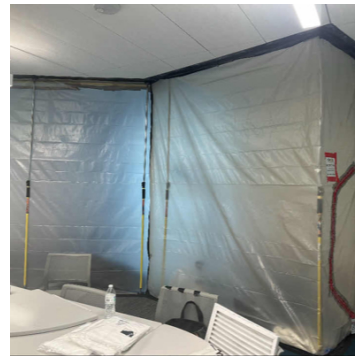
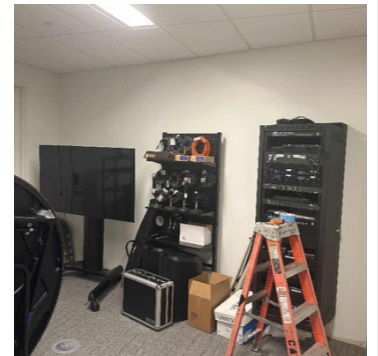
47. SO 201A: Containment Expansion

Based on the measurements from the containments in the rooms above (305 Pioneer and Storage Room 303), the containment will need to be expanded, possibly into the adjacent space, the I.T. lab closet. There are signs of water intrusion coming from the third floor, staining the ceiling tiles on the second floor in these areas. On the first floor, there are water trails around the same area, which means there is potential for microbial growth in the floor between the second and first floors. It will be known once the remediation process has begun in 201A.
