# Norman Public Library Central - Mold

103 W Acres St Norman, OK 73069

Date Thu 01/11/2024

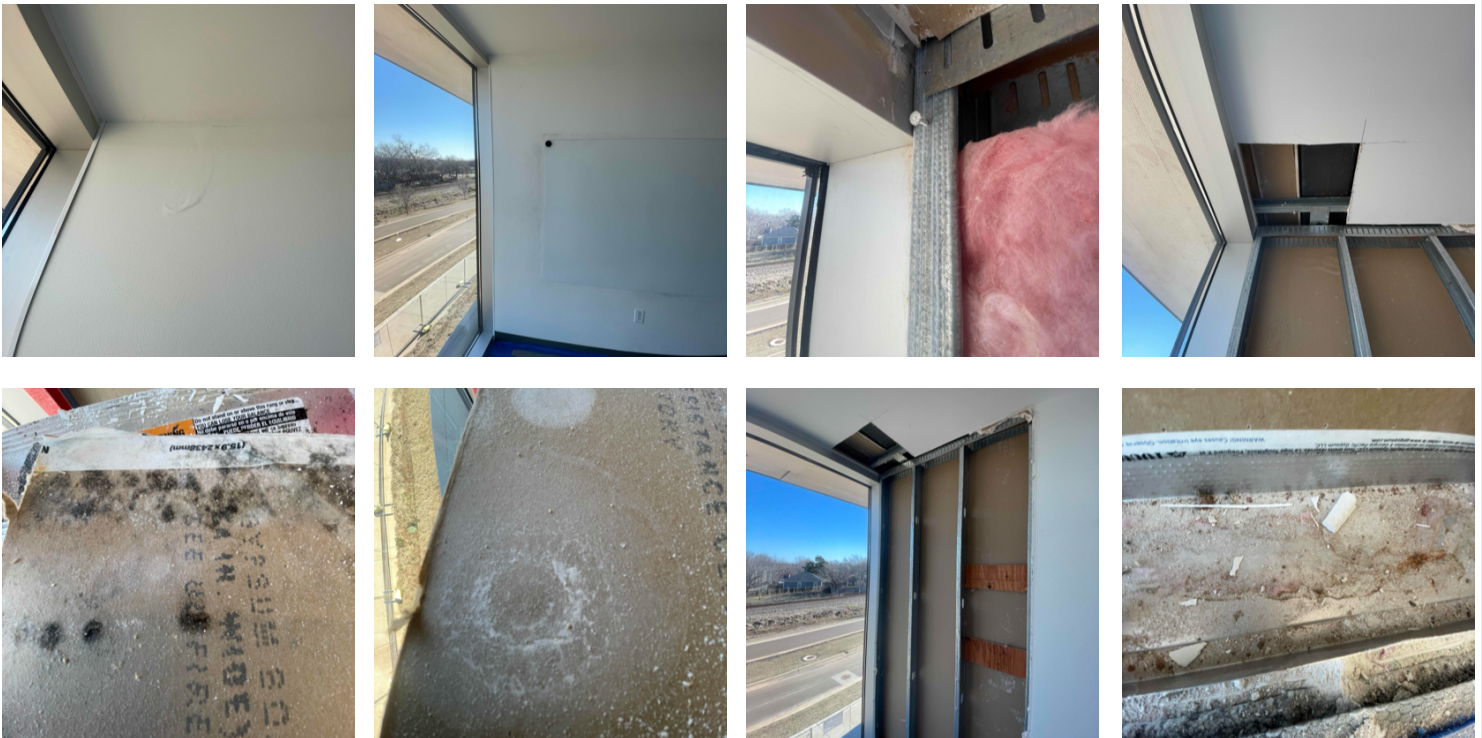
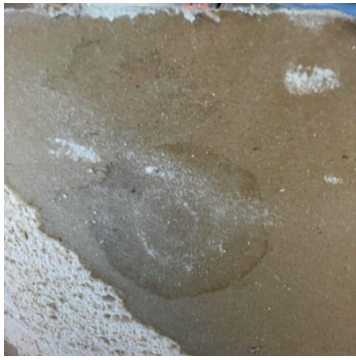
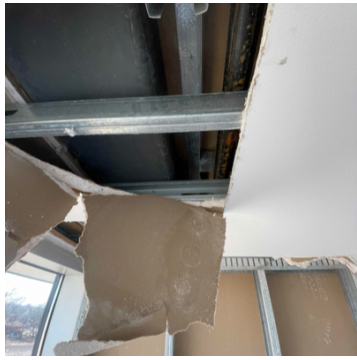
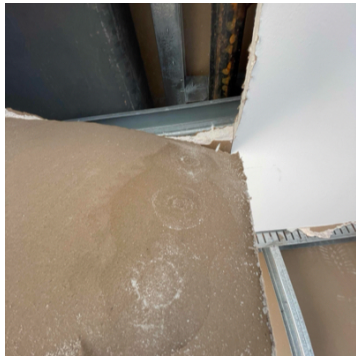
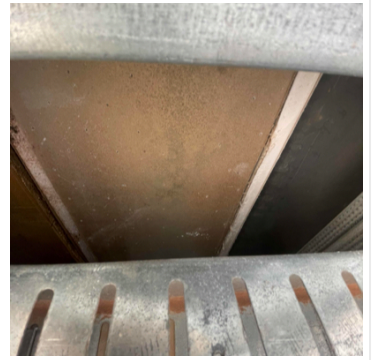
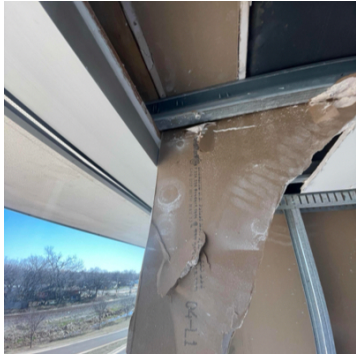
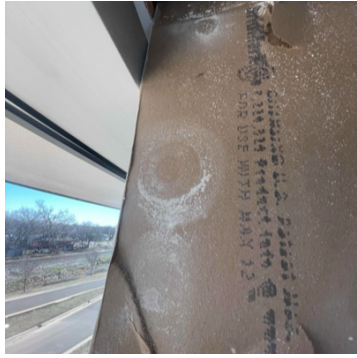
**21. Second Floor - Southeast Corner: Remediation**

Water damage can be seen on the wall in the middle office, on the east side by the windows. After removing water damaged drywall, visible microbial growth can be seen on the upper left corner. Drywall on the ceiling needs to be removed in order to ensure there is no microbial growth. Visible microbial growth is seen on the back of the ceiling drywall and all affected areas were removed. Microbial growth spreads to the inside of the office ceiling and this was removed as well. On top of soffit (overhang) visible microbial growth can be seen where possible windows/exterior siding has been leaking, demo of affected areas were completed.

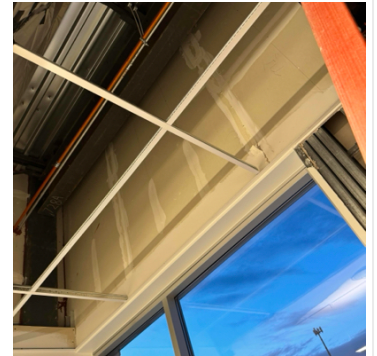
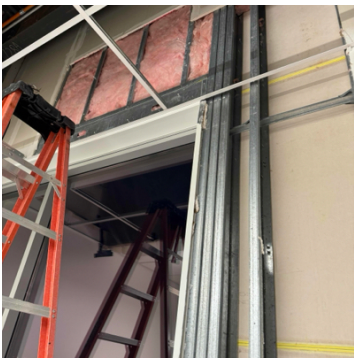
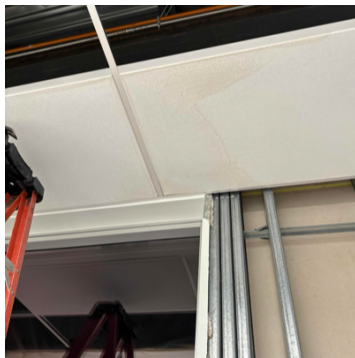
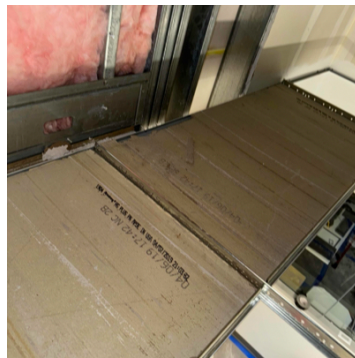
**58. 311 Local History: Selective demo for water intrusion investigation. Water intrusion appears to be from a former roof leak that may have already been repaired.**
