Date Mon 01/22/2024

Name	Description
Cavins Environmental	Cavins Group took temperature and humidity readings of affected areas, all common areas and one outside. Cavins technicians suited up in proper PPE and changed pre filters in air scrubbers within containments, along with all all pre filters in main areas. Air quality testing was performed on common areas to monitor current status of the building. An additional spore trap test was taken on the roof access stairwell for post remediation verification testing. Demo was performed on the second floor, SE corner study area and the bay windows in the children's area.
Total

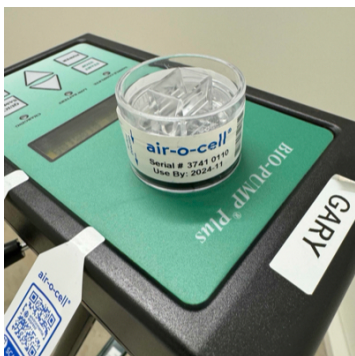
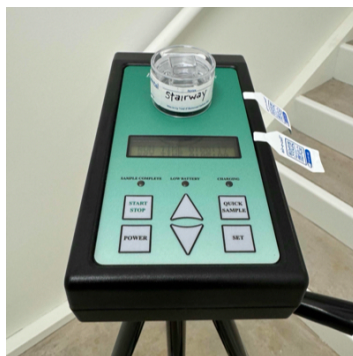
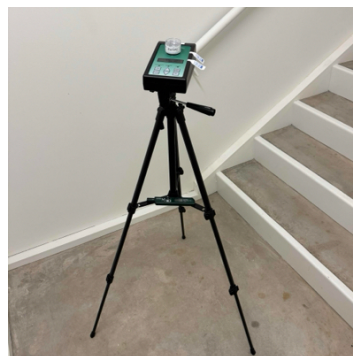
1. Stairwell: Clearance testing

A spore trap sample was taken

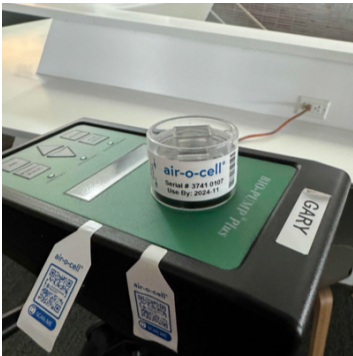
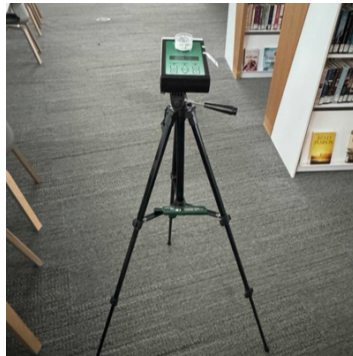
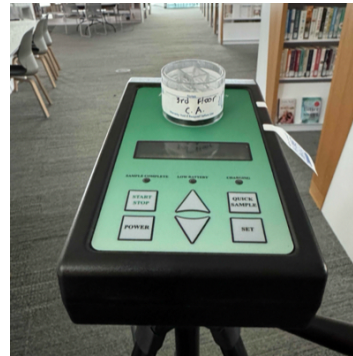
4. Third Floor - Common Area: Air Quality Testing

A spore trap sample was taken

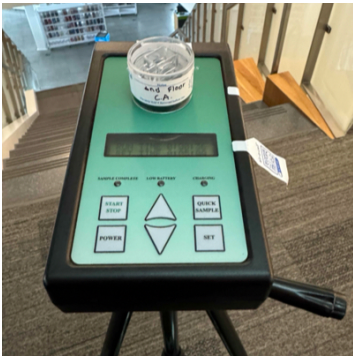
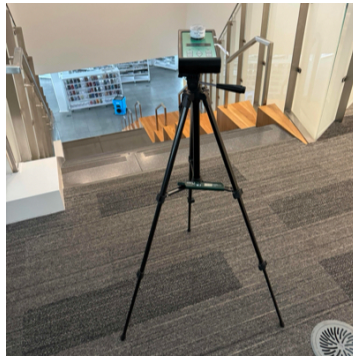
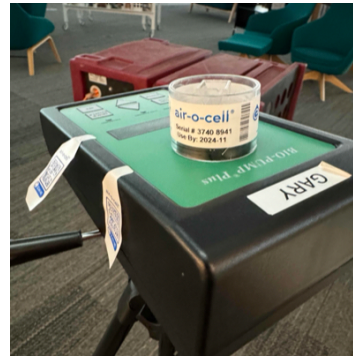
6. Second Floor - Common Area: Air Quality Testing

A spore trap sample was taken

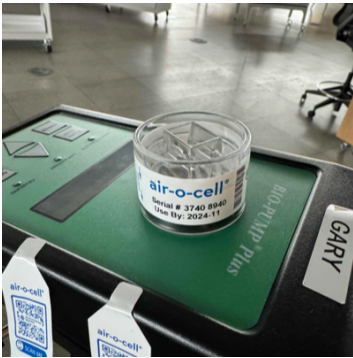
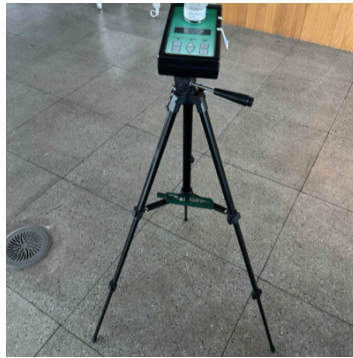
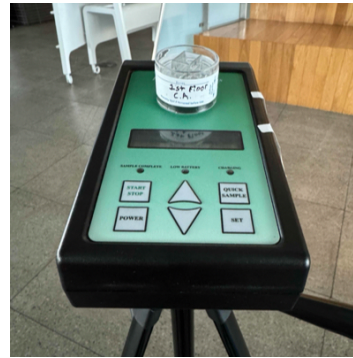
8. First Floor - Common Area: Air Quality Testing

A spore trap sample was taken

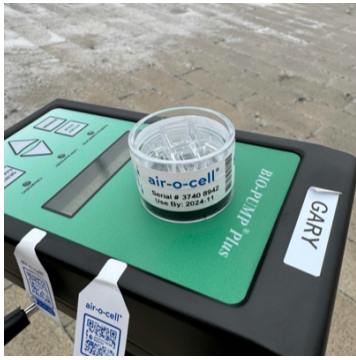
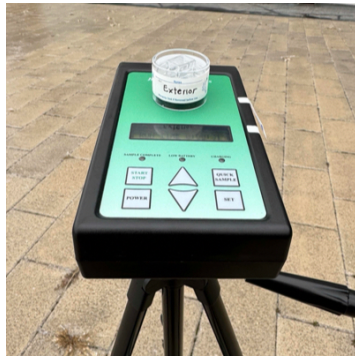
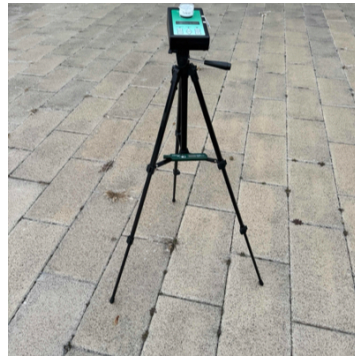
10. Exterior: Air Quality Testing

A spore trap sample was taken

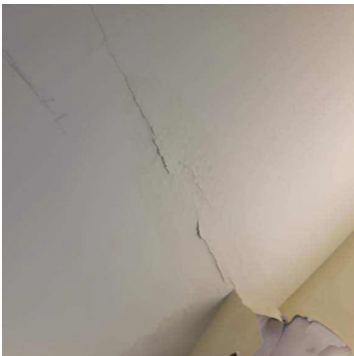
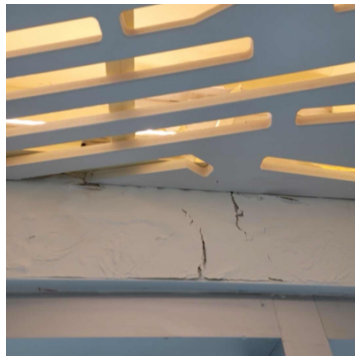
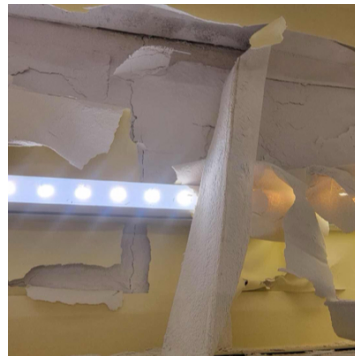
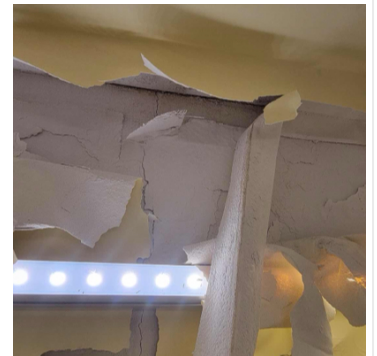
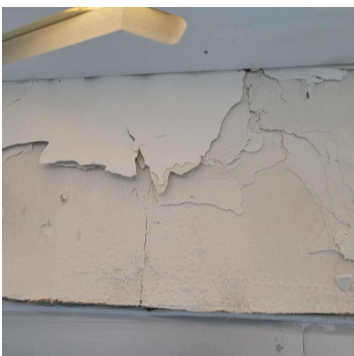
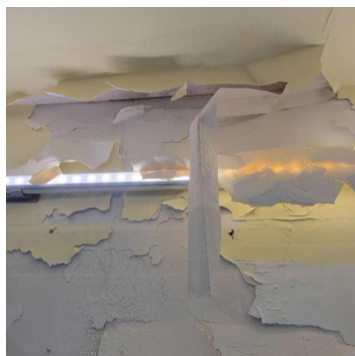
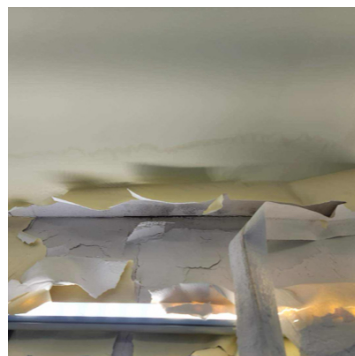
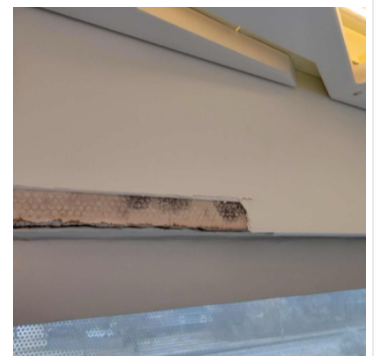
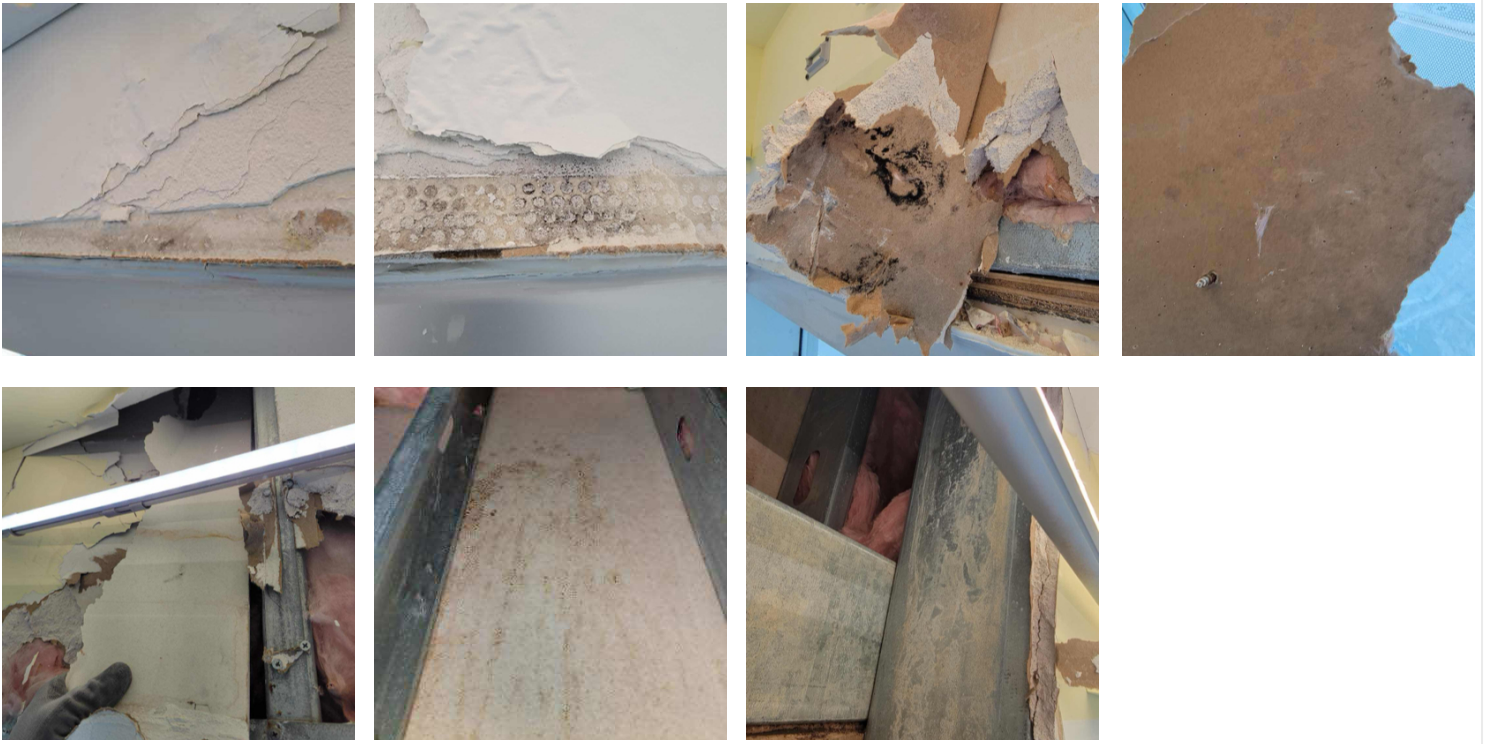
31. Second Floor - Southeast Corner: Study Room Remediation

Water damage was seen on wall and ceiling above windows in study room on Northeast corner of second floor, selective demo started at window height and followed any water signs or visible microbial growth. Visible microbial growth was seen after parts of drywall finish were removed.
