Date Tue 02/06/2024

Name	Description
Cavins Environmental	Cavins's technician arrived on site, suited up in proper PPE, changed all pre-filters in common and contained areas, temperature and humidity readings were recorded. Third floor stairwell wall, selective demo started. 149 Story time Phase two of cleaning with antimicrobial fog treatment was done. Microbial growth found on the third floor above the balcony.
Total

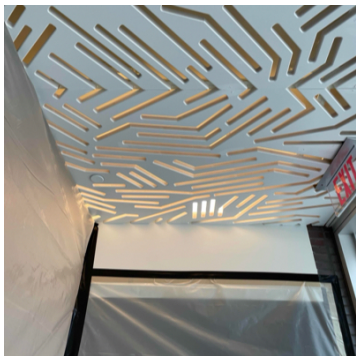
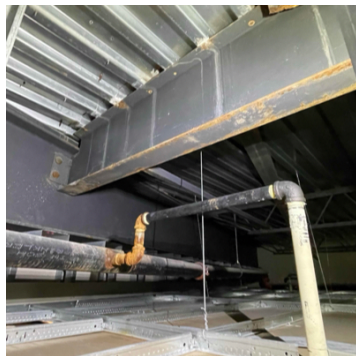
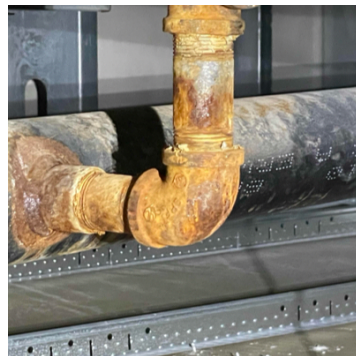
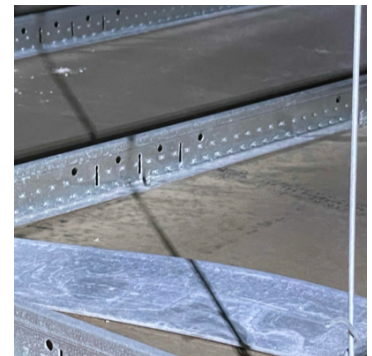
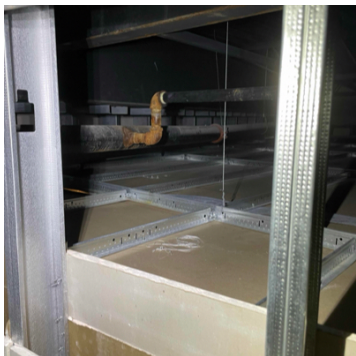
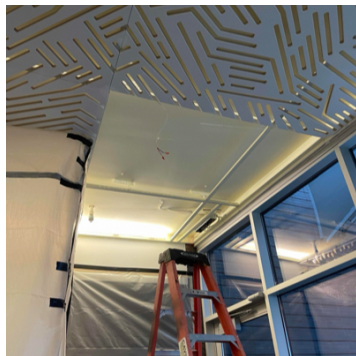
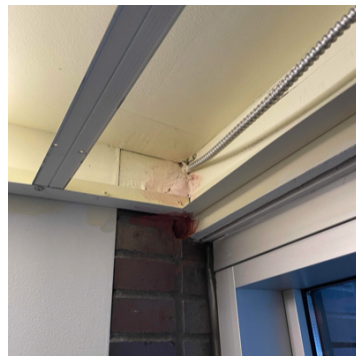
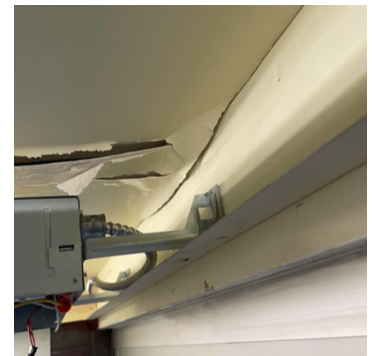
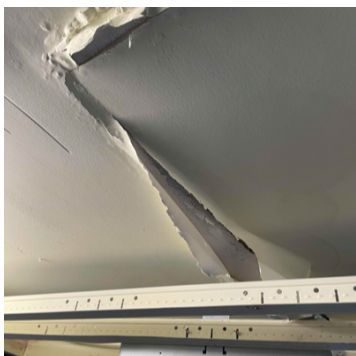
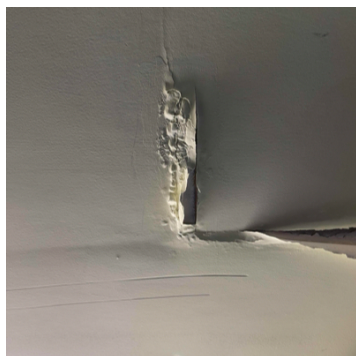
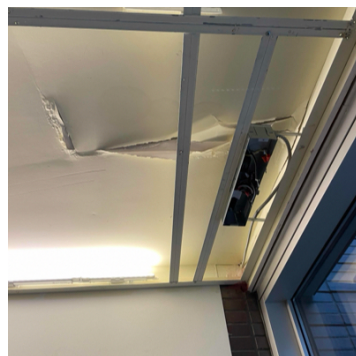
33. Third Floor - Stairwell Wall: Microbial Growth

Additional microbial growth found on sheetrock located above balcony door area.
