Date Sun 02/11/2024

Work Logs

Name	Description
Cavins Group Environmental	Completed fog treatment in stairwell, counted equipment, and changed all filters in the air scrubbers.
Total

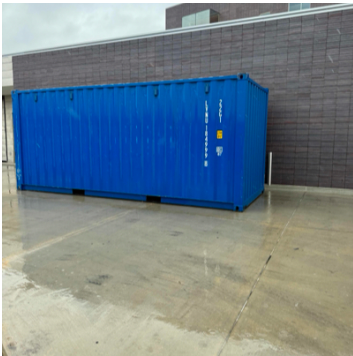
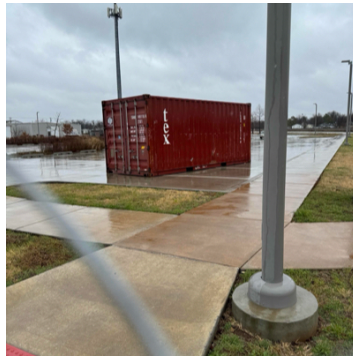
1. Exterior: Equipment
2 - 20' Job Conex

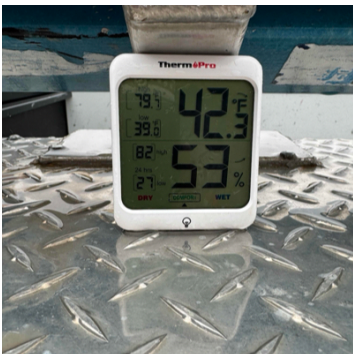
2. Exterior: Temperature And Humidity

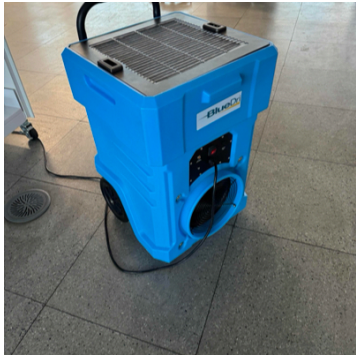
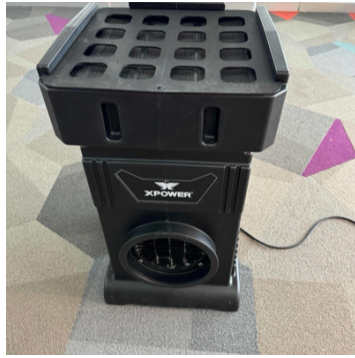
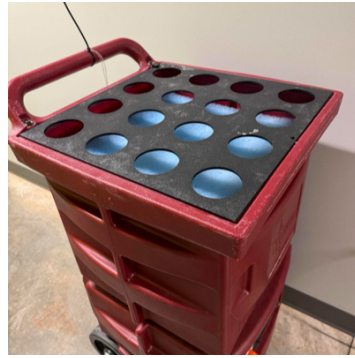
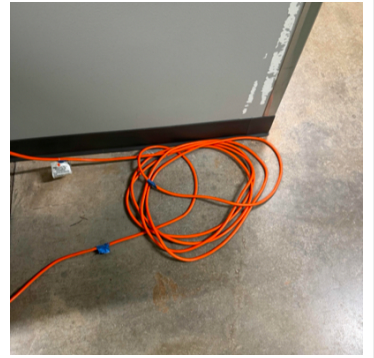
3. First Floor - Main Area: Equipment
3 - Air Scrubbers
1 - 25' Extension Cord

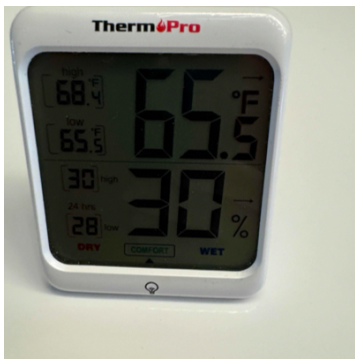
5. First Floor - Main Area: Temperature And Humidity

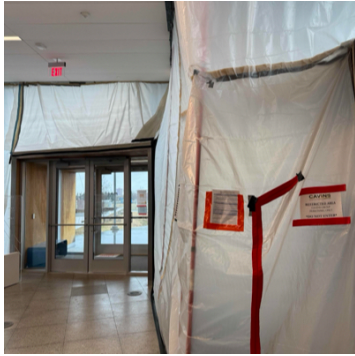
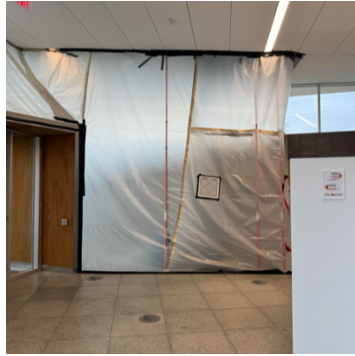
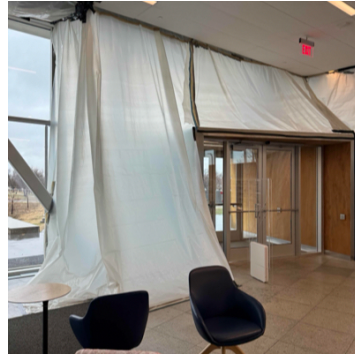
6. First Floor - Southwest Vestibule: Containment Upon Arrival/Departure

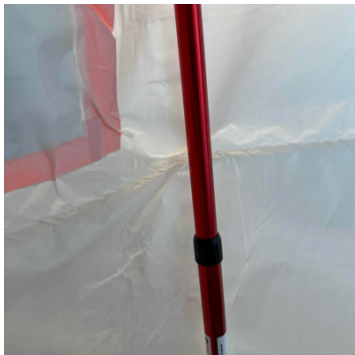
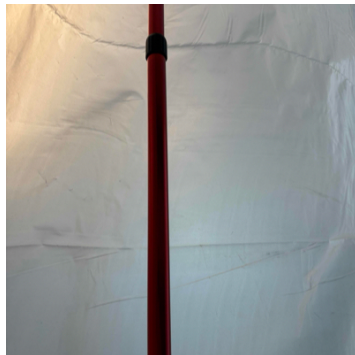
7. First Floor - Southwest Vestibule: Equipment
2 - Zip Posts

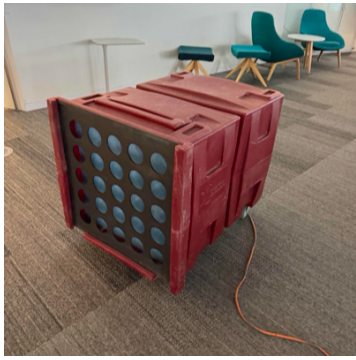
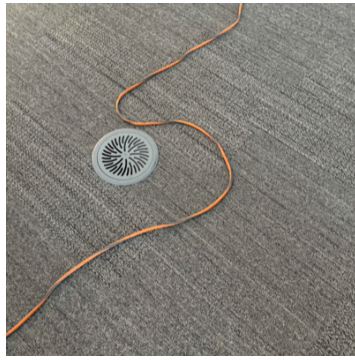
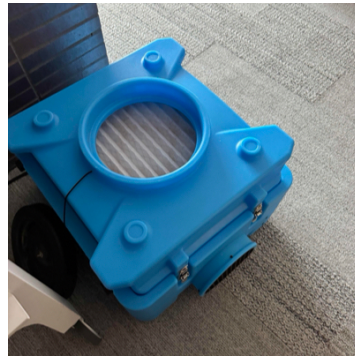
9. Second Floor - Main Area: Equipment

- 2 - Air Scrubbers
- 1 - 25' Extension Cord

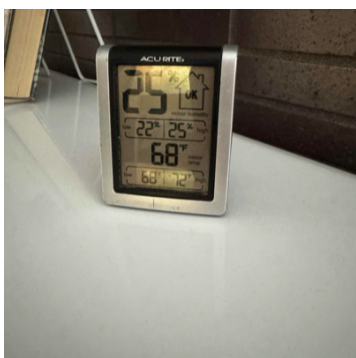
11. Second Floor - Main Area: Temperature And Humidity

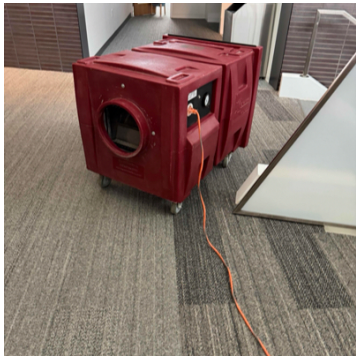
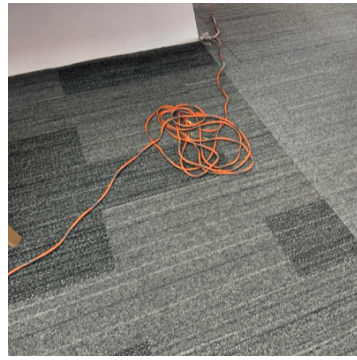
12. Third Floor - Main Area: Equipment

- 1 - Air Scrubbers
- 1 - 50' Extension Cord

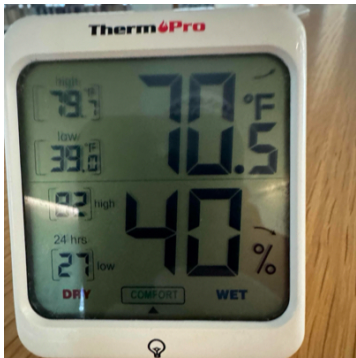
14. Third Floor - Main Area: Temperature And Humidity

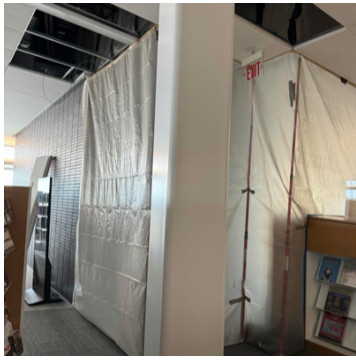
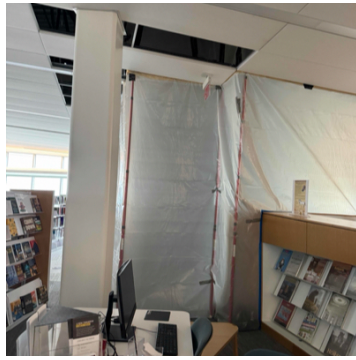
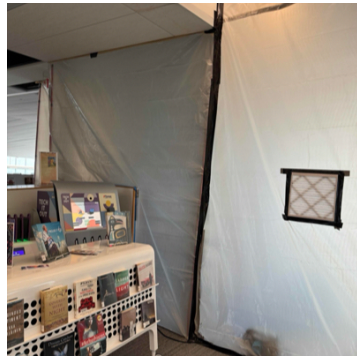
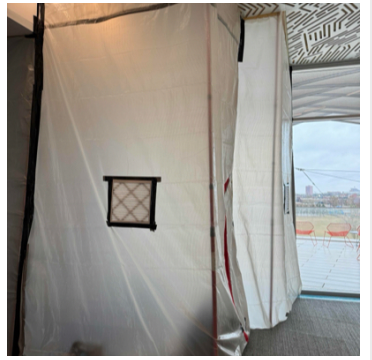
16. Third Floor - Stairwell Wall: Containment Upon Arrival/Departure

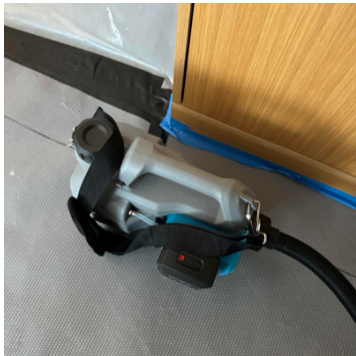
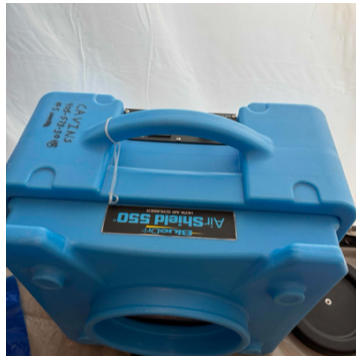
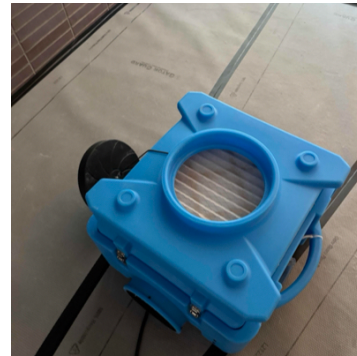
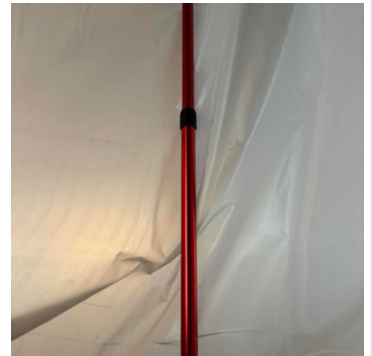
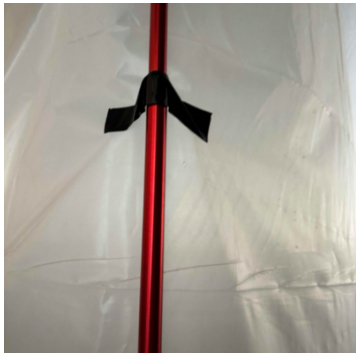
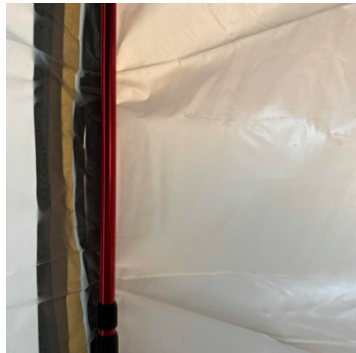
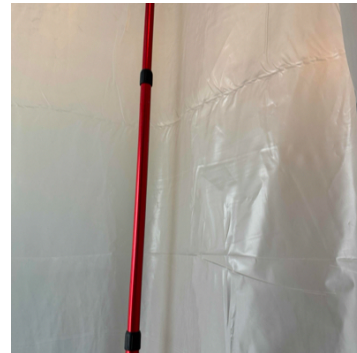
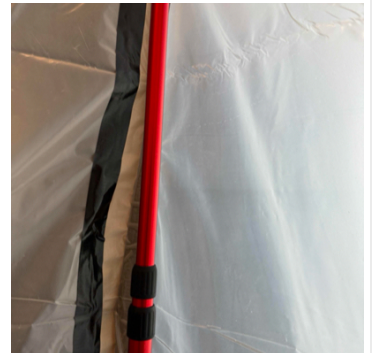
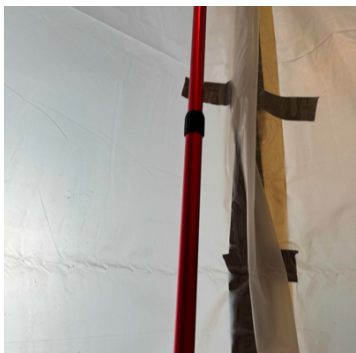
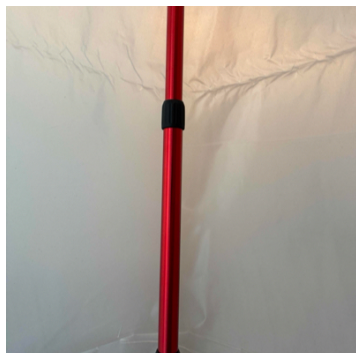
17. Third Floor - Stairwell Wall: Equipment
 7 - Zip Posts
 2 - Air Scrubbers
 1 - Fogger

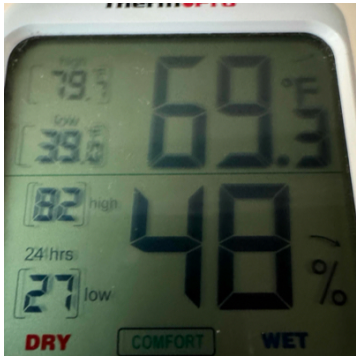
18. Third Floor - Stairwell Wall: Temperature And Humidity
