Date Sun 03/10/2024

Name	Description
Cavins Enviromental	Cavins technician arrived on-site and recorded temperature and humidity readings for the exterior, unaffected area, and affected area. Additionally, the technician took moisture and took thermal images. As needed, equipment was removed during the process. All readings have met the drying goal, resulting in the removal of equipment. The technician applied a biocide treatment to all affected areas.
Total

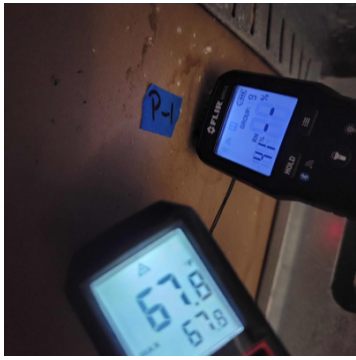
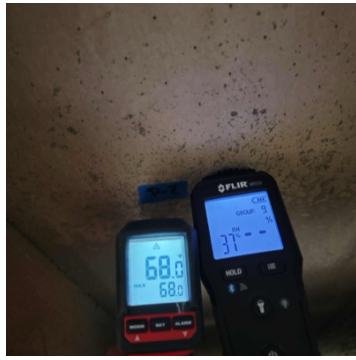
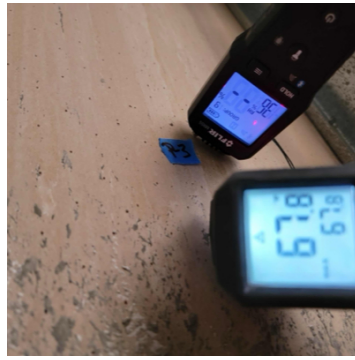
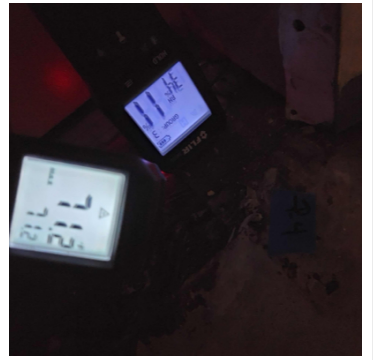
6. Stairwell- Moisture readings
All readings have dropped to drying goal

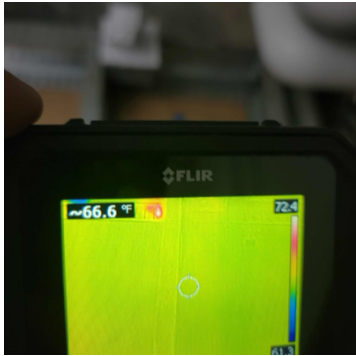
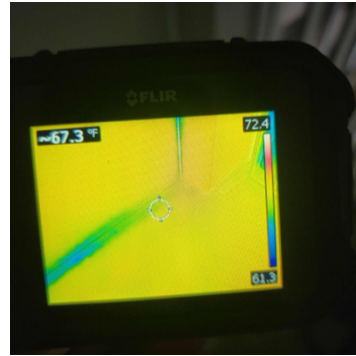
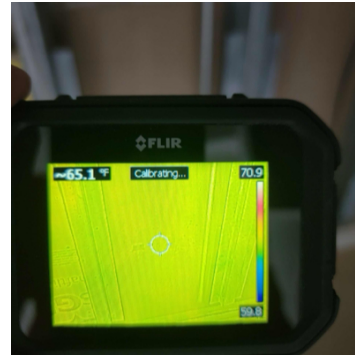
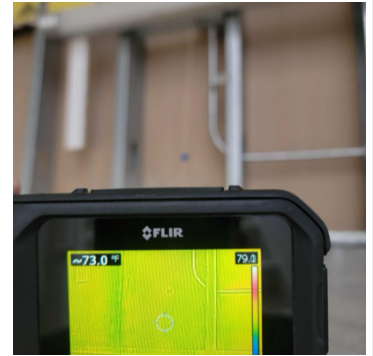
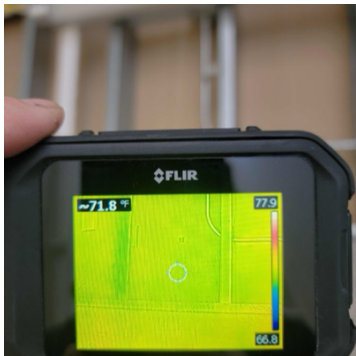
7. Stairwell - Thermal Imaging
Thermal Imaging shows no sign of moisture

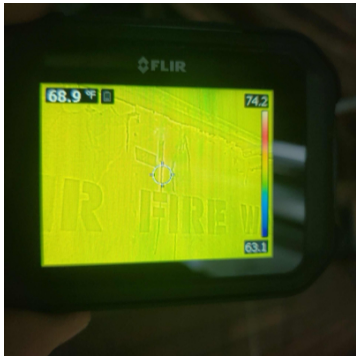
9. Third Floor - Stairwell wall: Thermal imaging
No signs of moisture
