Date Sat 03/09/2024

Name	Description
Cavins Environmental	Cavins Technician monitored drying Equipment, temperature and humidity. Drying standard was accomplished, and thermal images were taken to determine moisture content concentration within the structure.
Total

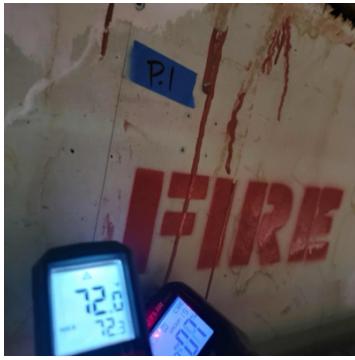
**10. Third Floor - Stairwell wall: Moisture Readings**

Moisture content returned to drying standard

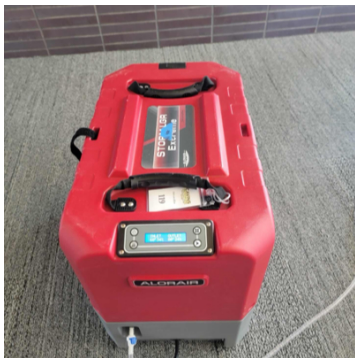
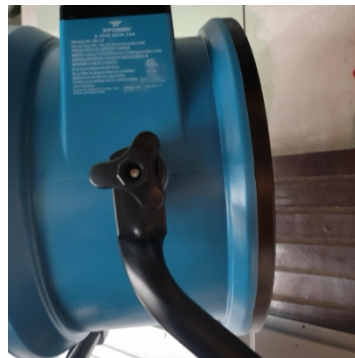
**12. Third Floor - Stairwell wall: Equipment**

- 1 - Axial Fan
- 1 - DHU

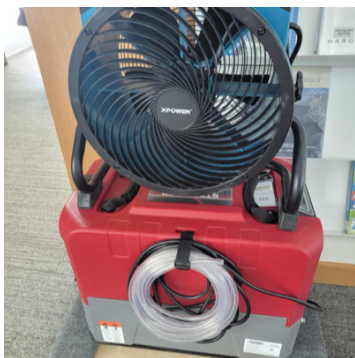
**13. Third Floor - Stairwell wall: Equipment Removed**

- 1 - Axial Fan
- 1 - DHU

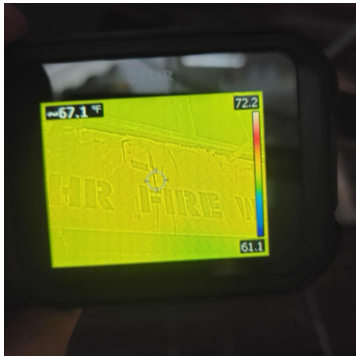
**14. Third Floor - Stairwell wall: Thermal imaging**

Thermal imaging shows no sign of moisture, moisture meter confirms

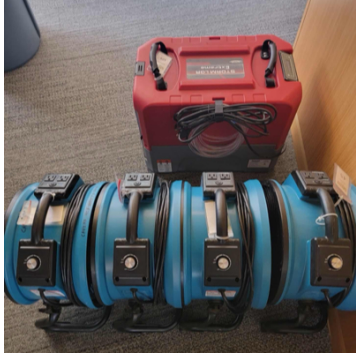
**15. Stairwell- Equipment Removed**  
4 - Axial Fans  
1 - DHU
