Date Fri 03/08/2024

Name	Description
Cavins Environmental	Cavins technician conducted a site inspection due to the fact of rainy weather the night before and the pertinent repairs not being performed yet. Thermal imaging, moisture readings and a visual assessment were done in all of the affected areas in order to determine possible water intrusion, upon arrival visible signs of water intrusion were noticed in the third-floor stairwell landing and opposing wall, drying equipment was set-up, and an antimicrobial biocide treatment was applied in all areas of concern.
Total

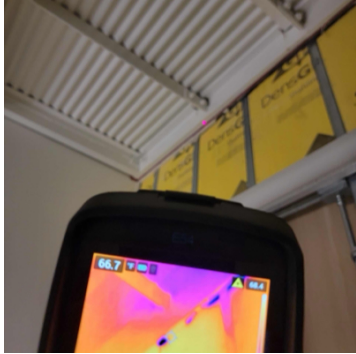
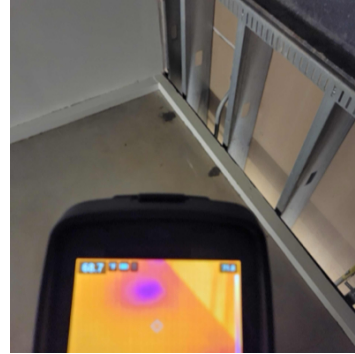
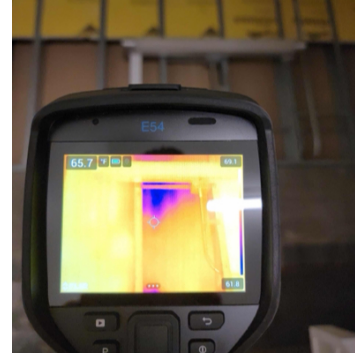
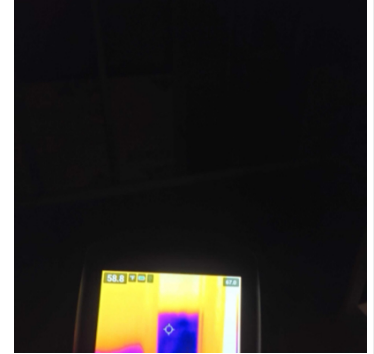
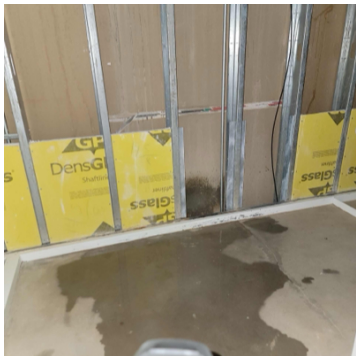
**15. Stairwell - Thermal Imaging**

Landing and wall behind interior brick wall has visible moisture.
