Date Sat 04/06/2024

## Work Logs

Name	Description
Cavins Environmental	Cavins technicians performed a visual and thermal inspection due to weather conditions. Signs of water intrusion were found in several areas of the library; however, the water content wasn't considerable enough for structural drying equipment to be set up.
Total

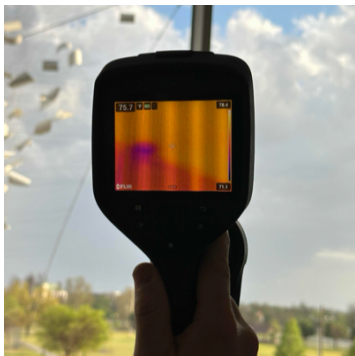
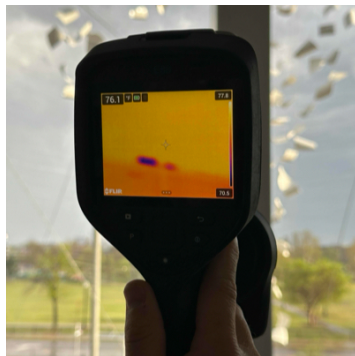
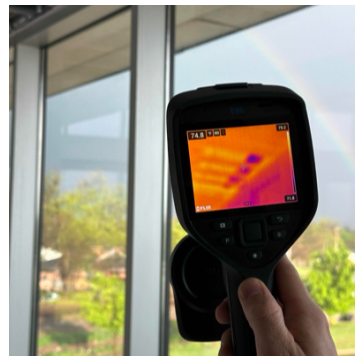
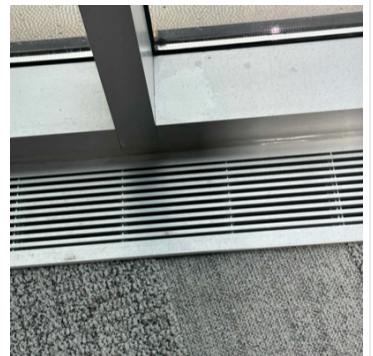
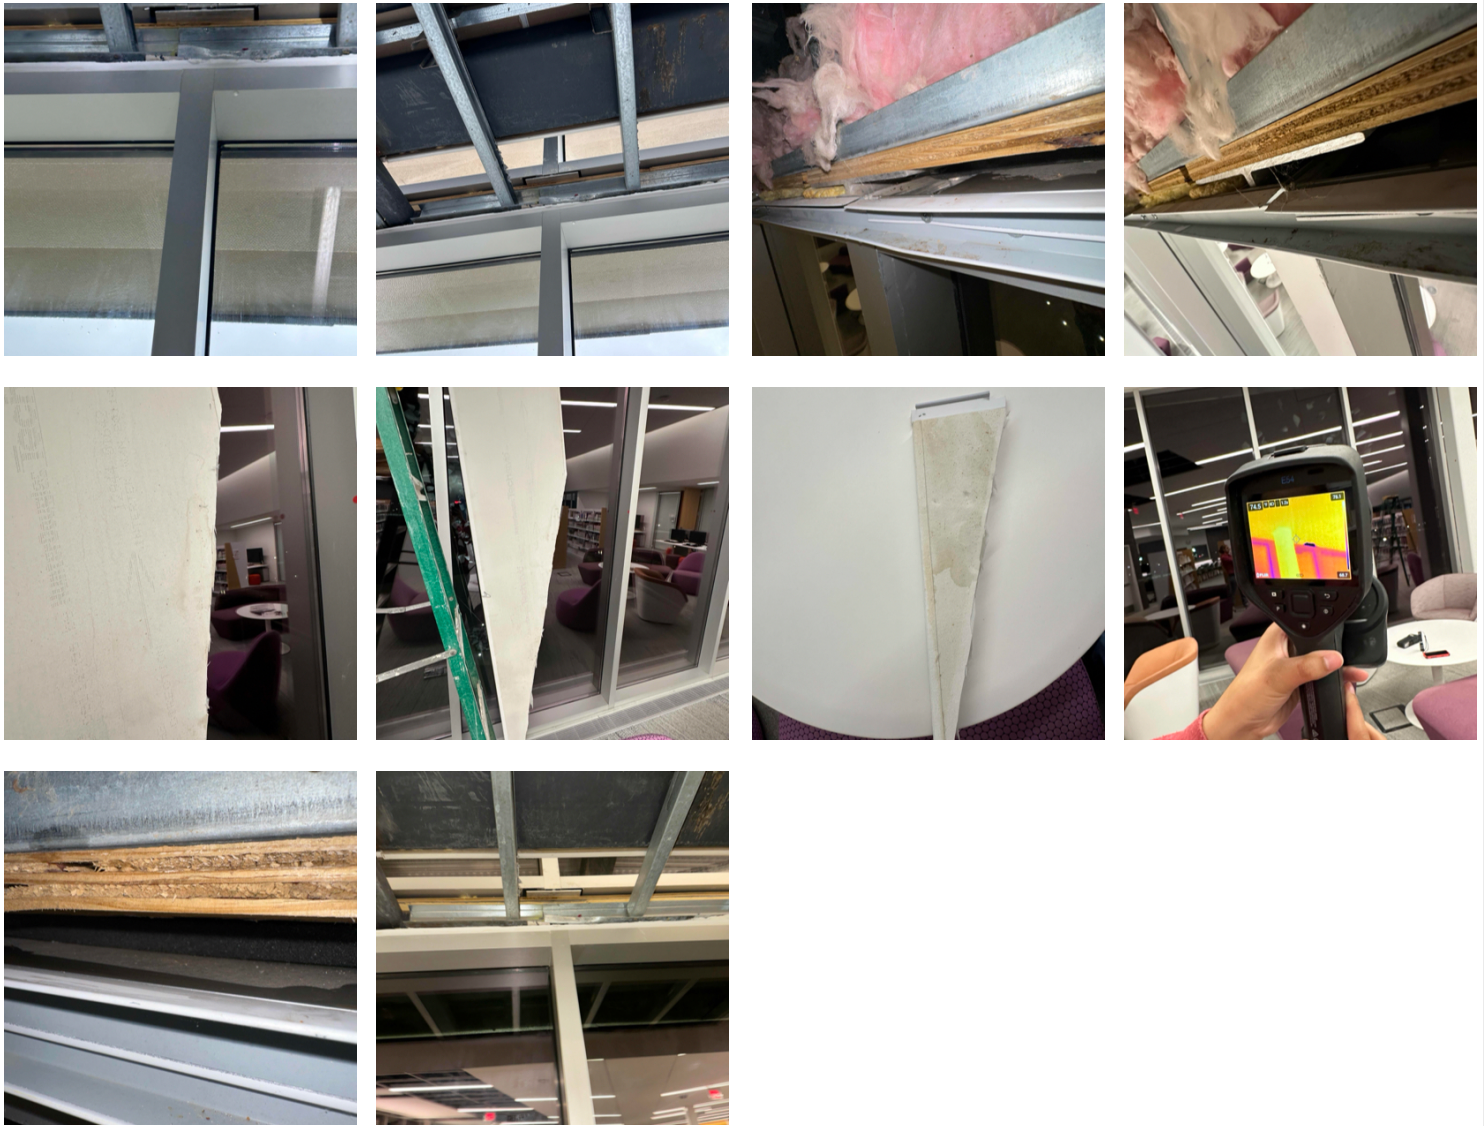
### 1. Second Floor - Common Area:

Water intrusion present by bay windows on the south side building, not enough water for structural drying equipment to be set.

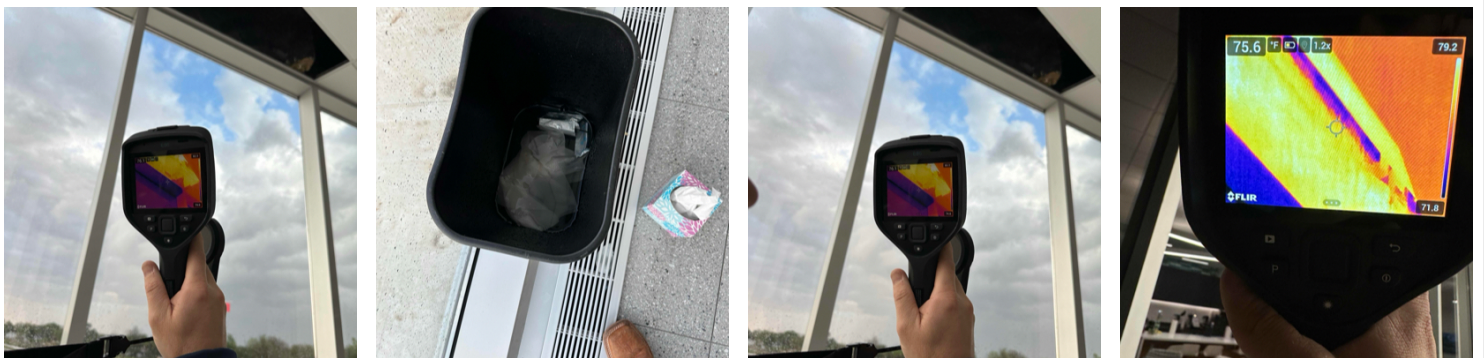
**2. Second Floor - Staff Kitchen:**

Cavins technicians removed the insulation from the far-left window on the North side of room and found that the insulation contained no moisture. Insulation was bagged to be removed, however there were about two gallons of water collected on a trashcan placed below leak.

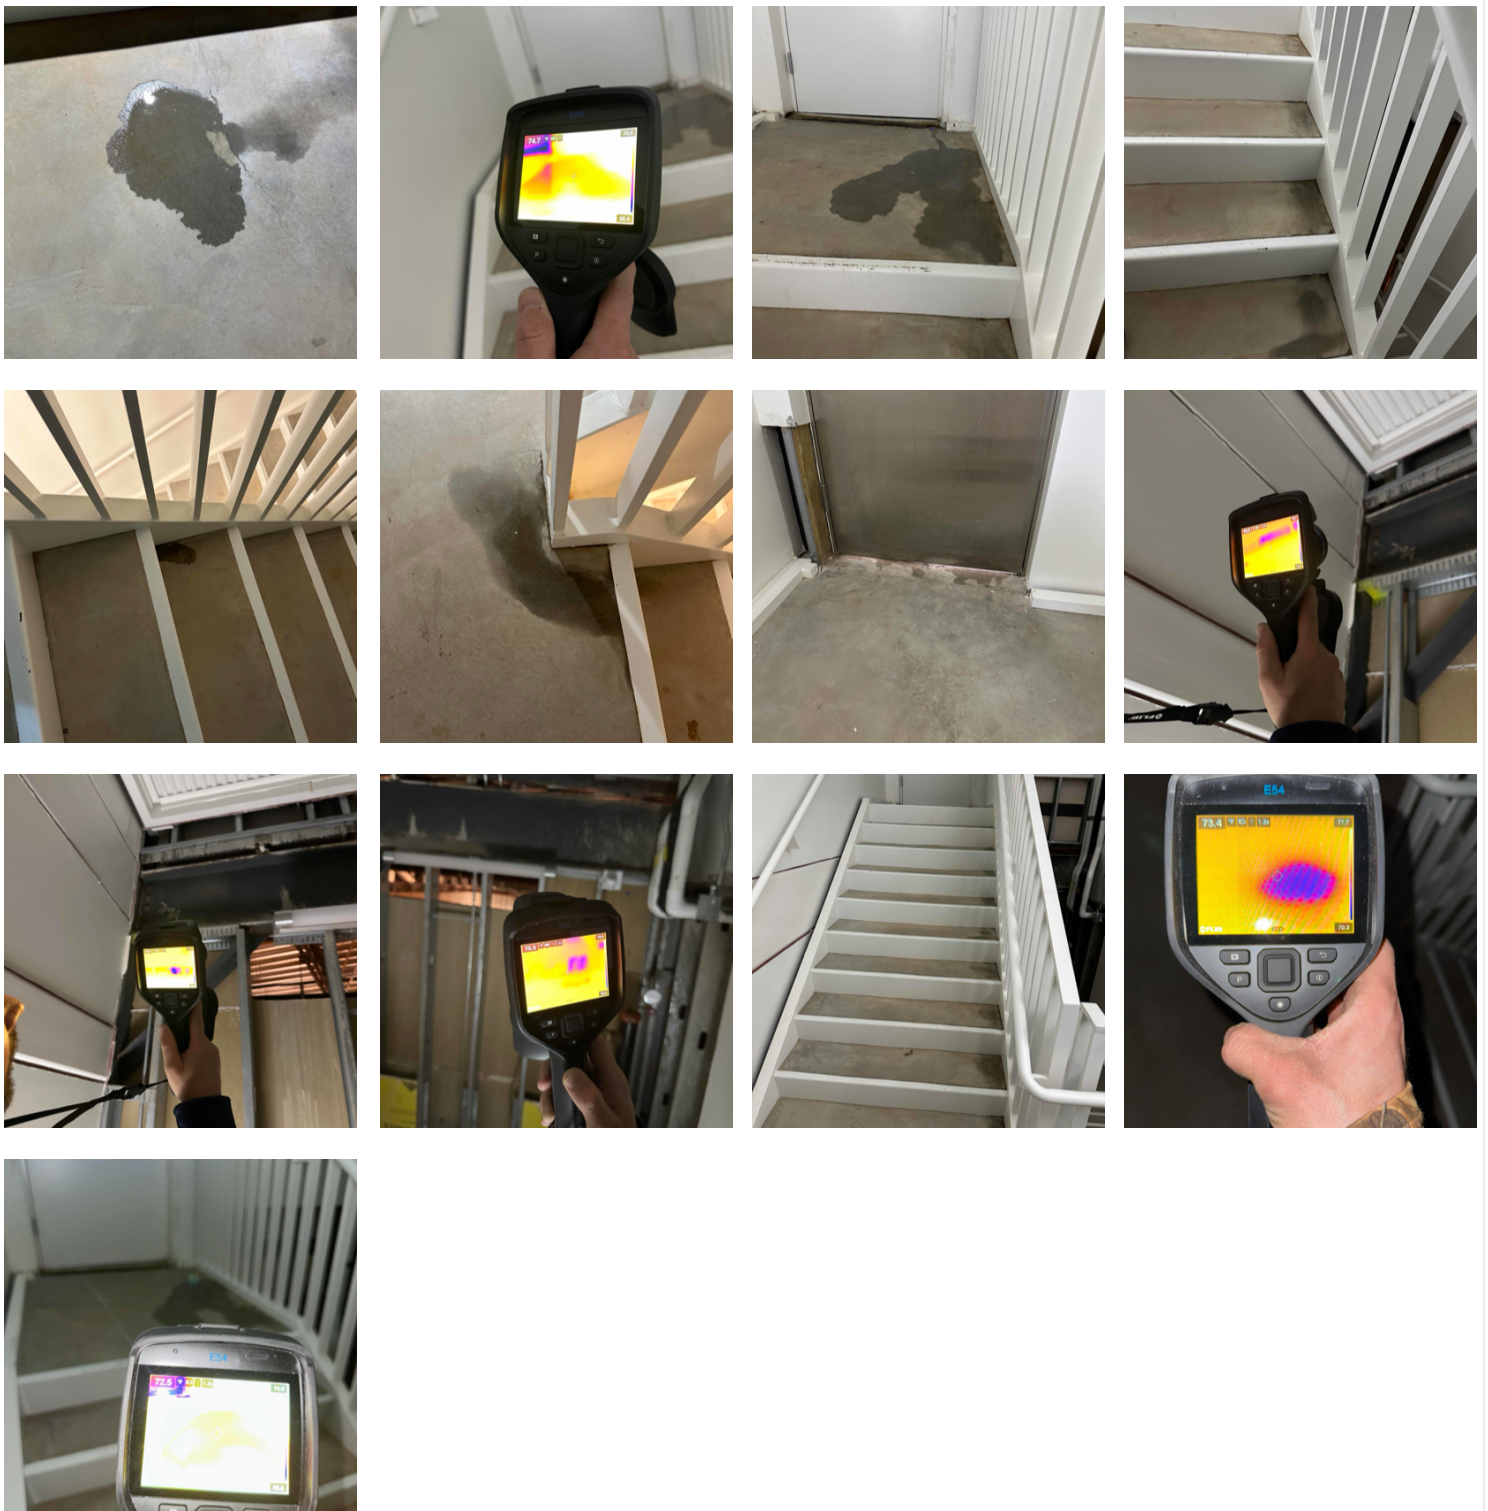
**3. Stairwell:**

Signs of water intrusion were found on the fourth-floor landing by the roof top access door.

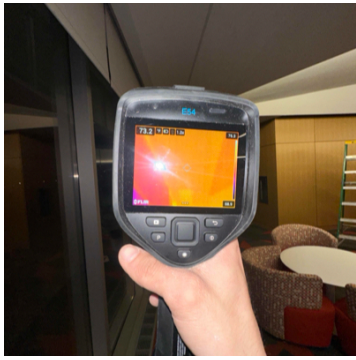
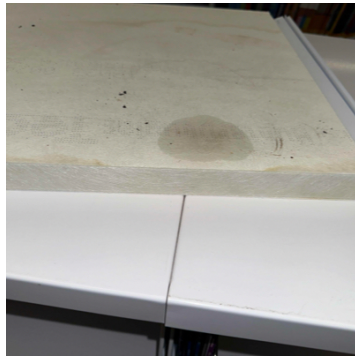
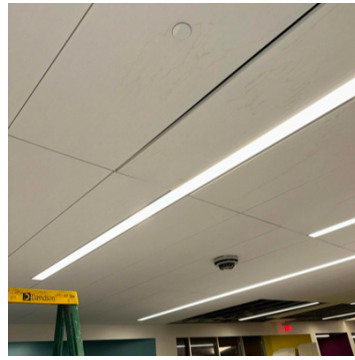
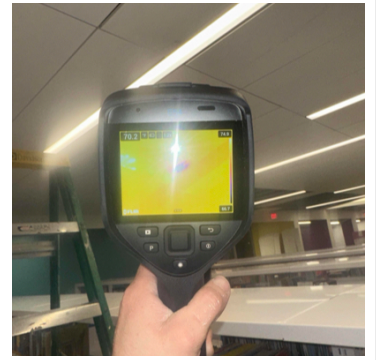
**4. First Floor - Children's Area:**

Water intrusion signs were found on ceiling tiles underneath the green roof and above bay windows on the south side of the building.

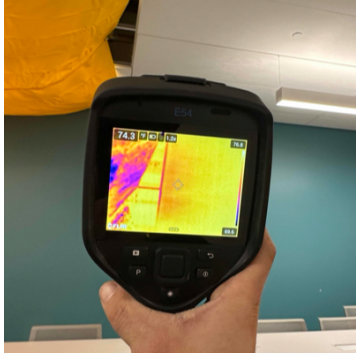
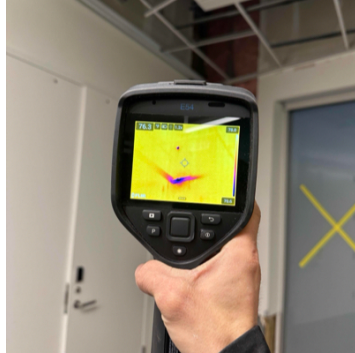
5. 305 - Pioneer:

Water intrusion signs were found on the SW corner of the ceiling grid.
