Date Wed 04/03/2024

Name	Description
Cavins Enviromental	Cavins technicians performed air quality testing in all common areas and areas of concern. Temperature and humidity readings were recorded. A bulk sample was taken from Room 301 - Oklahoma, and a tape lift was taken from Room 115. Containment was set up outside Room 301 - Oklahoma as a measure to mitigate cross-contamination.
Total

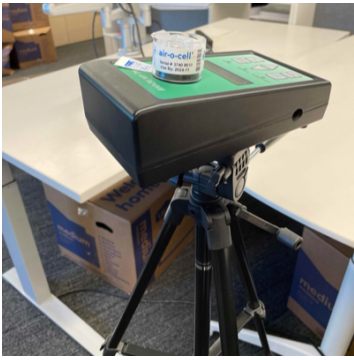
### 2. 115 Air Quality Testing:

A spore trap sample was taken.

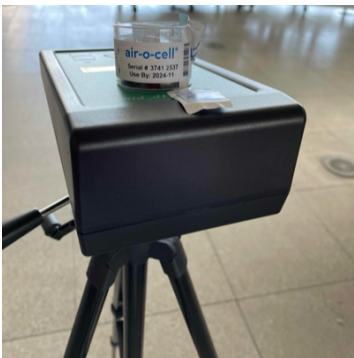
**4. First Floor Air Quality Testing:**

A spore trap sample was taken.

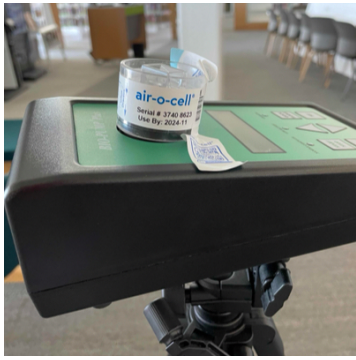
**6. Second Floor Air Quality Testing:**

A spore trap sample was taken.

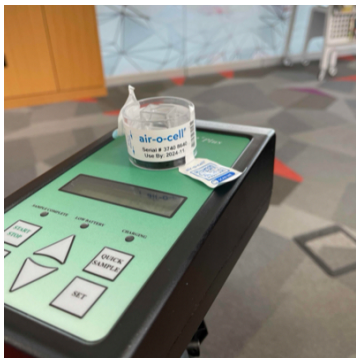
**8. Children's Area Air Quality Testing:**

A spore trap sample was taken.

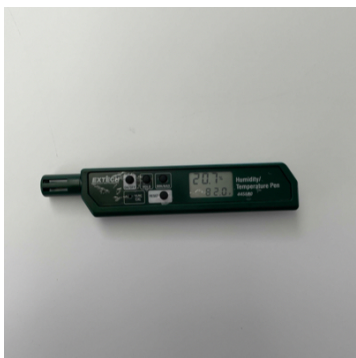
**9. Third Floor:**

Temperature and humidity.

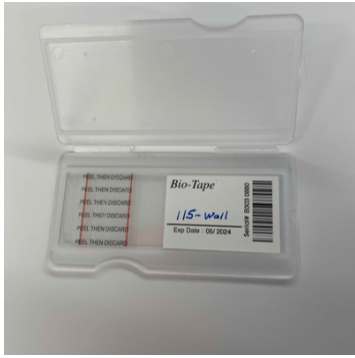
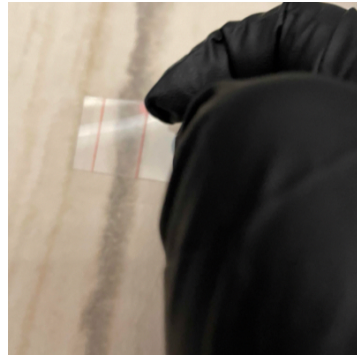
**11. 115:**

Cavins technicians inspected wall cavities and there were no visible signs of water intrusion or microbial

A tape sample was taken.

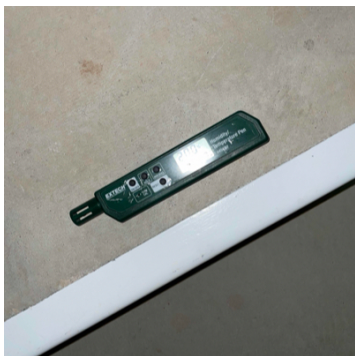
**12. Stairwell:**

Temperature and humidity.

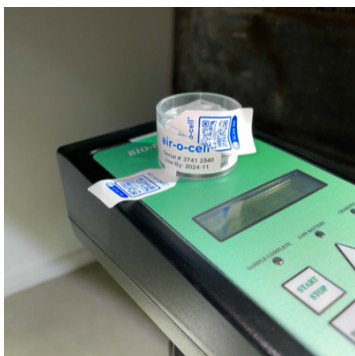
**13. Stairwell Air Quality Testing:**

A spore trap sample was taken.

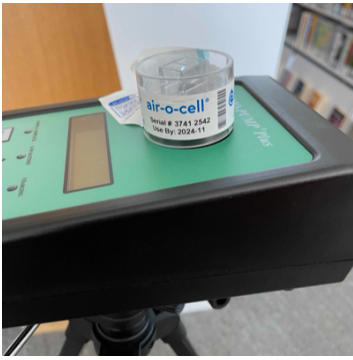
**14. Third Floor Air Quality Testing:**

A spore trap sample was taken.

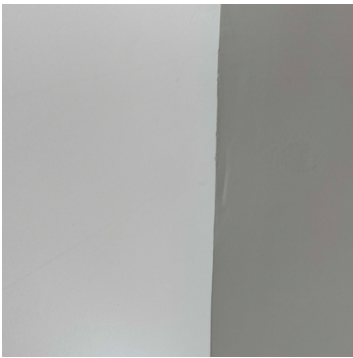
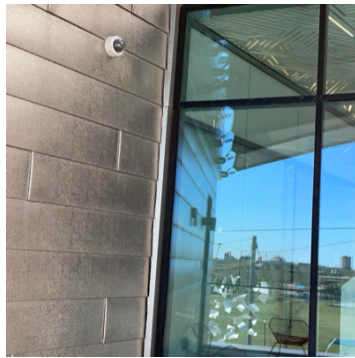
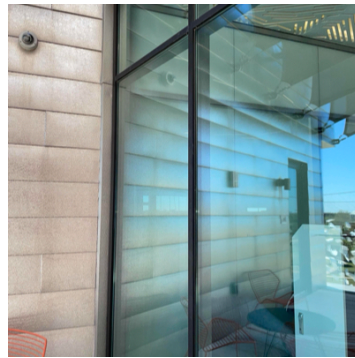
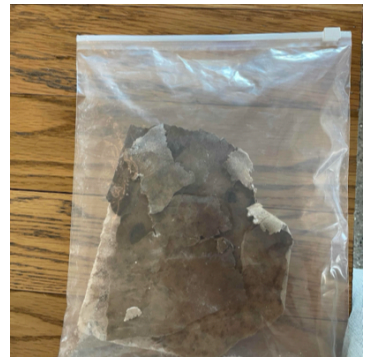
**17. Third Floor:**

Cavins technicians inspected the area and found that in room 301 Oklahoma there was water damage to the paint/drywall. It is recommended to cut the compromised drywall out or do a wall puncture.

Note: A bulk sample was taken.

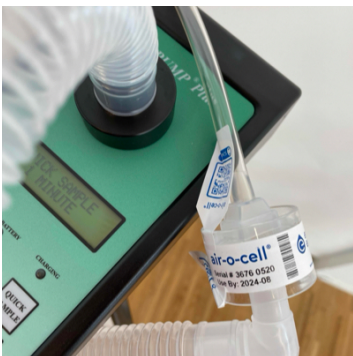
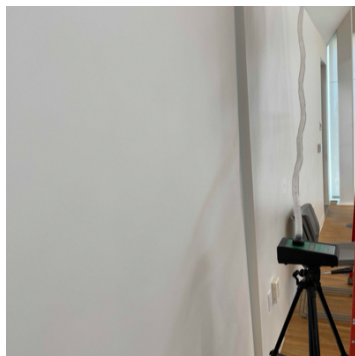
**18. 301 - Oklahoma - Air Quality Testing:**

A spore trap sample (wall puncture) was taken.

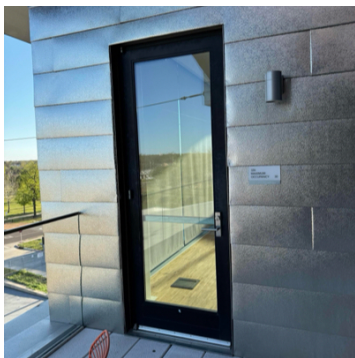
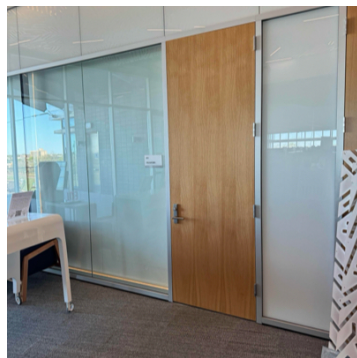
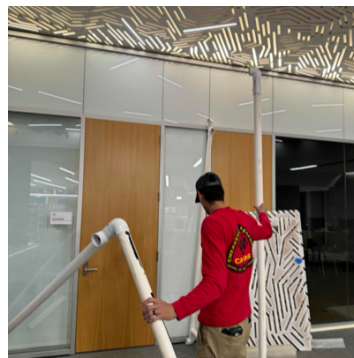
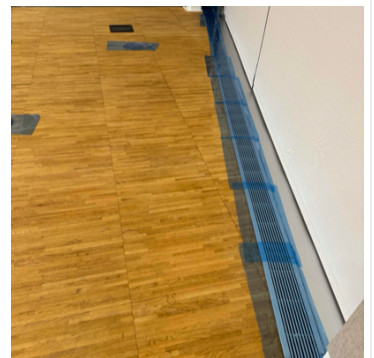
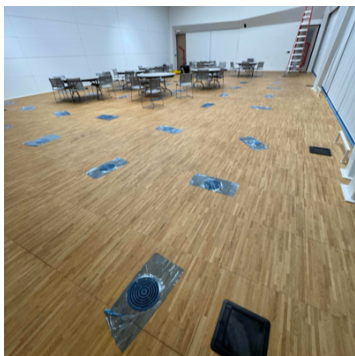
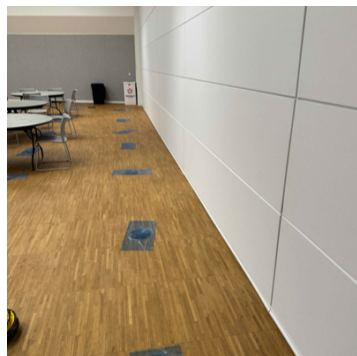
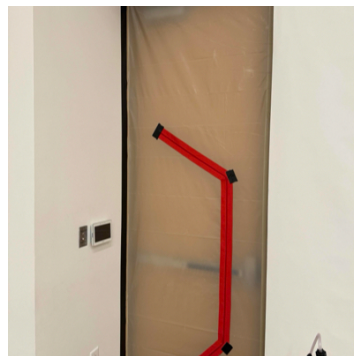
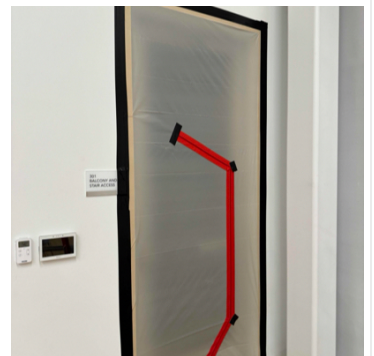
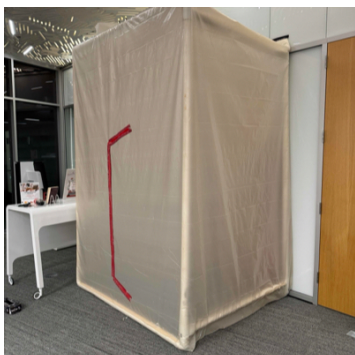
22. 301 - Oklahoma:

Containment and a changing room/chamber were built over main access points in room 301.

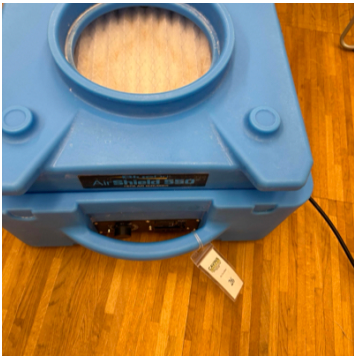
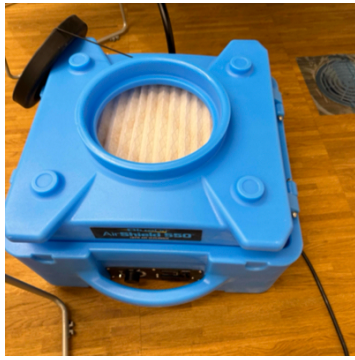
23. 301 - Oklahoma - Equipment count:

2 Air Scrubbers.
