Date Tue 04/02/2024

Name	Description
Cavins Environmental	A Cavins technician conducted a site inspection on all three floors and the stairwell of the building due to the rainy weather the previous day. This inspection also included areas where successful remediation had been performed previously. The technician used thermal imaging and visual inspection techniques, which did not reveal any signs of water intrusion, except for the stairwell on the landing by the roof access door. As a preventative measure, a biocide was applied in the stairwell area and in the children's area due to a musty smell.
Total

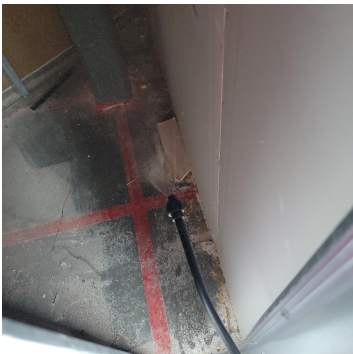
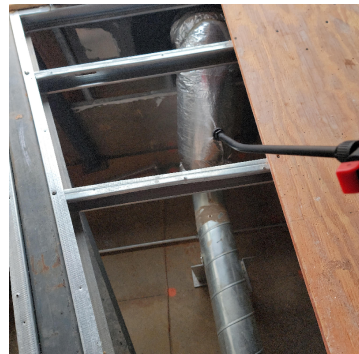
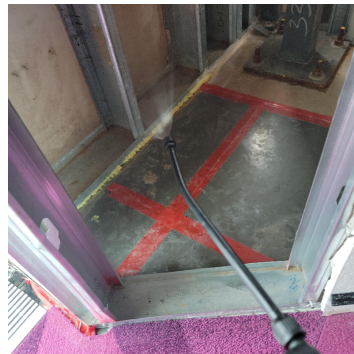
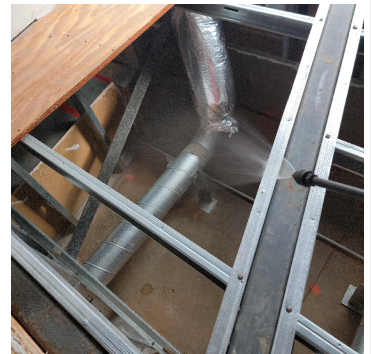
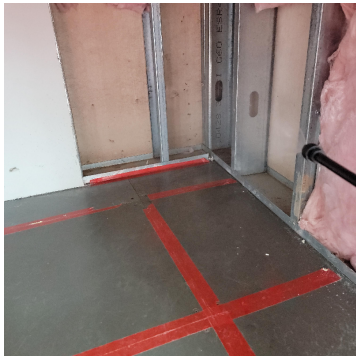
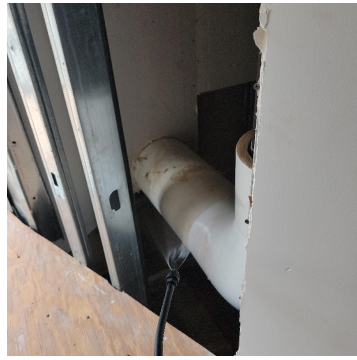
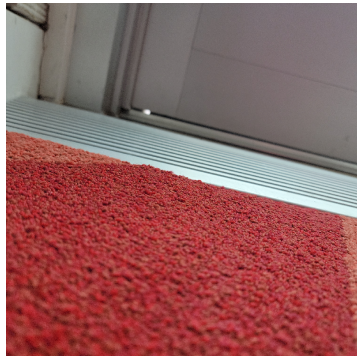
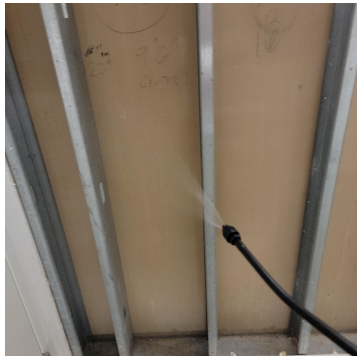
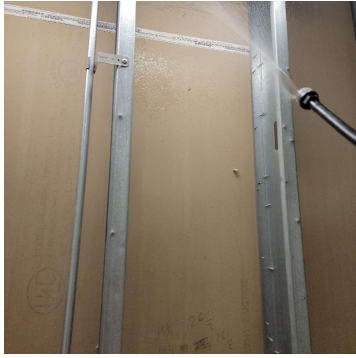
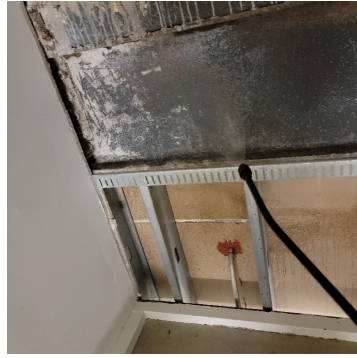
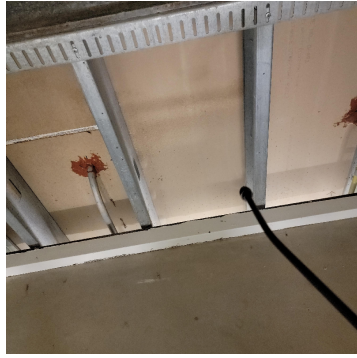
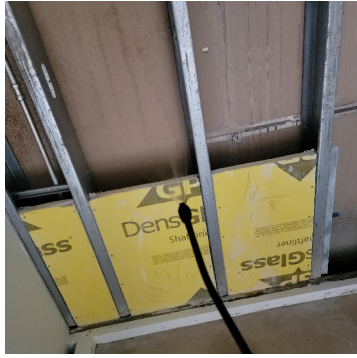
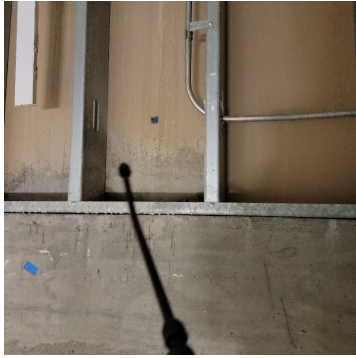
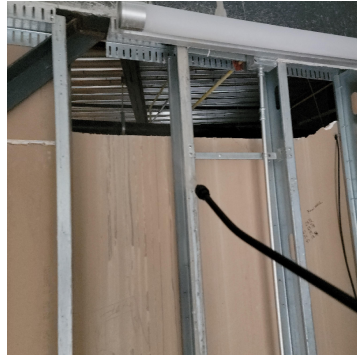
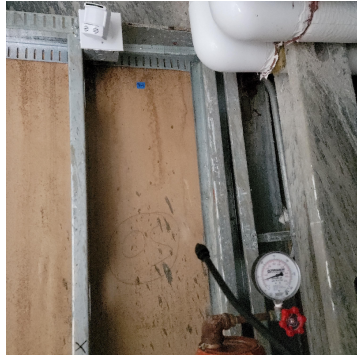
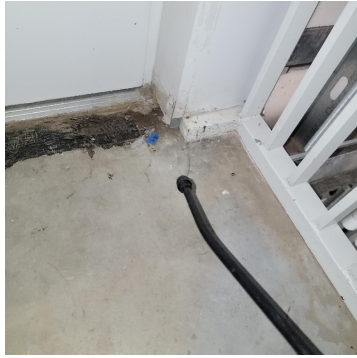
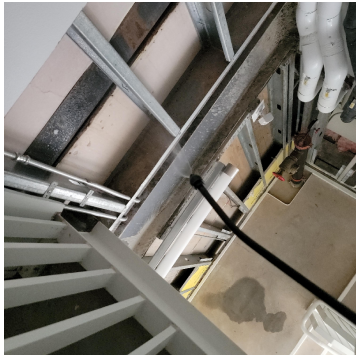
### 1. Biocide:

A biocide treatment was applied in the children's area and on the second and third floor landings of the stairwell as a preventative measure against future microbial growth.

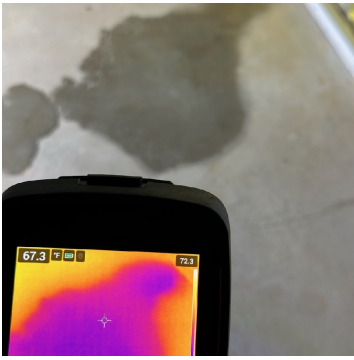
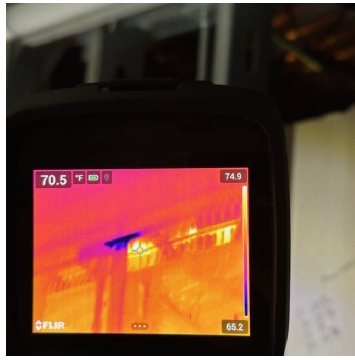
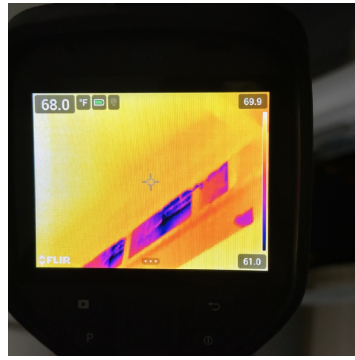
**2. Stairwell:**

A small puddle was noticed in the stairwell.
