Date Sun 08/11/2024

Name	Description
Cavins Environmental	On Sunday, August 11, 2024, Cavins Group monitored the Norman Public Library-Central after continuous hours of directional rain began early in the morning and continued intermittently throughout the day. Several affected areas were identified both visually and with the use of a thermal camera. Moisture readings were taken as needed, along with temperature, humidity, and drying standards, to set up structural drying equipment.
Total

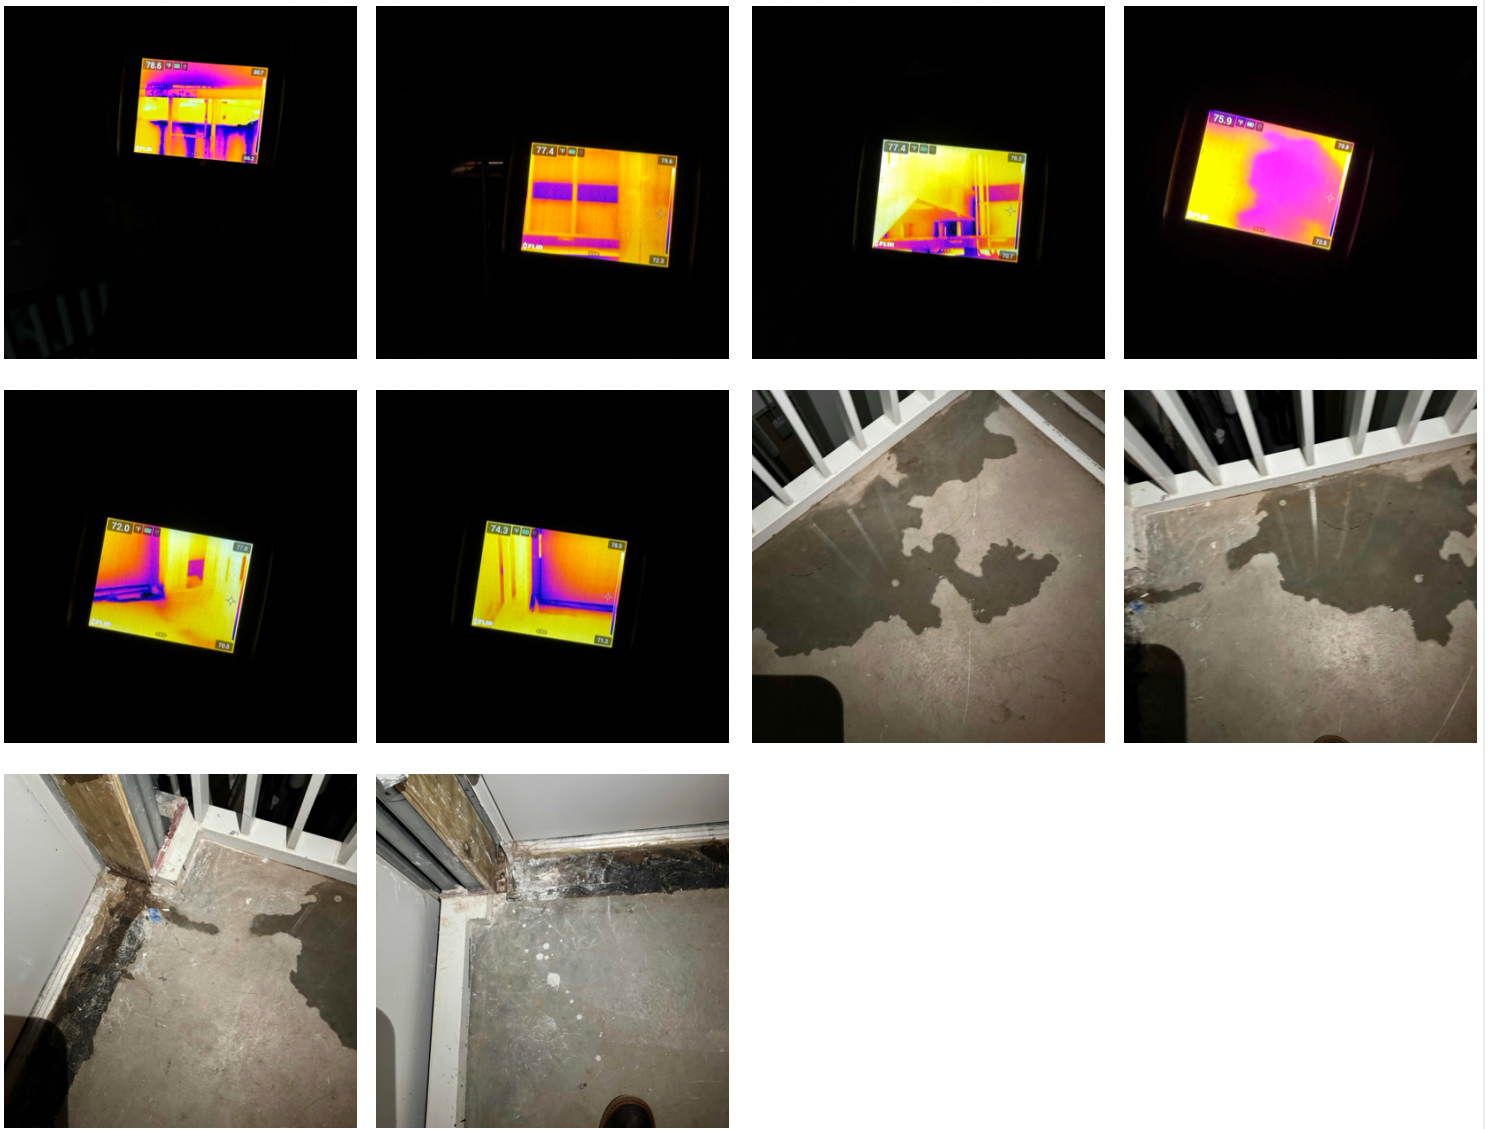
1. Stairway:

Thermal imaging and visual inspection show signs of residual water on all four stories and each landing facing north, as well as on the drywall.

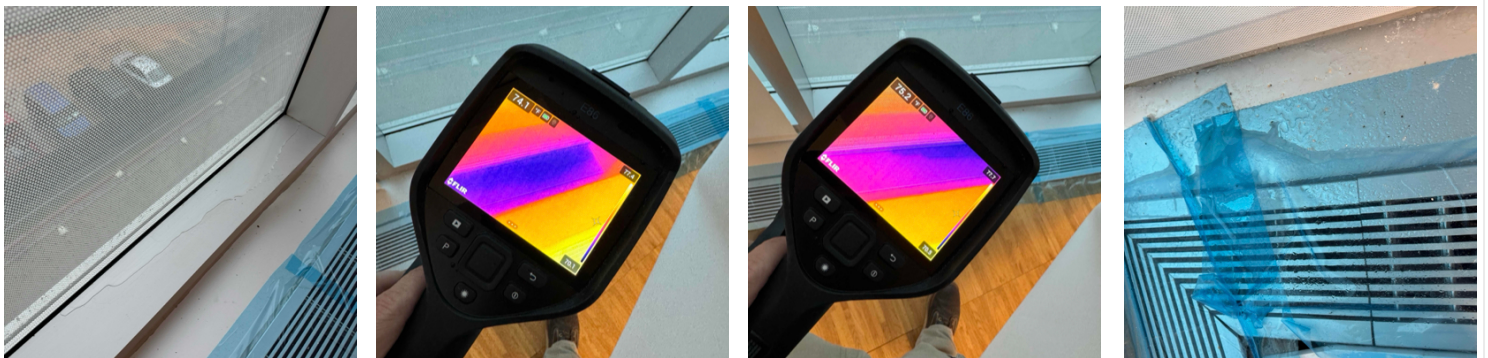
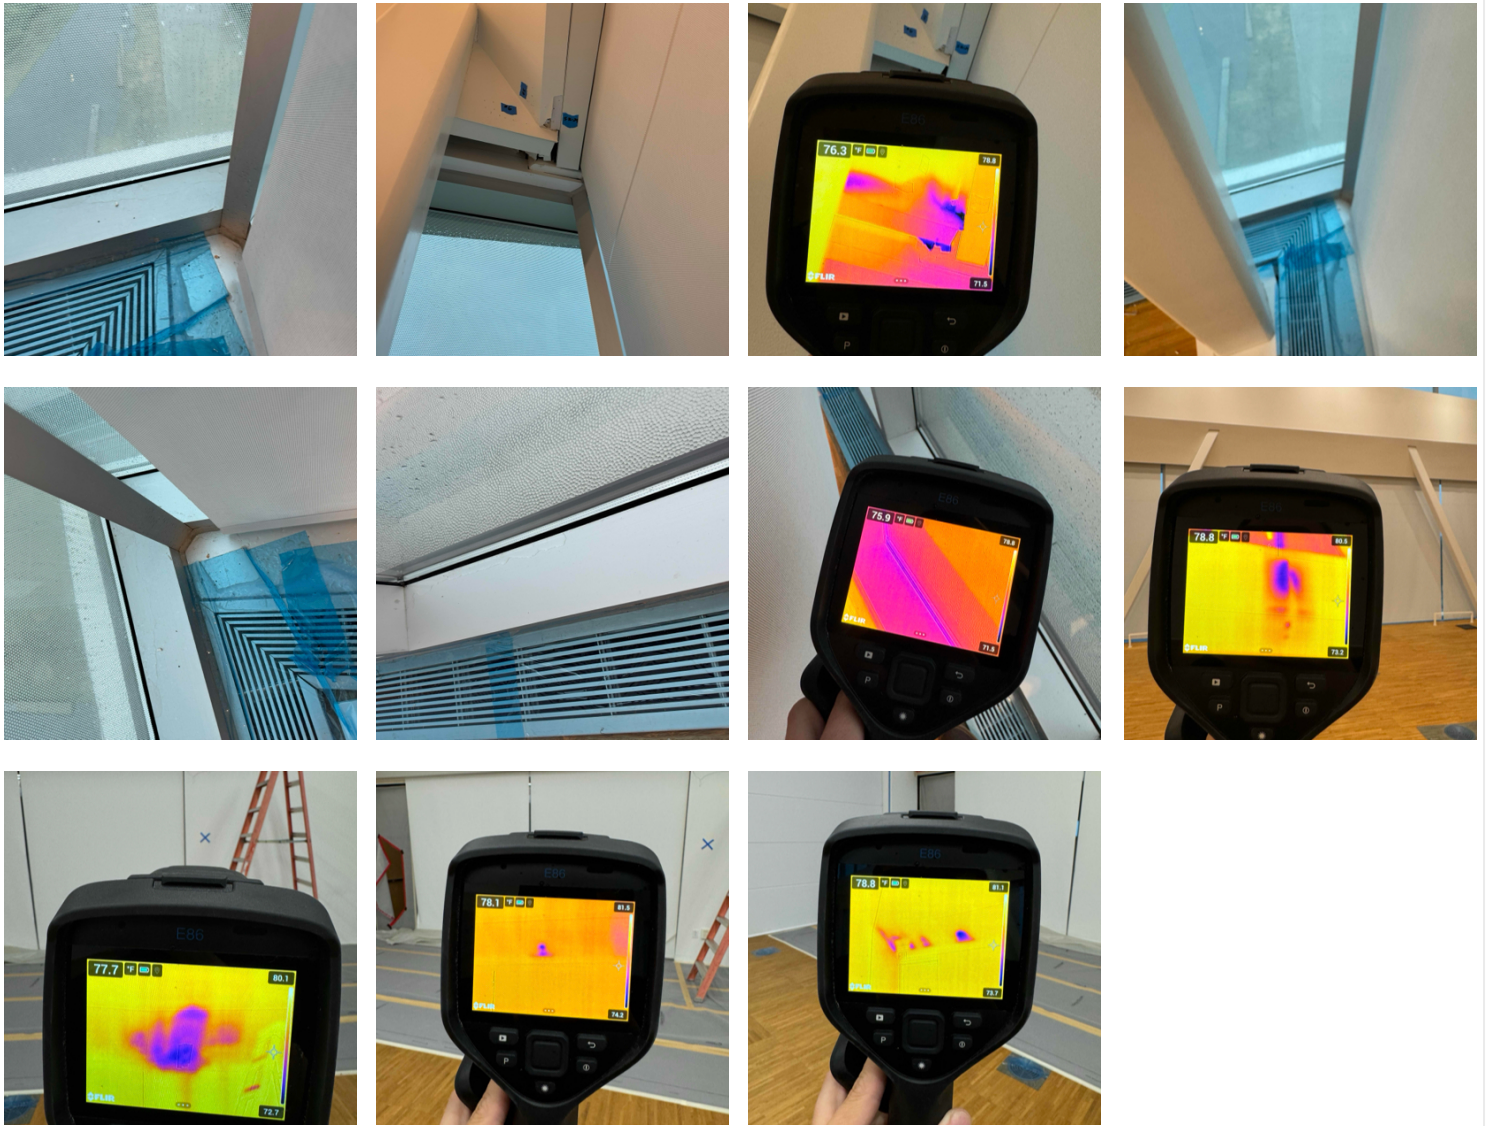
2. Oklahoma-301:

Thermal imaging and visual inspection show signs of residual water on windows facing west as well as on the drywall above the windows facing south.

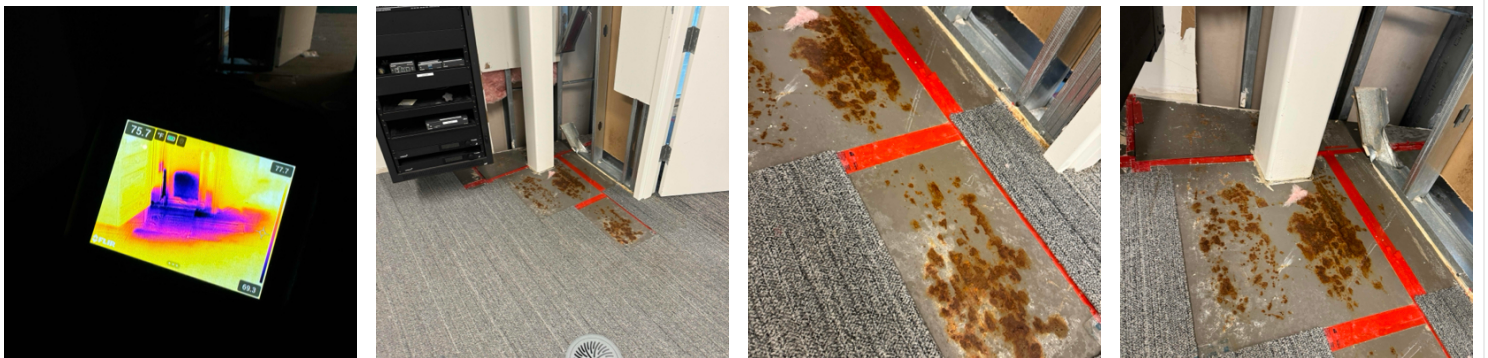
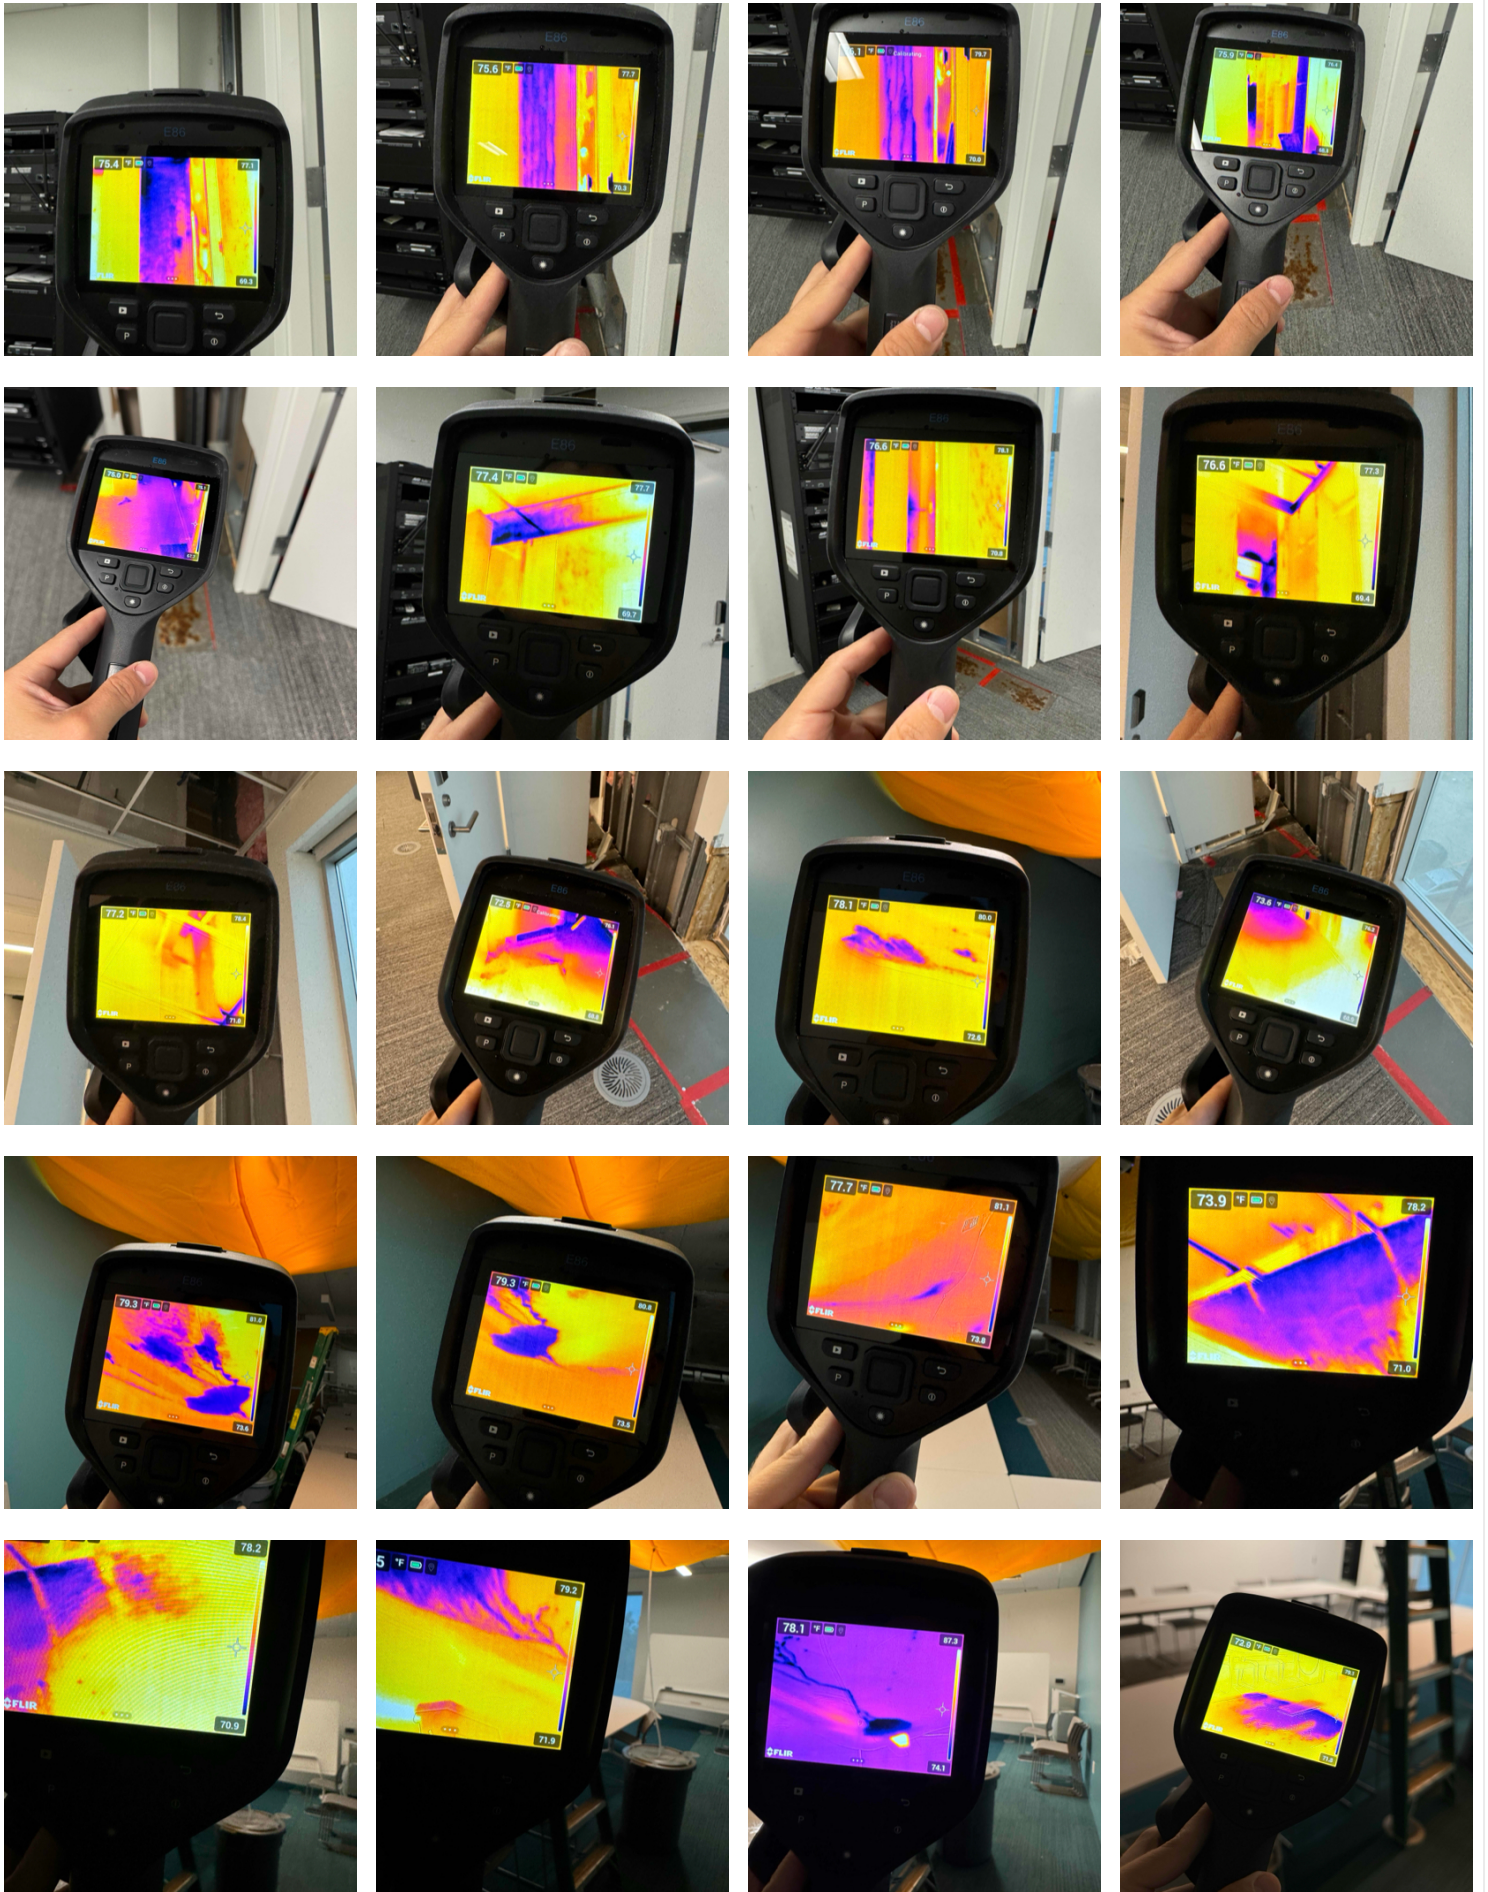
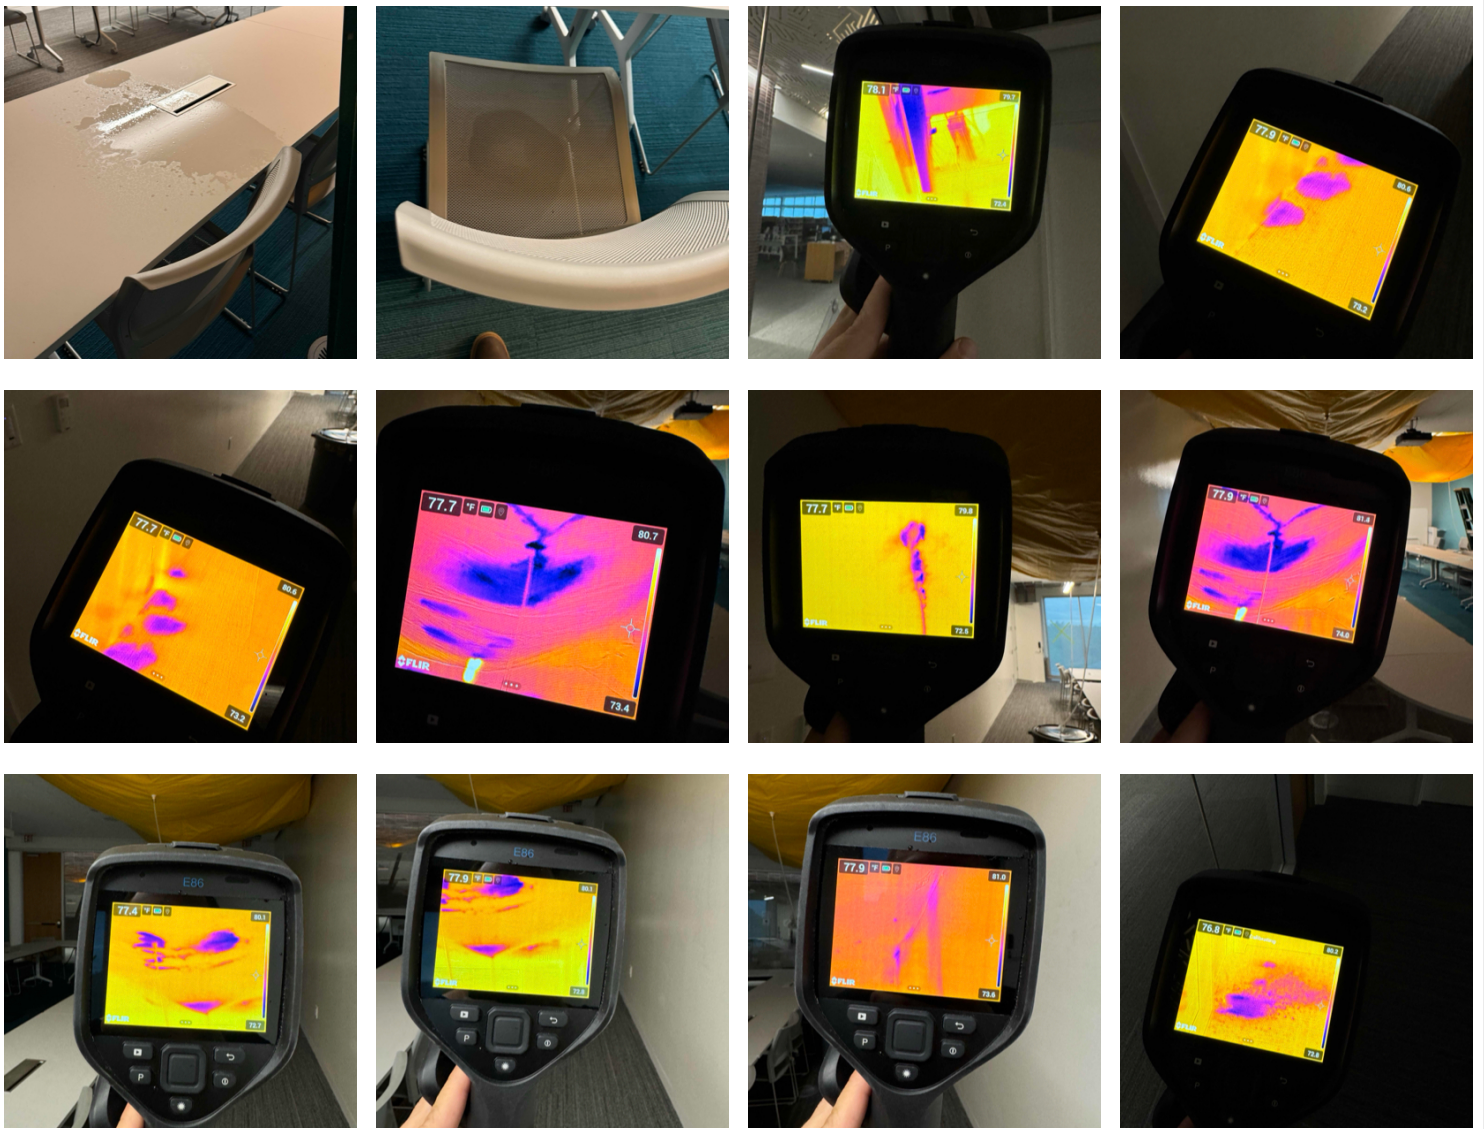
3. Pioneer-305:

Thermal imaging and visual inspection show signs of residual water on floors, desks, couple ceiling tiles as well as on the diversion tarps.

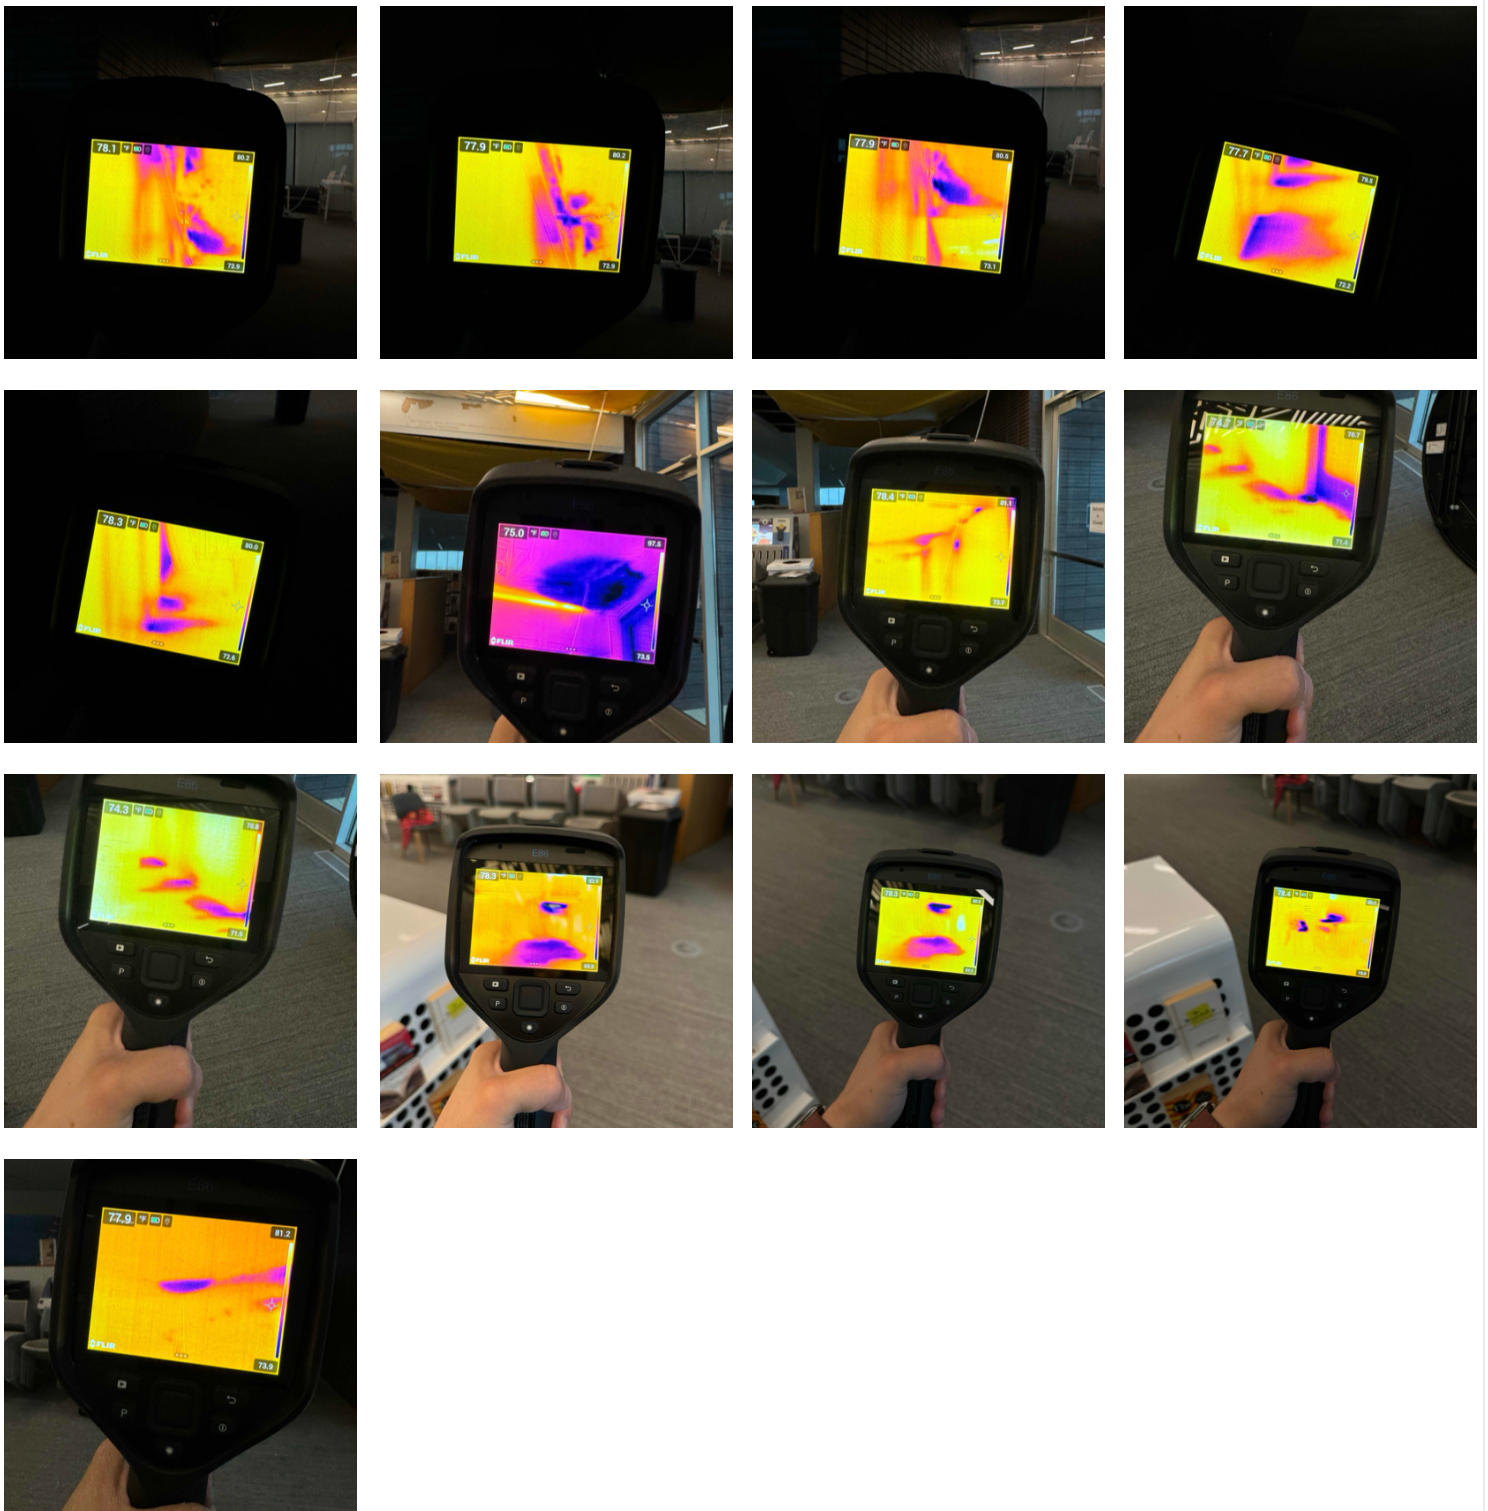
8. Third floor common area:

Thermal imaging and visual inspection show signs of residual water on diversion tarps and on several spots along the carpeted floors and furniture.

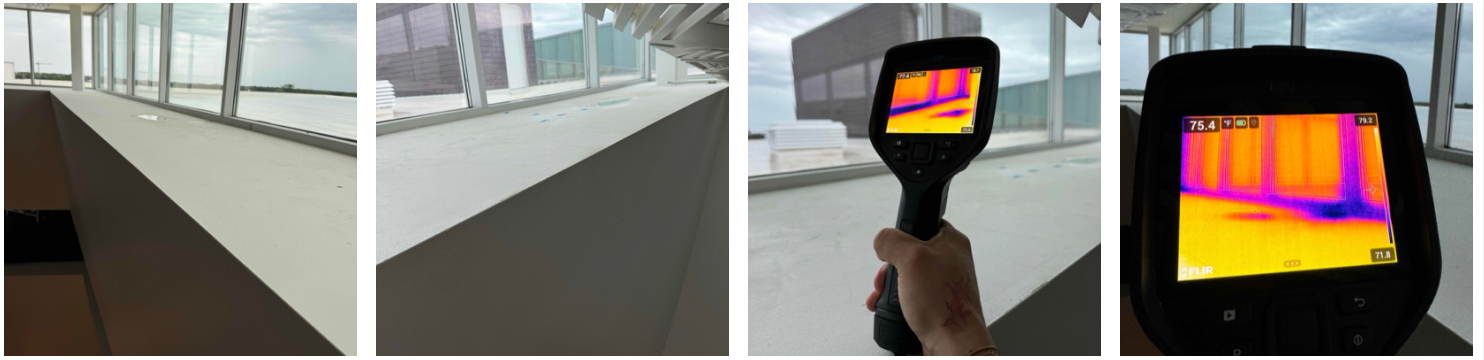
9. Third floor elevated windows:
 Thermal imaging and visual inspection show signs of residual water on the drywall surface coming from the adjacent windows.

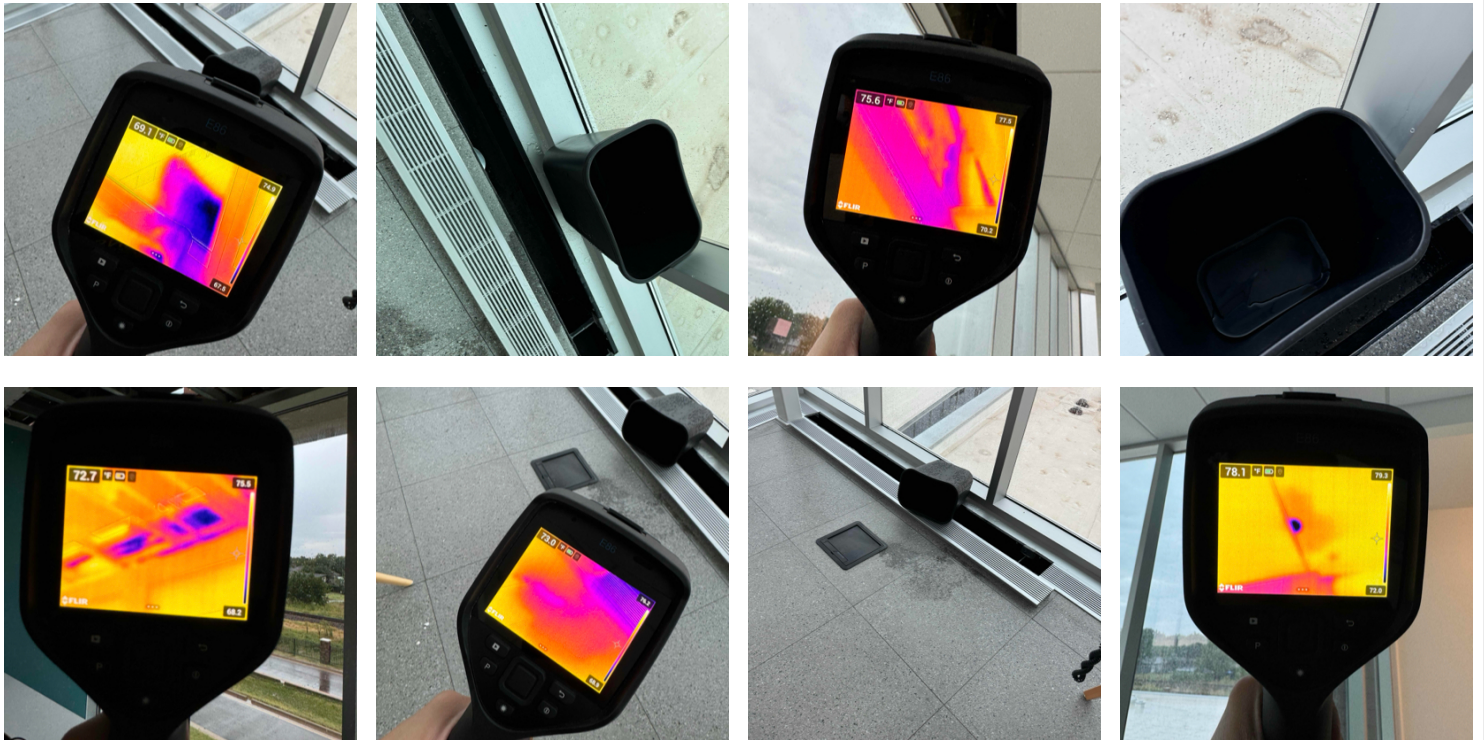
10. Staff only 212:

Thermal imaging and visual inspection show signs of residual water on the floor, collection bin and in the ceiling tile by the entrance to this area.

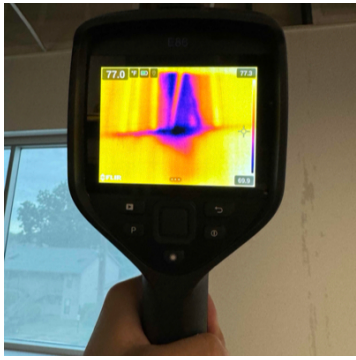
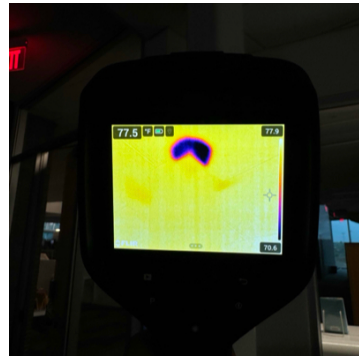
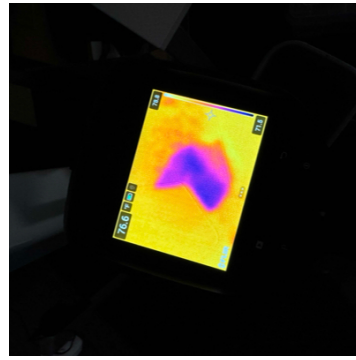
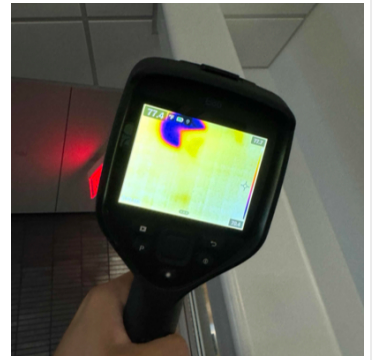
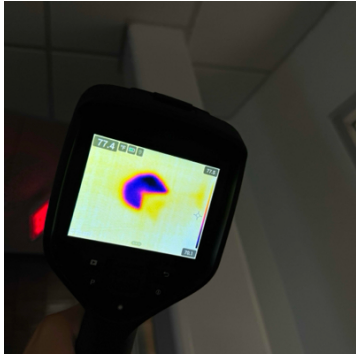
11. Staff Only - 201A:

Thermal imaging and visual inspection show signs of residual water on the floor by the north exterior wall, on the drywall in the southwest corner, and at the base of the column next to the south door access.

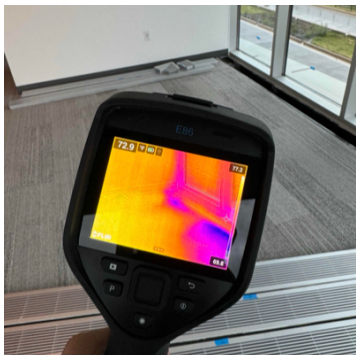
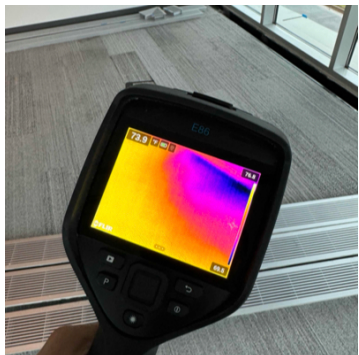
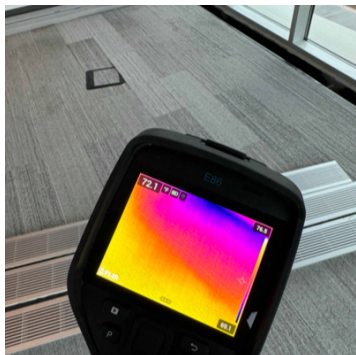
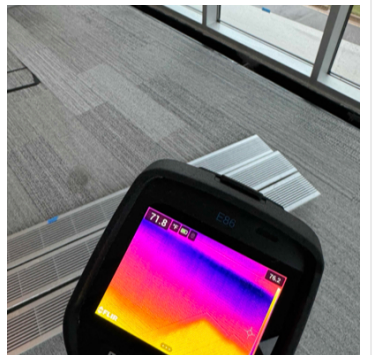
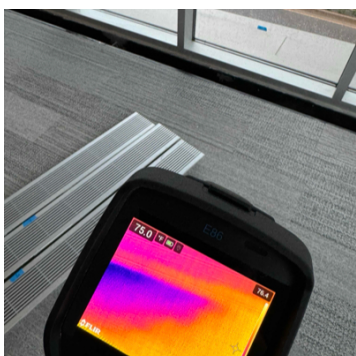
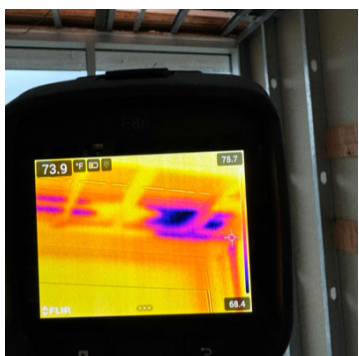
12. Second Floor Common Area:

Thermal imaging and visual inspection show signs of residual water actively collecting inside the HVAC cavity and on the diversion tarp due to active leaks from the uncovered ceilings. Dripping water has also affected the adjacent carpet.

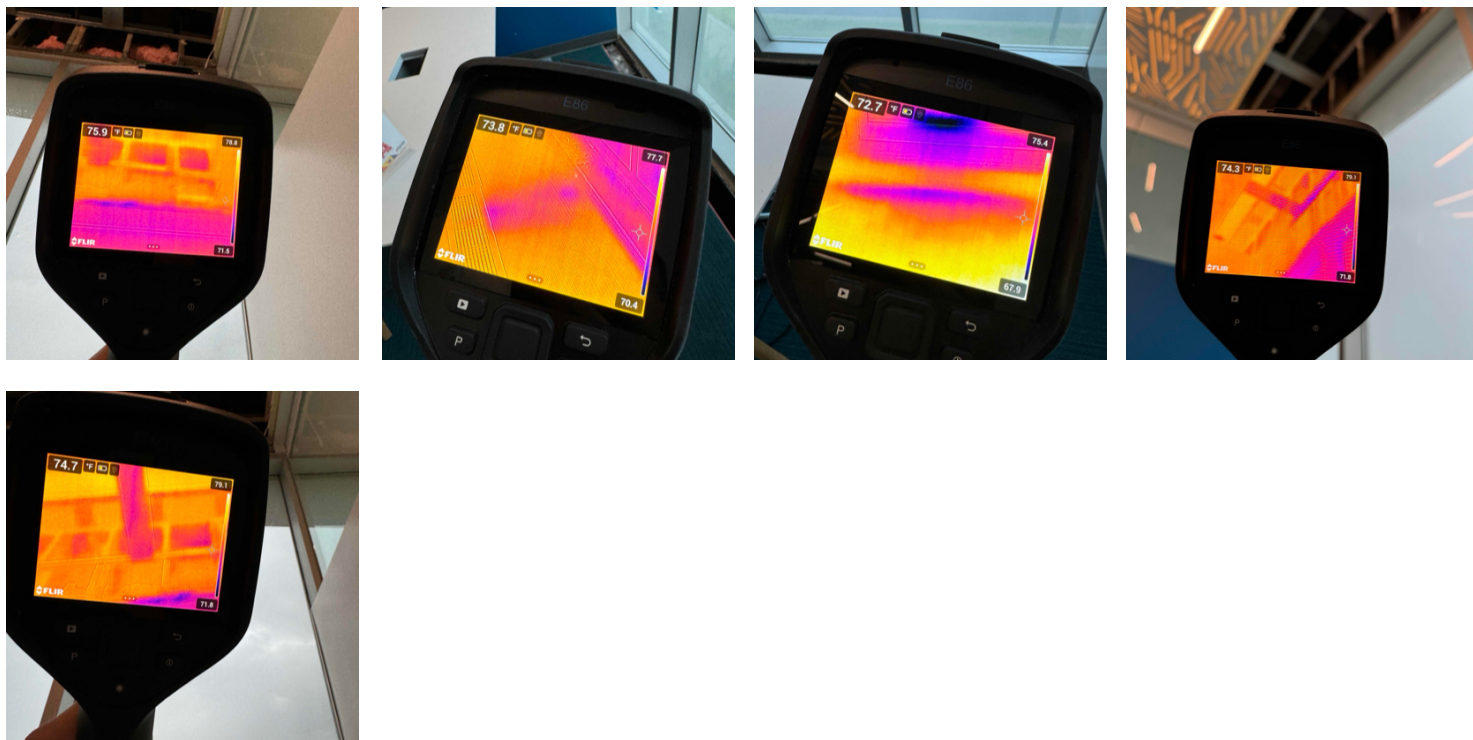
13. Study room-231:
Thermal imaging and visual inspection show signs of residual water actively collecting inside the HVAC

cavity. Dripping water has also affected the adjacent floor.

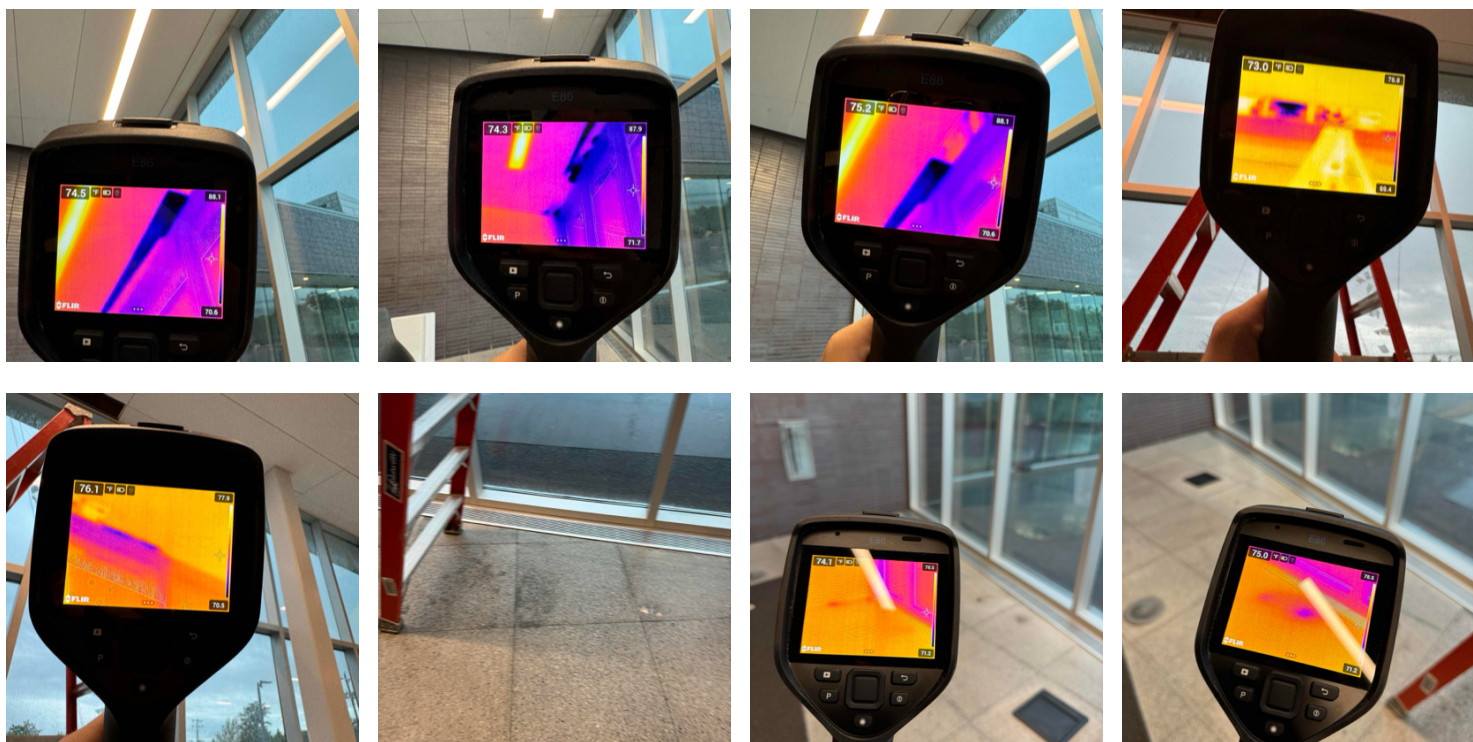
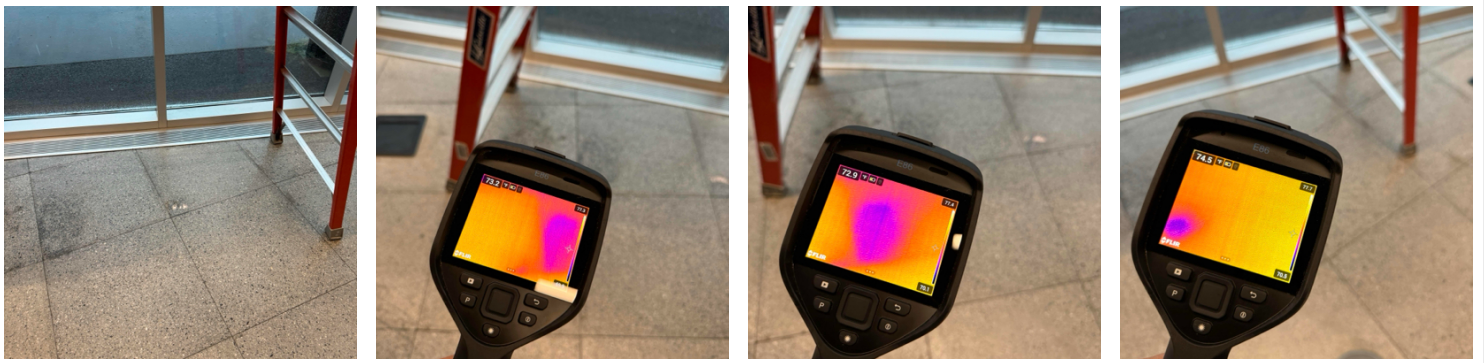
14. First floor vestibule:

Thermal imaging and visual inspection show signs of residual water on diversion tarps and on several spots along the floors.

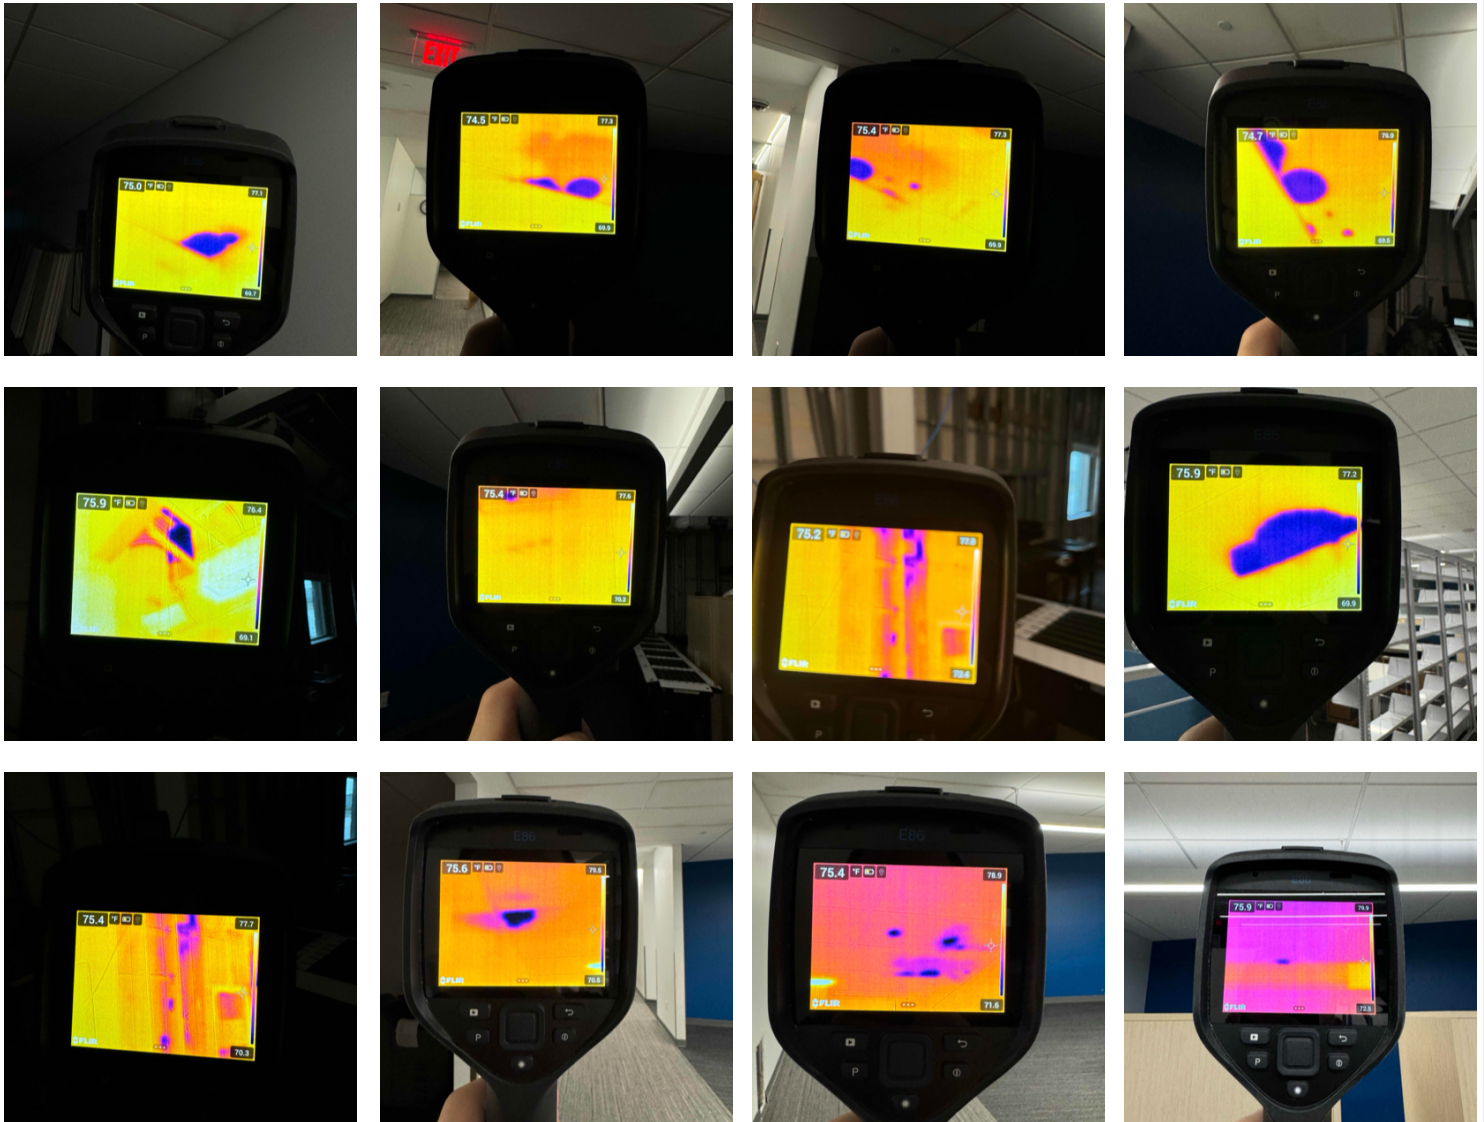
15. Staff only-105:

Thermal imaging and visual inspection show signs of residual water on the floor as well as on the drywall on the west side wall, several ceiling tiles show signs of moisture.

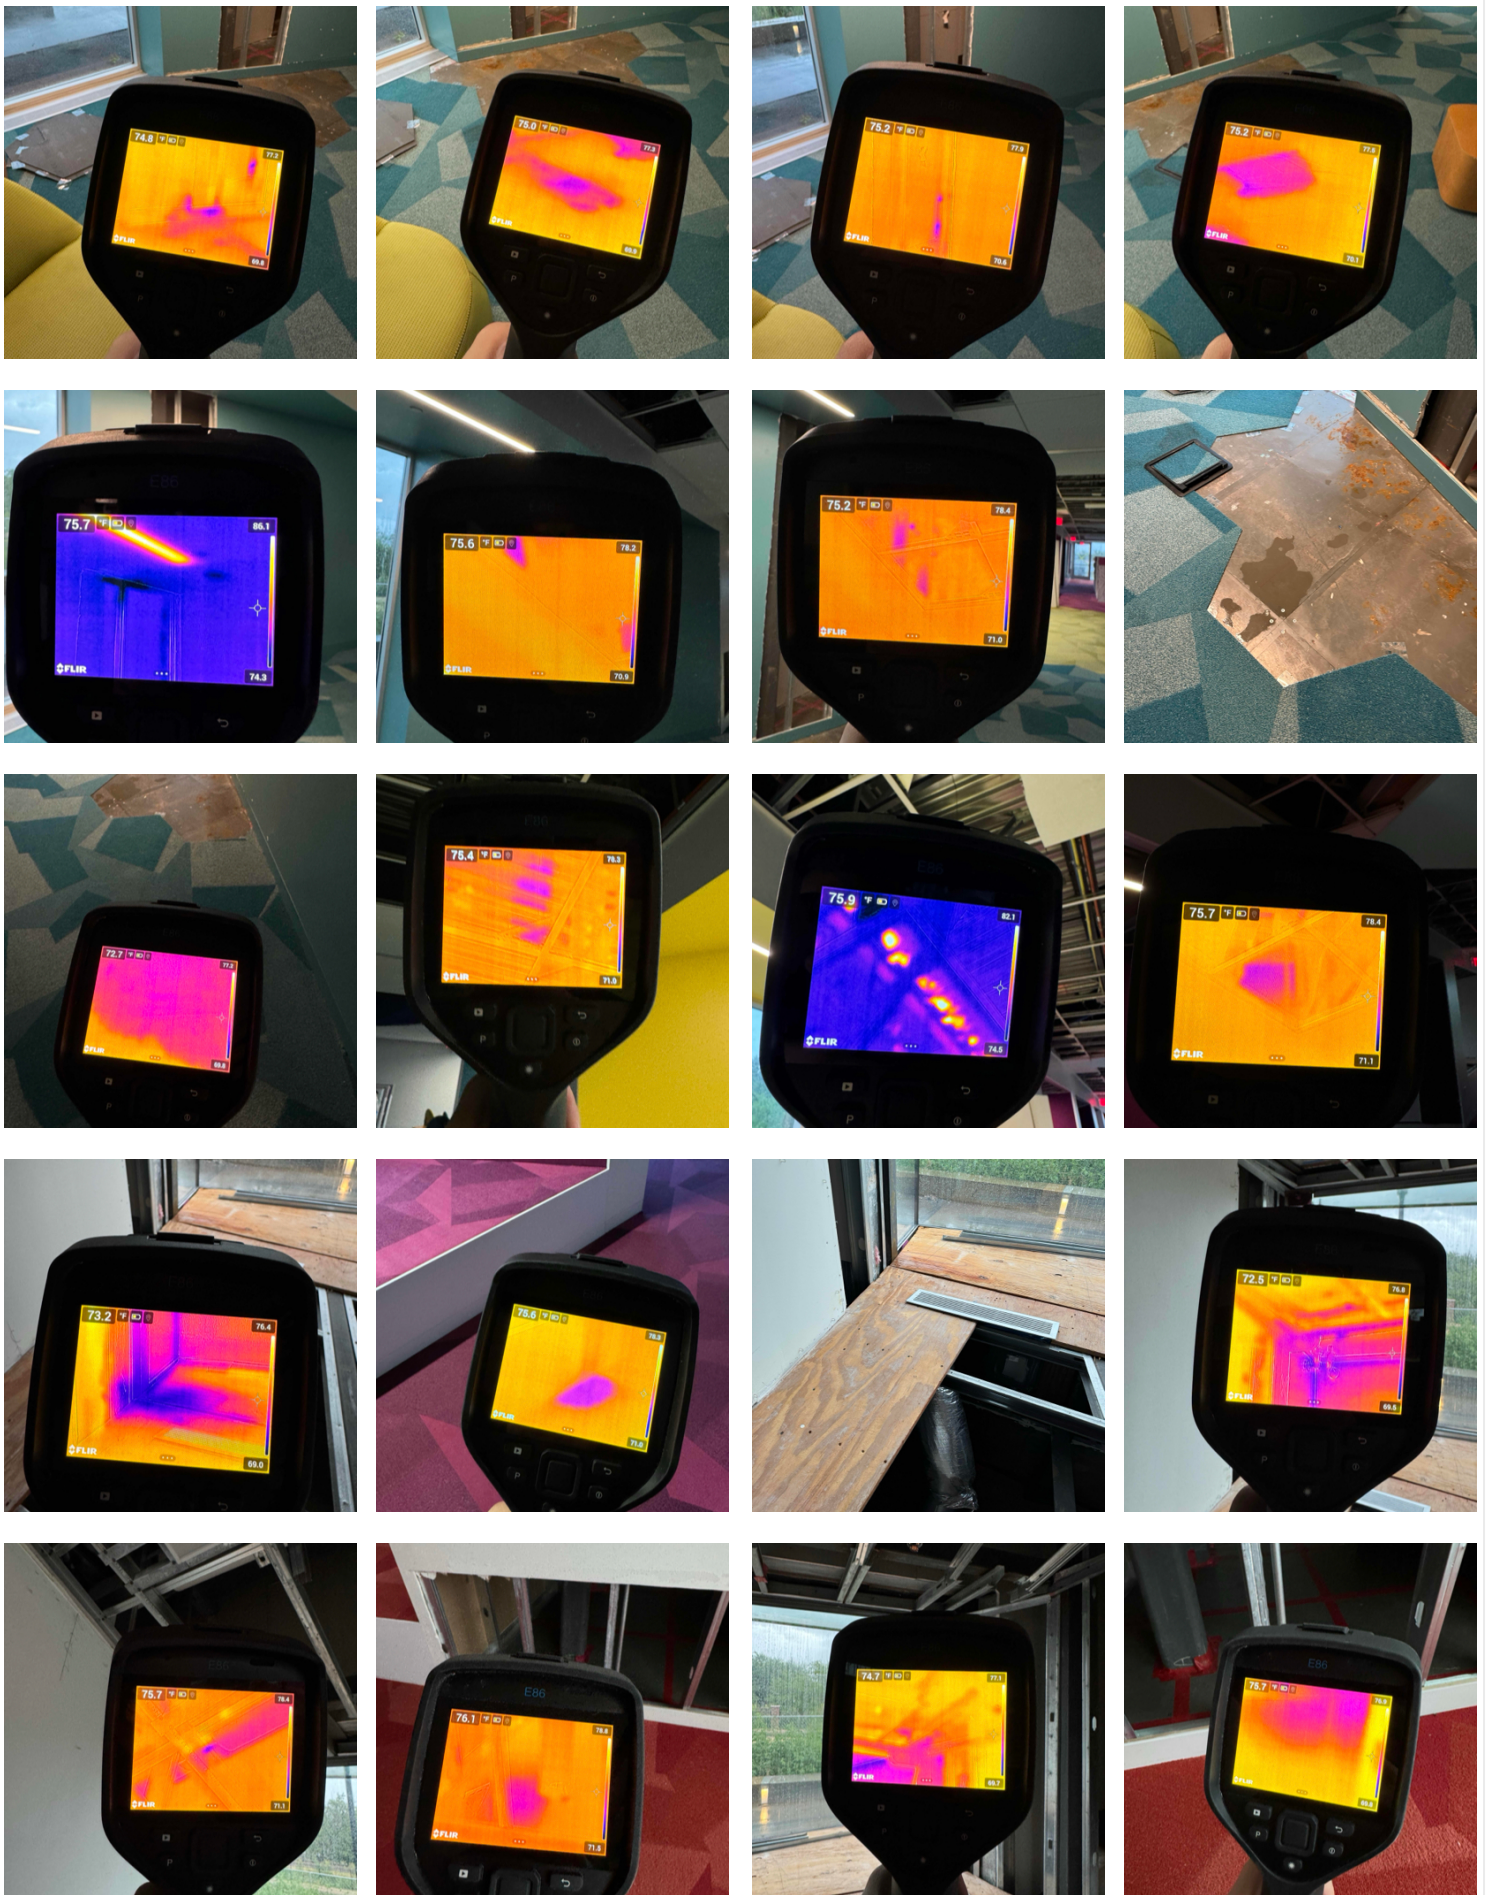
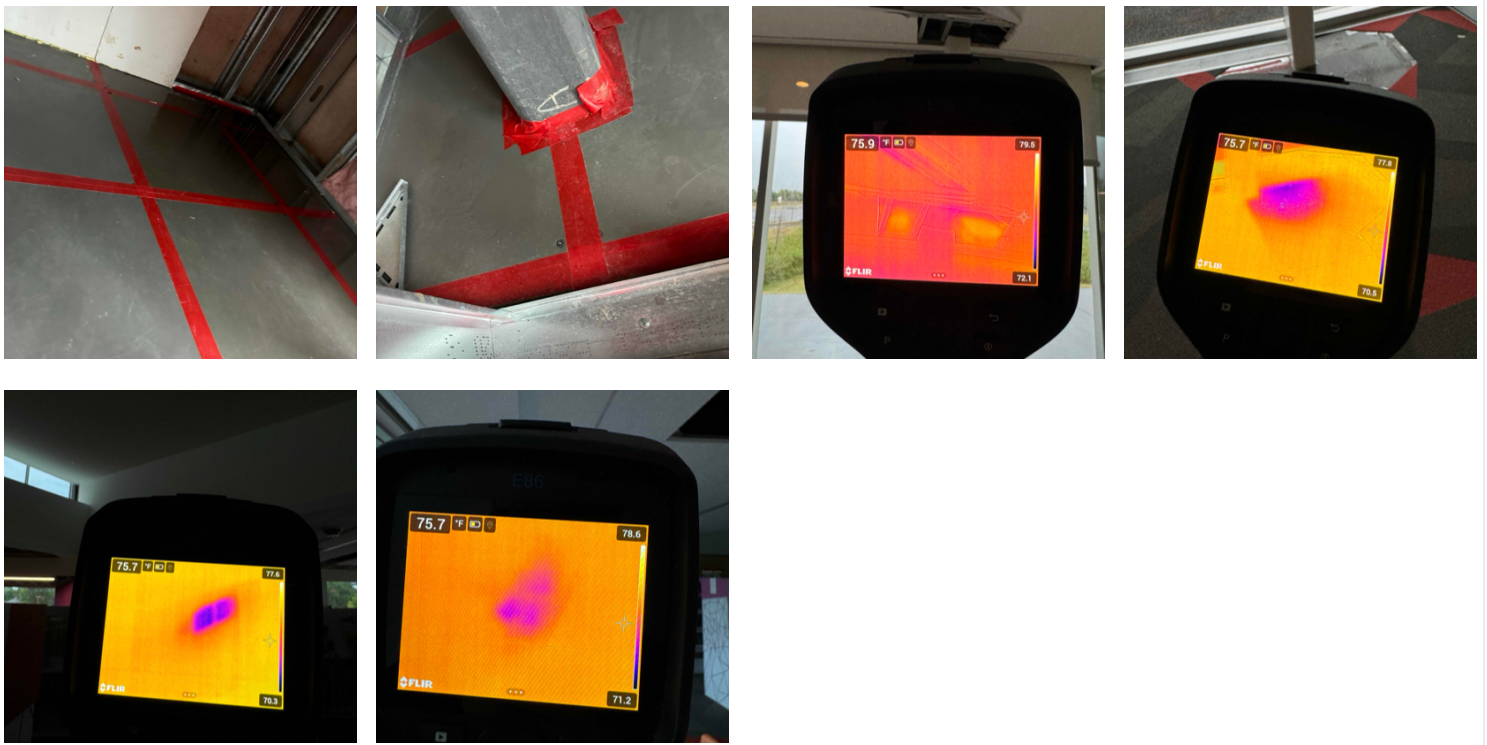
16. Children's area:

Thermal imaging and visual inspection show signs of residual water on diversion tarps and on several spots along the carpeted floors and furniture as well as in the fur out wall over the south side of the area.
