Date Sun 08/11/2024

Name	Description
Cavins Environmental	On Sunday, August 11, 2024, Cavins Group monitored the Norman Public Library-Central after continuous hours of directional rain began early in the morning and continued intermittently throughout the day. Several affected areas were identified both visually and with the use of a thermal camera. Moisture readings were taken as needed, along with temperature, humidity, and drying standards, to set up structural drying equipment.
Total

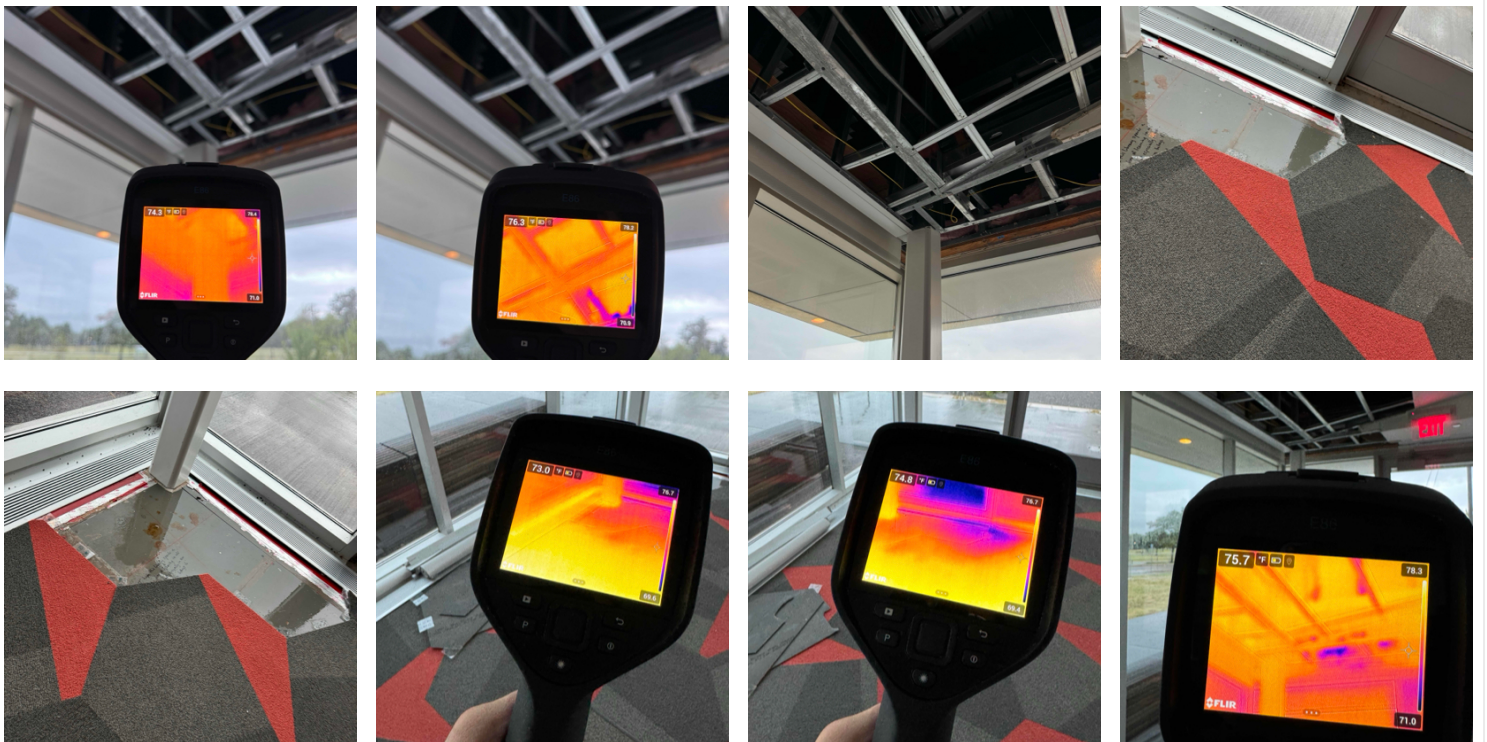
17. Story time:
Thermal imaging and visual inspection show signs of residual water on the floor.
