Wednesday, October 2, 2024

Norman Public Library Central
103 West Acres Street
Norman, OK 73069

Water Intrusion/Loss Investigation Report for September 22, 2024,

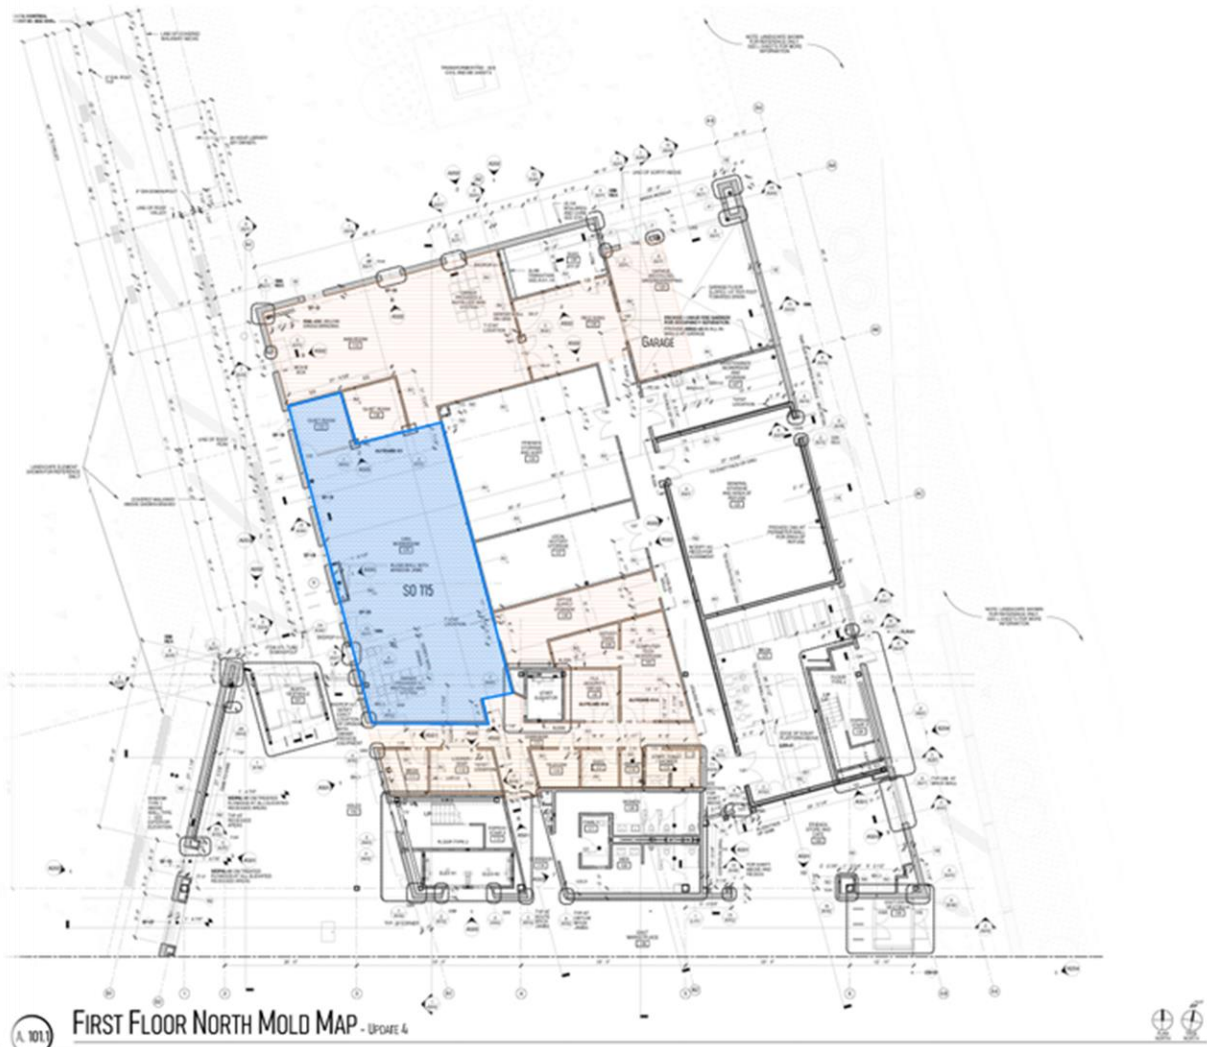
1. First Floor:

- Residual water was found on the floor due to a leak from a RTU drain line in the ceiling. The water-damaged ceiling tile was removed, and structural drying equipment was set up.

- Residual water was found on the floor due to a leak from a drain line in the ceiling. The water-damaged ceiling tiles were removed, and structural drying equipment was set up.

- Residual water was found on the floor due to a leak from a drain line in the ceiling. The water-damaged ceiling tile was removed, and structural drying equipment was set up.

- Moisture is present in the ceiling due to a roof leak. Structural drying equipment has been set up.

- Moisture is present in the ceiling due to a roof leak. Drywall had previously been removed in this area due to an ongoing point of intrusion, which helped discover surface water over carpeted floors, plumbing lines, and plywood surfaces. Structural drying equipment has been set up.

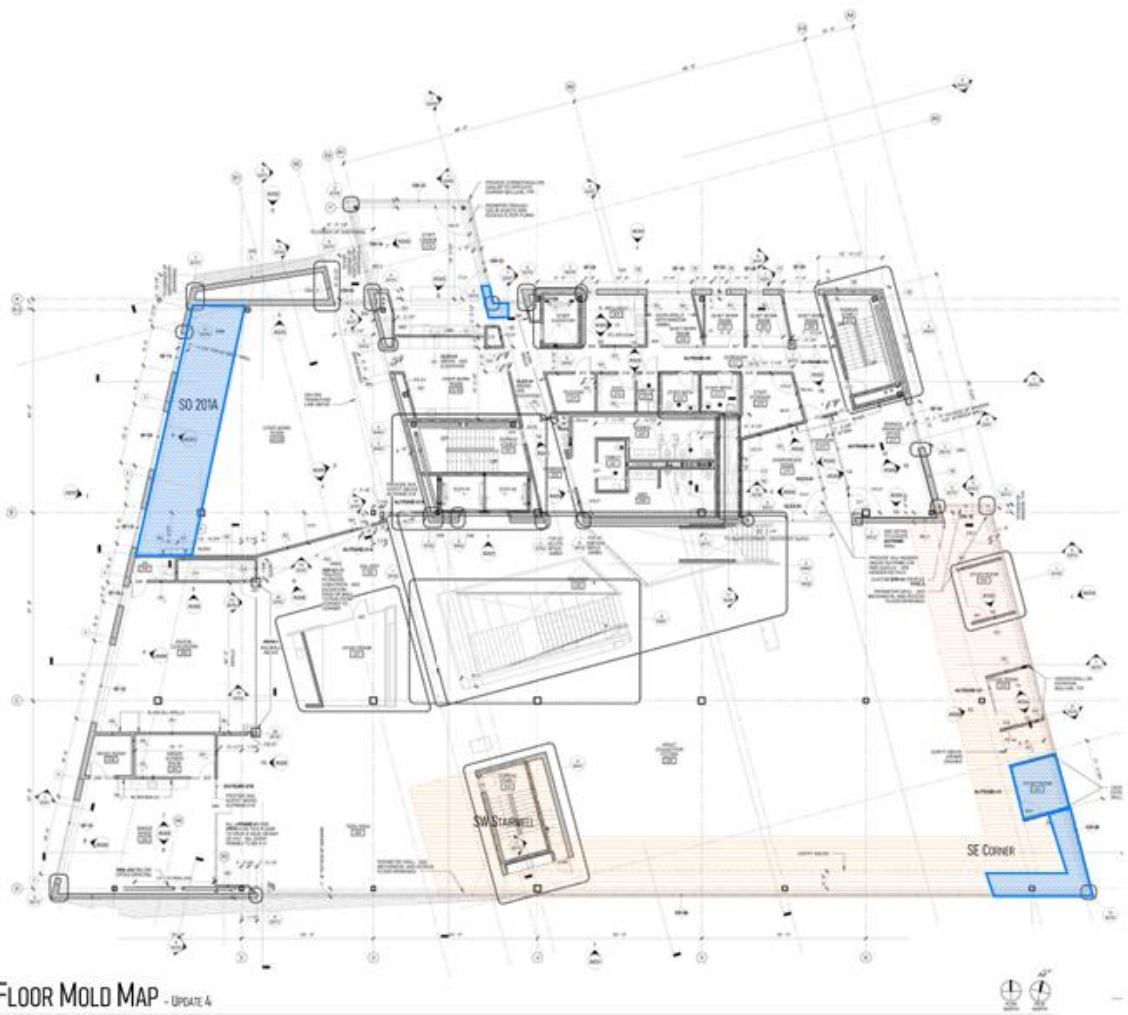
SECOND FLOOR MOLD MAP - UPDATE 4

2. Second Floor:

- Moisture is present in the ceiling along wood beams due to compromised window seals. Ceiling drywall had previously been removed in this area due to an ongoing point of intrusion, which helped discover surface water over the carpeted floor and inside the air vent. Structural drying equipment has been set up.

- Moisture is present on the exterior wall, starting above the ceiling grid and extending all the way to the bottom of the wall. Structural drying equipment has been set up.

- Moisture is present in the drywall above the ceiling grid in the NE corner by the surveillance camera. Structural drying equipment has been set up.

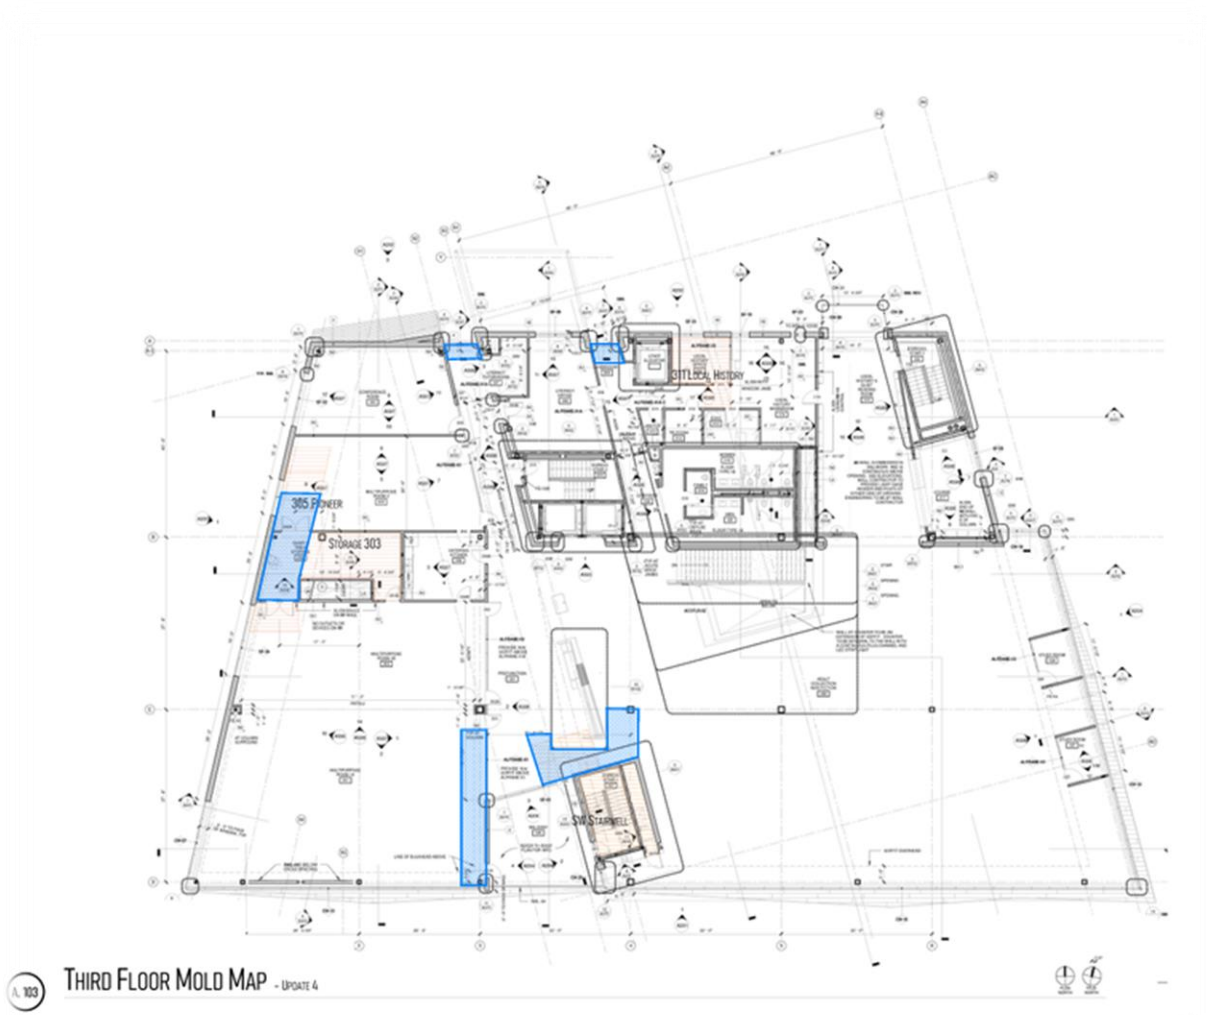
3. Third Floor:

- Residual water was discovered on the floor along the opposite site of the South stairwell wall, even though diversion tarps had been previously installed in this location due to ongoing roof leaks, the source of moisture and points of intrusion at this location increase or decrease depending on the extent of the weather event. Structural drying equipment has been set up.

Moisture is present in the east wall. Structural drying equipment was not installed at this time due to preexisting microbial growth that hasn't been remediated yet per clients request. Access to the area is currently restricted, and containment was set up prior to the weather event.

- Moisture is present on the West wall, starting above the ceiling grid and extending all the way to the bottom of the wall. Structural drying equipment has been set up.

- Moisture is present on the West wall, starting above the ceiling grid and extending all the way to the bottom of the wall. Due to the interior drywall installation being previously removed because of water damage and remediation, the wall cavity is currently exposed and did not require structural drying equipment.

- Moisture is present on the carpet tiles. The underlying materials are dry, so the carpet tiles were removed, and structural drying equipment was not needed.
