Date Fri 12/08/2023

Name	Description
Cavins Environmental	<p>Cavins Group arrived on site and suited up in appropriate PPE. Upon suiting up all containments and equipment were checked for defects. Filters were changed in all air scrubbers. Temperature and humidity readings were taken in all contained areas, all three floors in the main area, and outside.</p> <p>The cleaning process was completed in Room 305 and it will be in the air scrubbing process over the weekend and will be ready for post remediation verification testing on Tuesday, December 12, 2023.</p> <p>Room 201A had it's initial round of cleaning and is ready for further remediation action on structural items.</p> <p>Demo in the stairwell began under the roof access landing and significant microbial growth was found. Additional demo was performed on the third floor deck door, and ground level under the stairs. Two additional air scrubbers were added to the stairwell containment due to the expansive nature of the mold colonies found during the demo process.</p>

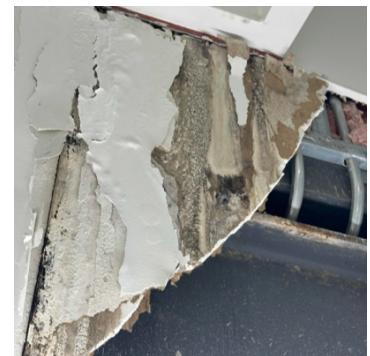
## 4. Stairwell - Remediation:

Demo began under the roof access landing in the stairwell and a significant amount of microbial growth was found in this area. This mold colony travels down to the third floor landing and potentially farther down.

Mold was also found around the bottom of the third floor, deck door.

Mold growth was also found on the NE corner at the top of the stairwell and travels all the way to the first floor. There was microbial growth found here underneath the stairwell. Water trails are visible throughout the area on metal framing and drywall.

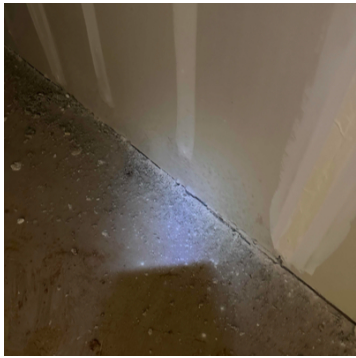
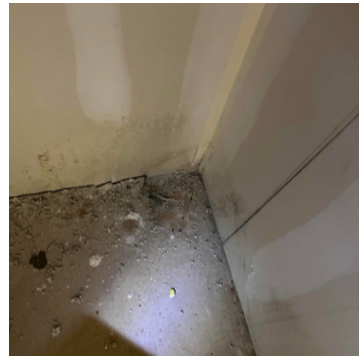
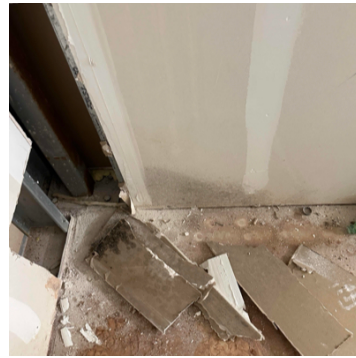
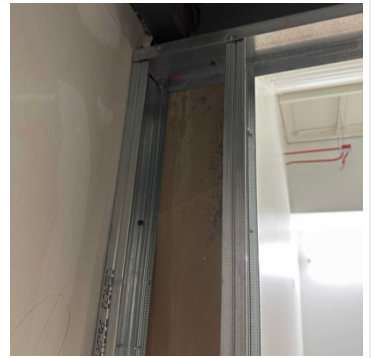
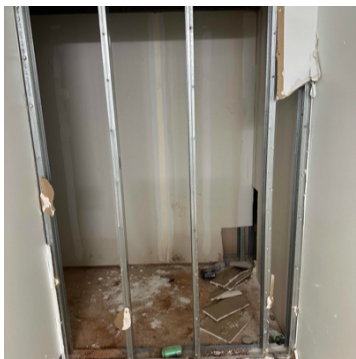
Under Stairs On Ground Level

Deck Door (3rd Floor)
