Date Fri 01/12/2024

Name	Description
City of Norman Central Library - Mold	Cavins Group arrived on site and suited up in proper PPE. Upon suiting up, Cavins technicians checked all containments and equipment for defects. All air scrubber filters were changed, temperature and humidity readings were taken in all containments, all three floors in the main area, and one exterior reading. Demo continued in the second floor southeast corner Phase one cleaning began in the stairwell. Investigative demo continued in room 311.
Total

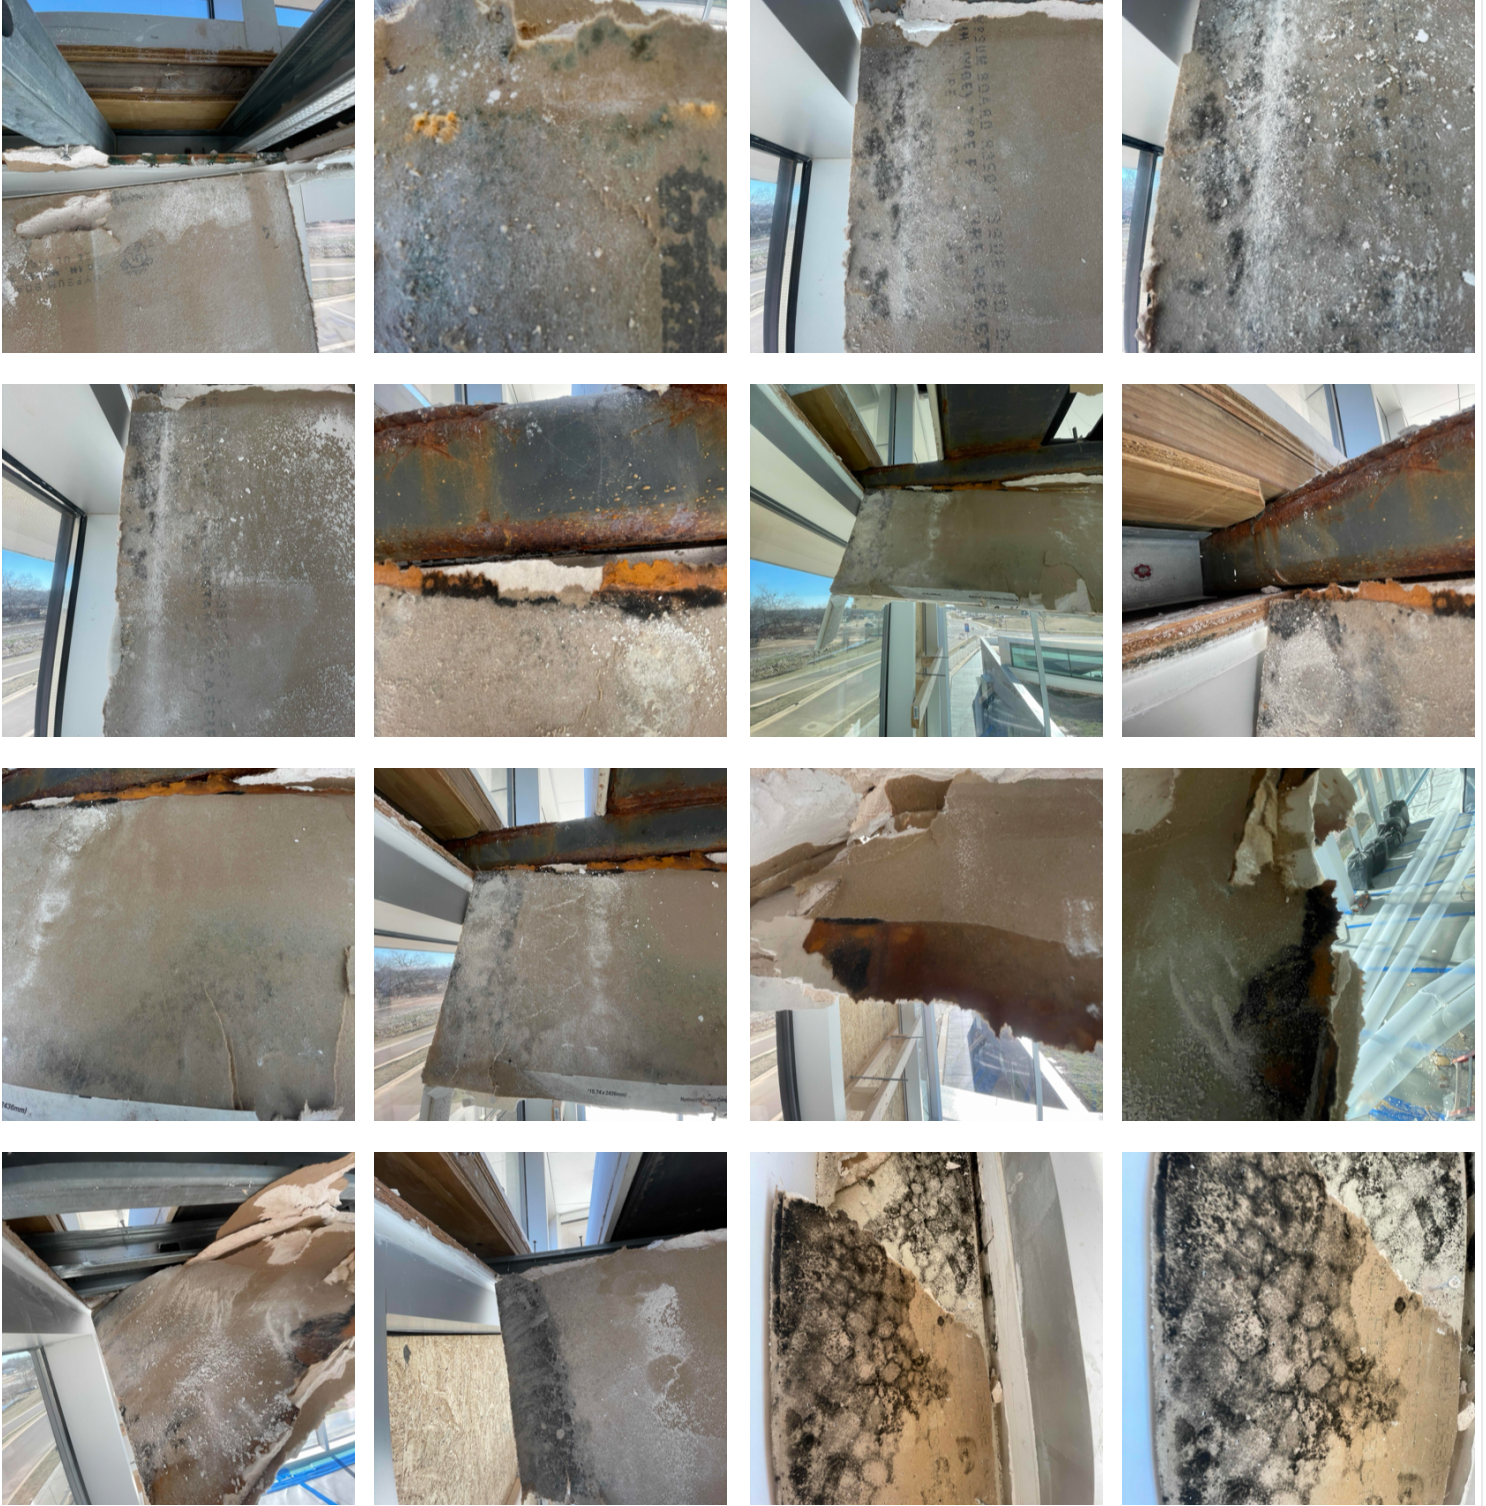
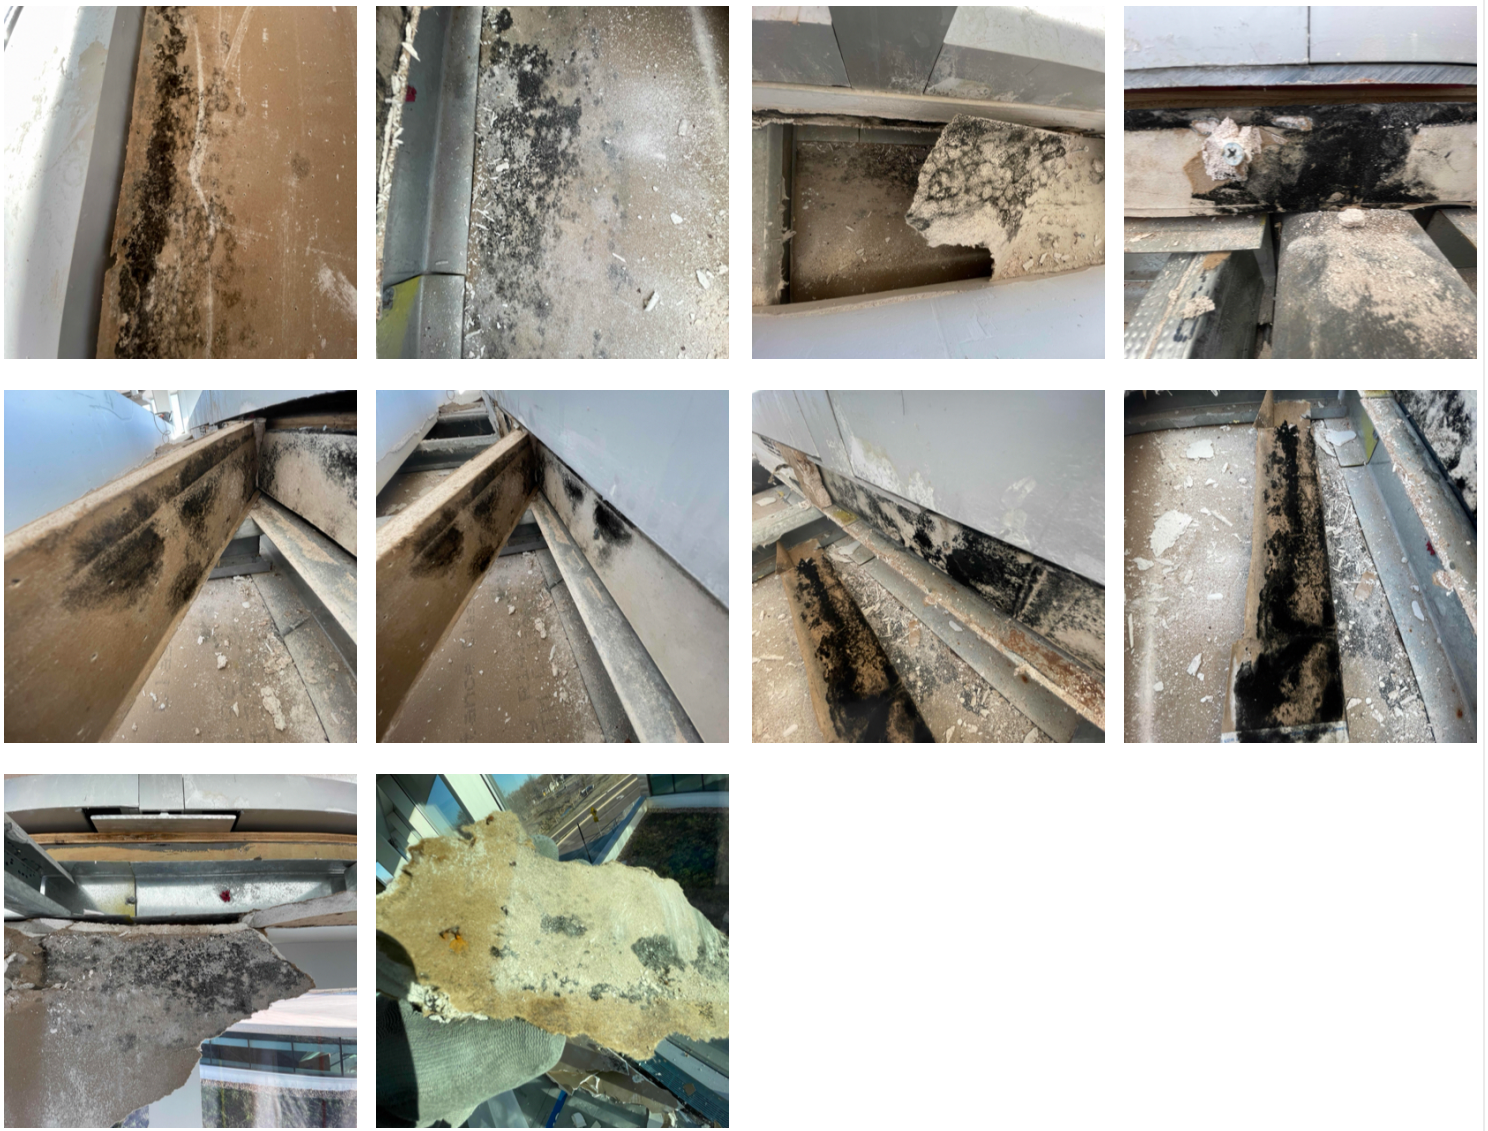
25. Second Floor -Southeast Corner: Remediation

Demo continued on the underside of the soffit (overhang) and in areas on top of the soffit (overhang) visible microbial growth is seen around the window area and spread out to the underside, all of the affected areas were removed.

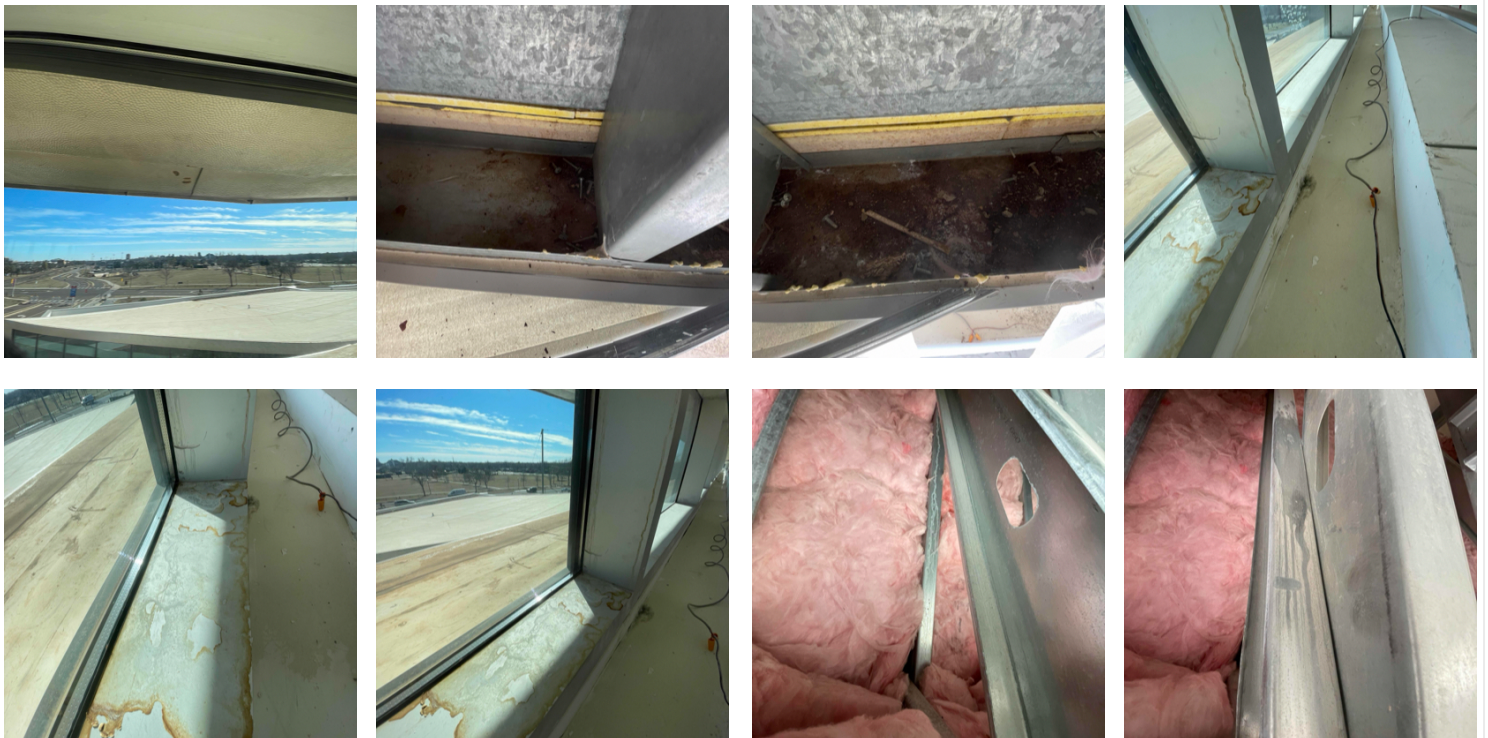
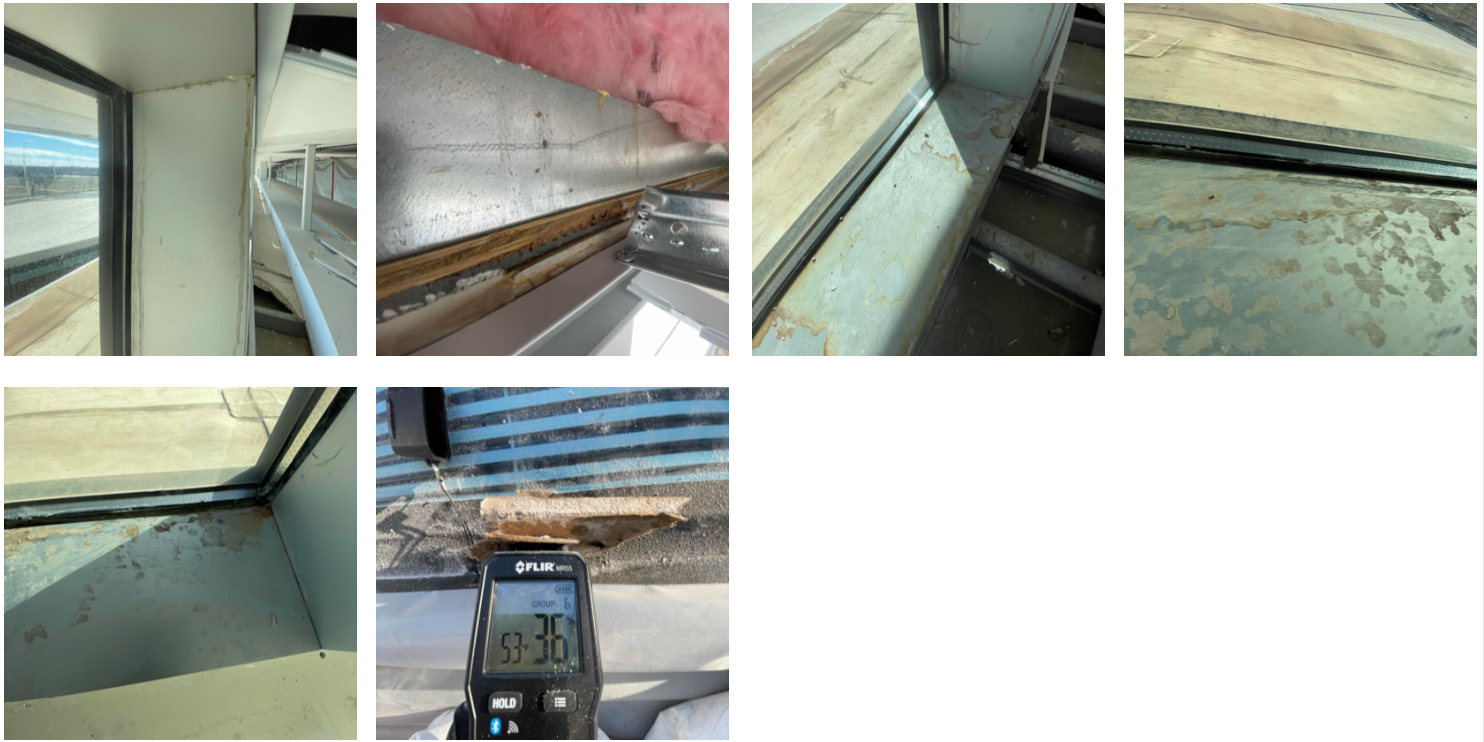
55. Second Floor- Southeast Corner: Water Trails

Visible water trails can be seen around 3 windows and above drop down ceiling inside exterior soffit area.
