1839 Atchison Drive  
 Norman  
 OK  
 USA

Encircle Hydro Full Report [City of Norman - Central Library - 9/22/24](#)

<b>Carrier Identifier</b>	<b>Contractor Identifier</b>	<b>Assignment Identifier</b>
City of Norman - Central Library - 9/22/24	--	--
<b>Project Manager</b>	<b>Date of Loss</b>	<b>Date Claim Created</b>
--	Sep 22, 2024	Sep 22, 2024
<b>Insurance Company</b>	<b>Adjuster</b>	<b>Policy Number</b>
--	--	--
<b>Source of Loss</b>	<b>Initial Category of Water</b>	
Water Intrusion from Rain Storm	Category 1

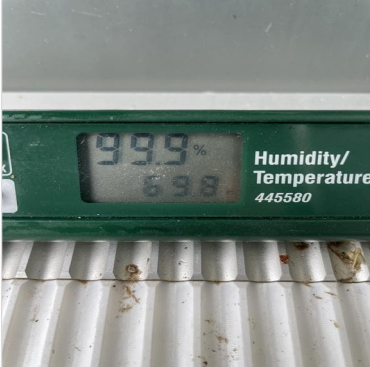
#	Time	Relative Humidity	Specific Humidity	Air Temperature	Notes & Photos
1	Sep 22, 4:38 PM	99%	108.5 gpp	69.8°F	Active Rain

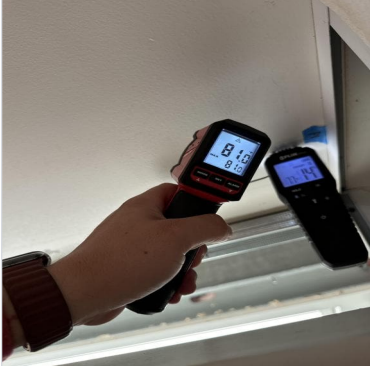
#	Time	Meter	Moisture Content	Surface Temperature	Notes & Photos
2	Sep 23, 6:31 PM	Flir 100%	14%	81°F

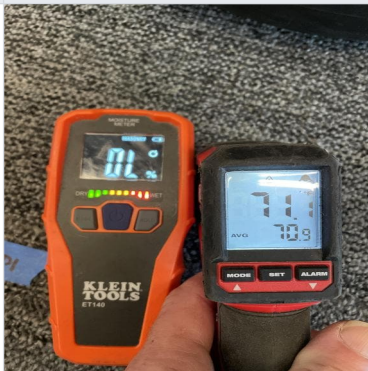
#	Time	Meter	Moisture Content	Surface Temperature	Notes & Photos
1	Sep 22, 5:44 PM	Klein Tools Pinless ET140	99.9%	71.1°F

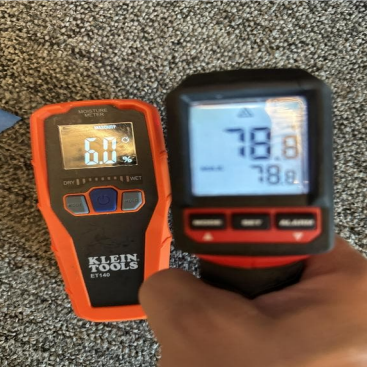
#	Time	Meter	Moisture Content	Surface Temperature	Notes & Photos
2	Sep 23, 6:38 PM	Klein Tools Pinless ET140	6%	78.8°F

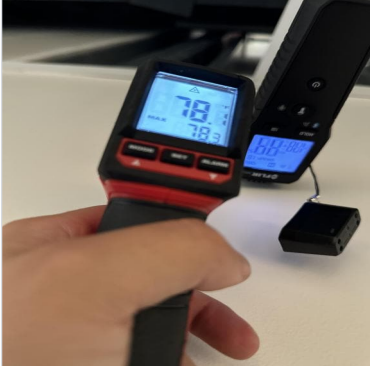
#	Time	Meter	Moisture Content	Surface Temperature	Notes & Photos
2	Sep 23, 7:11 PM	Flir 100%	14%	78.1°F

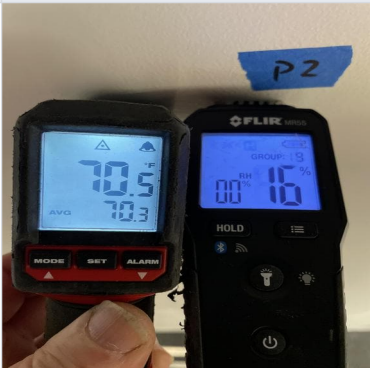
#	Time	Meter	Moisture Content	Surface Temperature	Notes & Photos
1	Sep 22, 6:28 PM	Flir 100%	16%	70.5°F

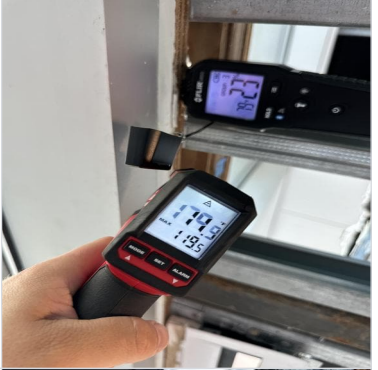
#	Time	Meter	Moisture Content	Surface Temperature	Notes & Photos
2	Sep 23, 6:50 PM	Flir 100%	23%	71.9°F

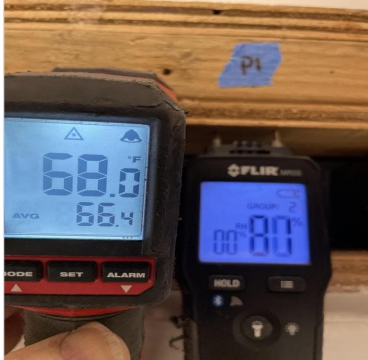
#	Time	Meter	Moisture Content	Surface Temperature	Notes & Photos
1	Sep 22, 8:28 PM	Flir 100%	81%	68°F

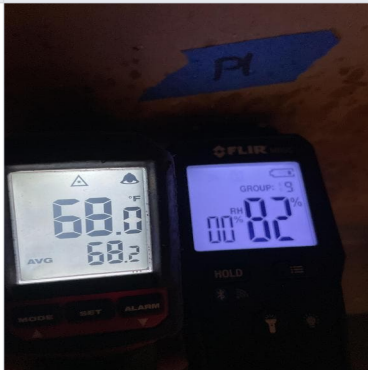
#	Time	Meter	Moisture Content	Surface Temperature	Notes & Photos
1	Sep 22, 9:26 PM	Flir 100%	82%	68°F

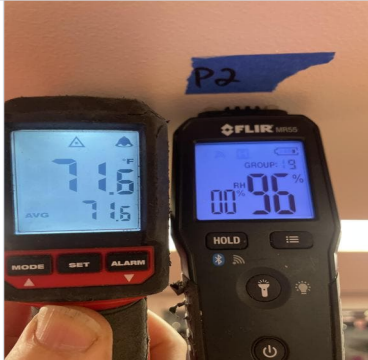
#	Time	Meter	Moisture Content	Surface Temperature	Notes & Photos
1	Sep 22, 10:19 PM	Flir 100%	96%	71.6°F

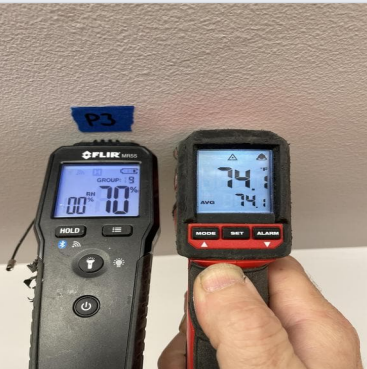
#	Time	Meter	Moisture Content	Surface Temperature	Notes & Photos
1	Sep 22, 10:43 PM	Flir 100%	70%	74.1°F

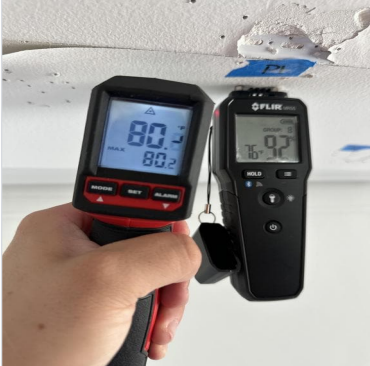
#	Time	Meter	Moisture Content	Surface Temperature	Notes & Photos
2	Sep 23, 5:28 PM	Flir 100%	92%	80.4°F

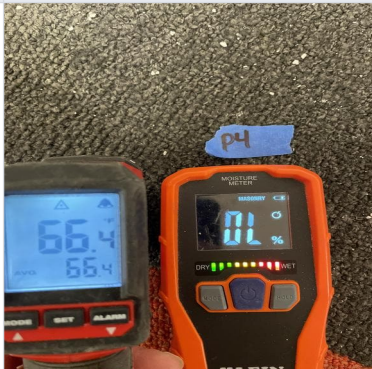
#	Time	Meter	Moisture Content	Surface Temperature	Notes & Photos
1	Sep 22, 11:25 PM	Klein Tools Pinless ET140	99.9%	66.4°F

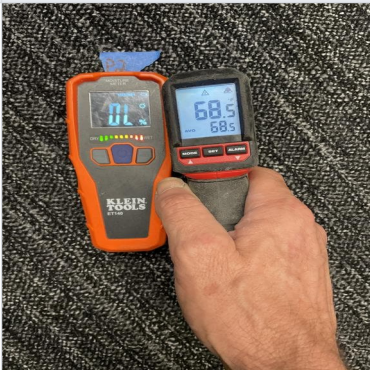
#	Time	Meter	Moisture Content	Surface Temperature	Notes & Photos
1	Sep 22, 11:50 PM	Klein Tools Pinless ET140	99.9%	68.5°F
