Date Mon 01/22/2024

Name	Description
Cavins Environmental	Cavins Group took temperature and humidity readings of affected areas, all common areas and one outside. Cavins technicians suited up in proper PPE and changed pre filters in air scrubbers within containments, along with all all pre filters in main areas. Air quality testing was performed on common areas to monitor current status of the building. An additional spore trap test was taken on the roof access stairwell for post remediation verification testing. Demo was performed on the second floor, SE corner study area and the bay windows in the children's area.
Total

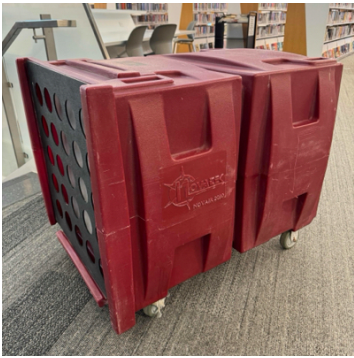
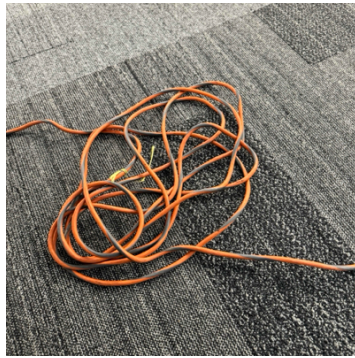
21. Third Floor - Main Area: Equipment

- 1 - Air Scrubber
- 1 - 50' Extension Cord

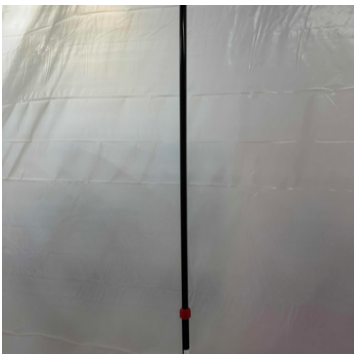
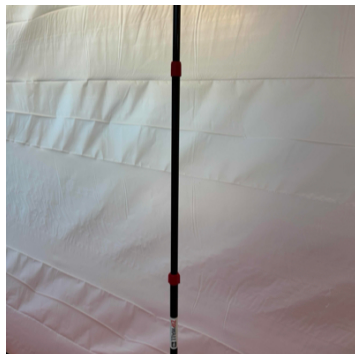
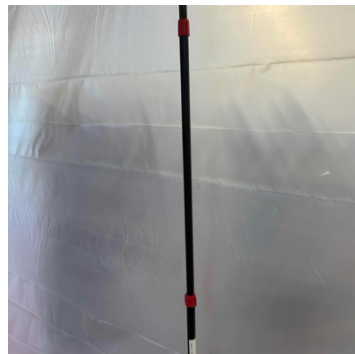
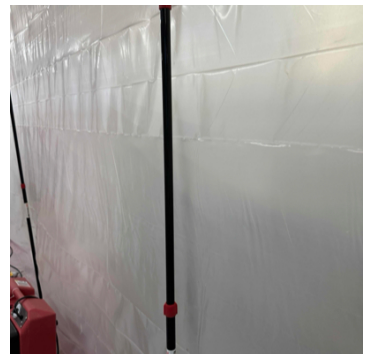
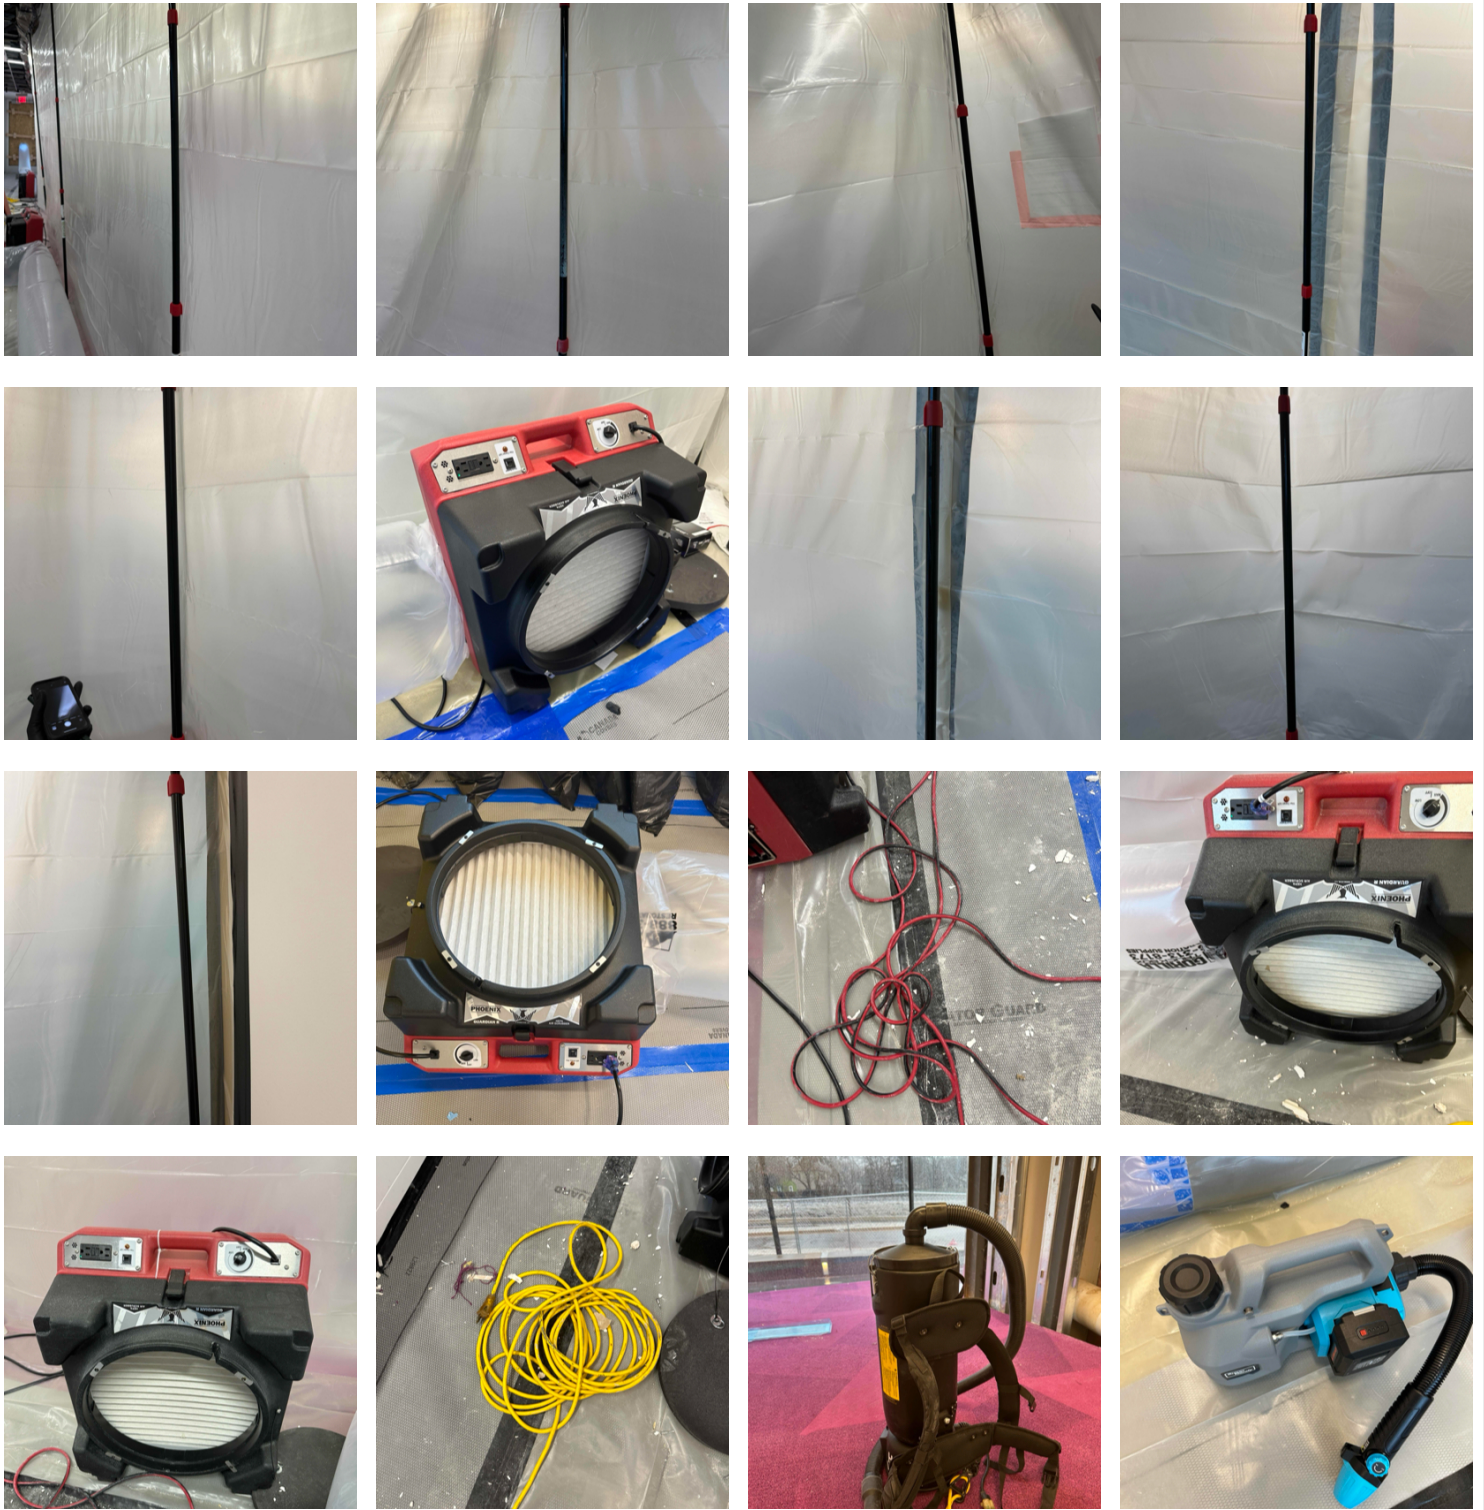
24. First Floor - Bay Windows (Children's Area): Equipment

- 12 - Zip Posts
- 4 - Air Scrubbers
- 1 - 50' Extension Cord
- 1 - HEPA Vac
- 1 - Fogger

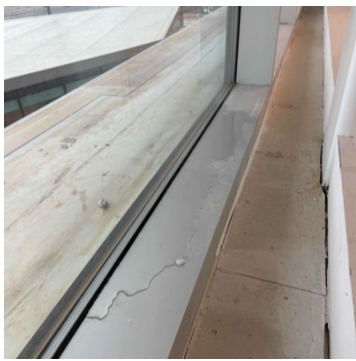
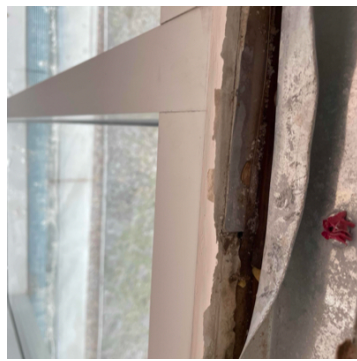
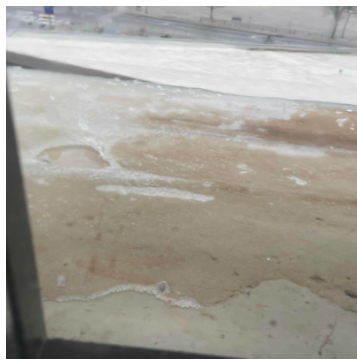
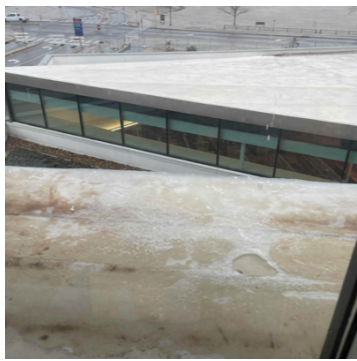
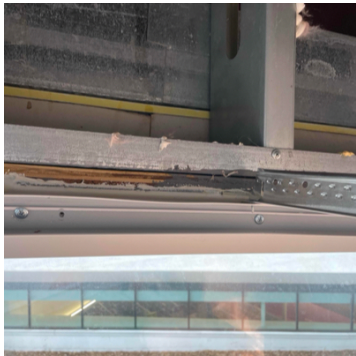
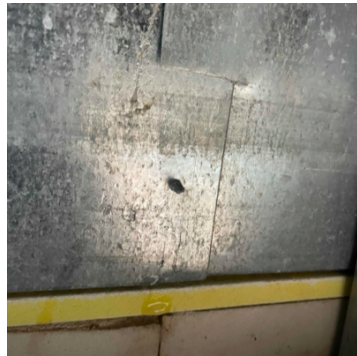
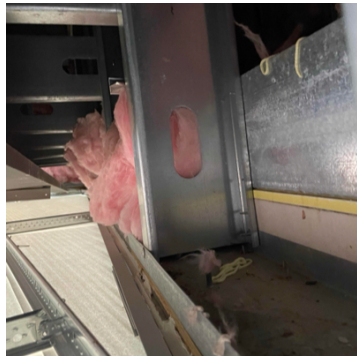
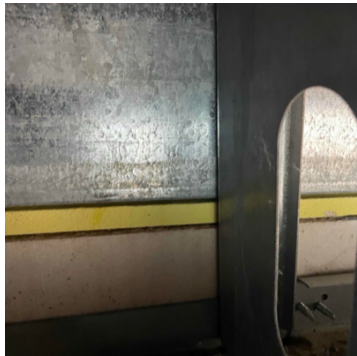
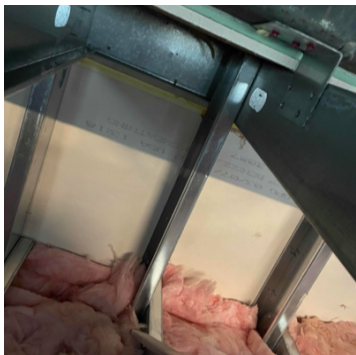
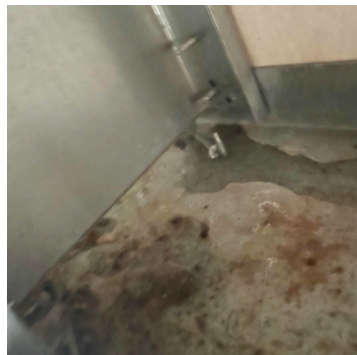
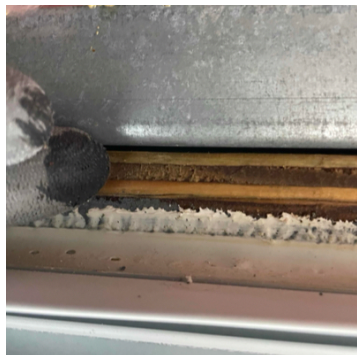
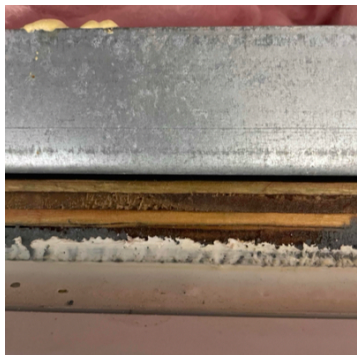
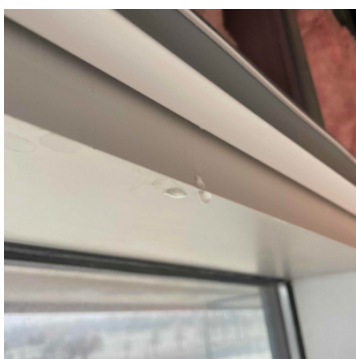
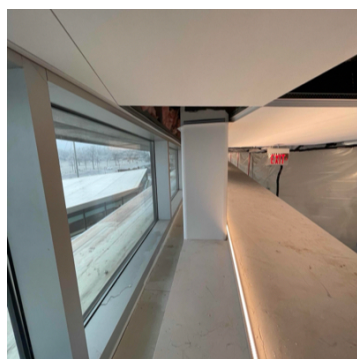
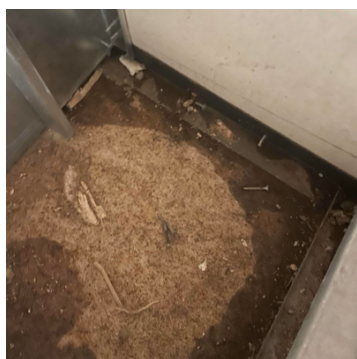
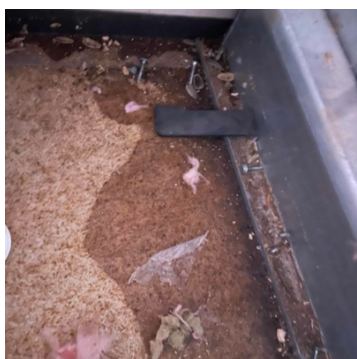
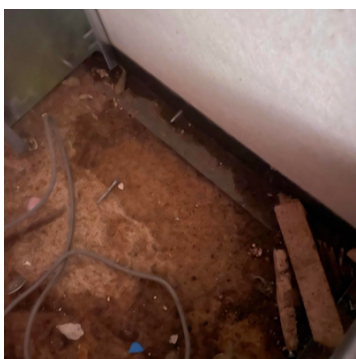
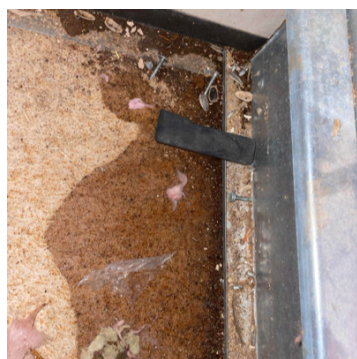
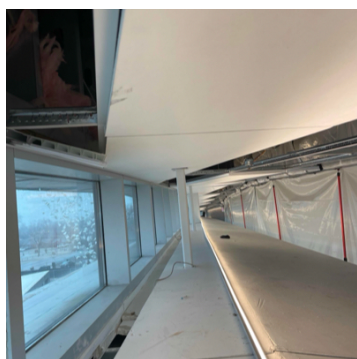
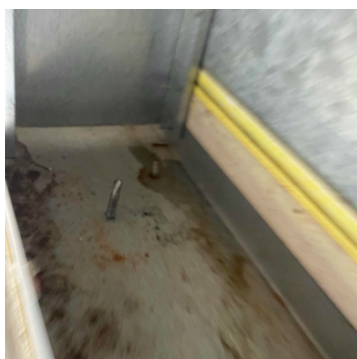
29. Second Floor - Southeast Corner: Water Intrusion

Water intrusion is visible on the southeast corner about 20' west from corner, visible signs of water are seen in bottom of metal track of exterior wall above ceiling grid and in overhang above windows

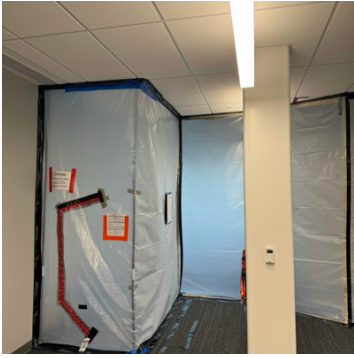
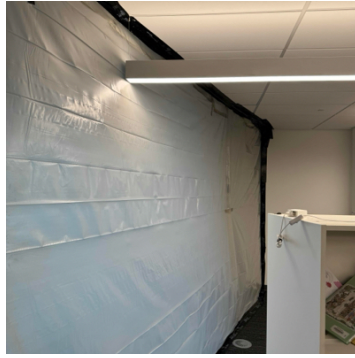
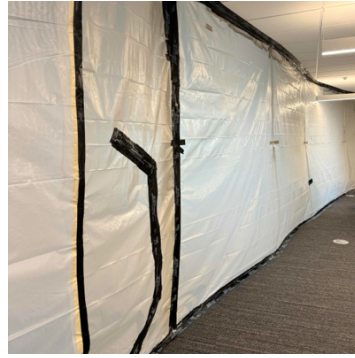
31. Second Floor - Southeast Corner: Study Room Remediation

Water damage was seen on wall and ceiling above windows in study room on Northeast corner of second floor, selective demo started at window height and followed any water signs or visible microbial growth. Visible microbial growth was seen after parts of drywall finish were removed.

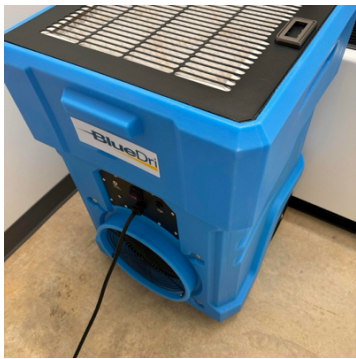
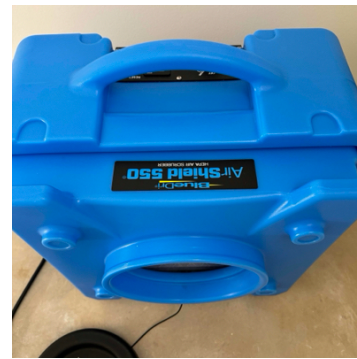
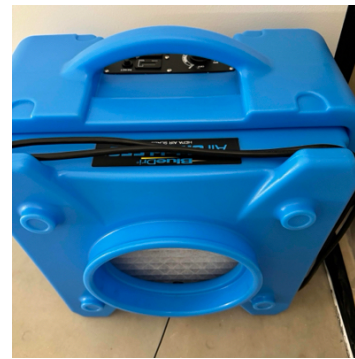
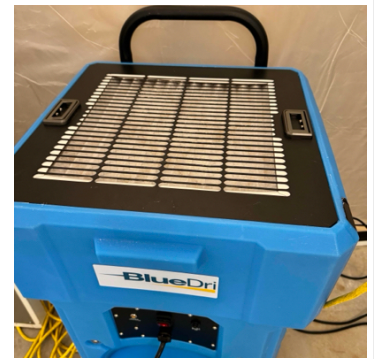
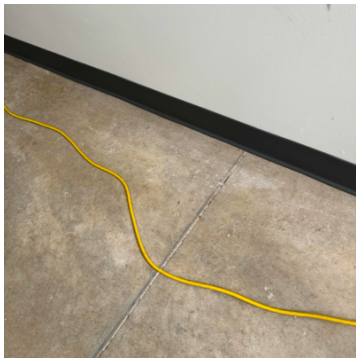
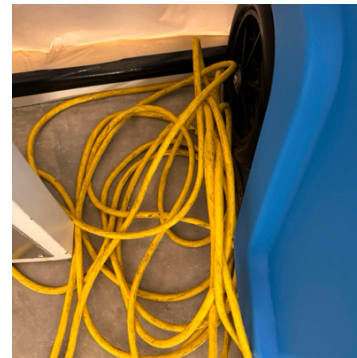
- 40. Stairwell: Equipment**
 4 - Air Scrubbers
 1 - Zip Post
 2 - 100' Extension Cords
 1 - 50' Extension Cords
 1 - Fogger

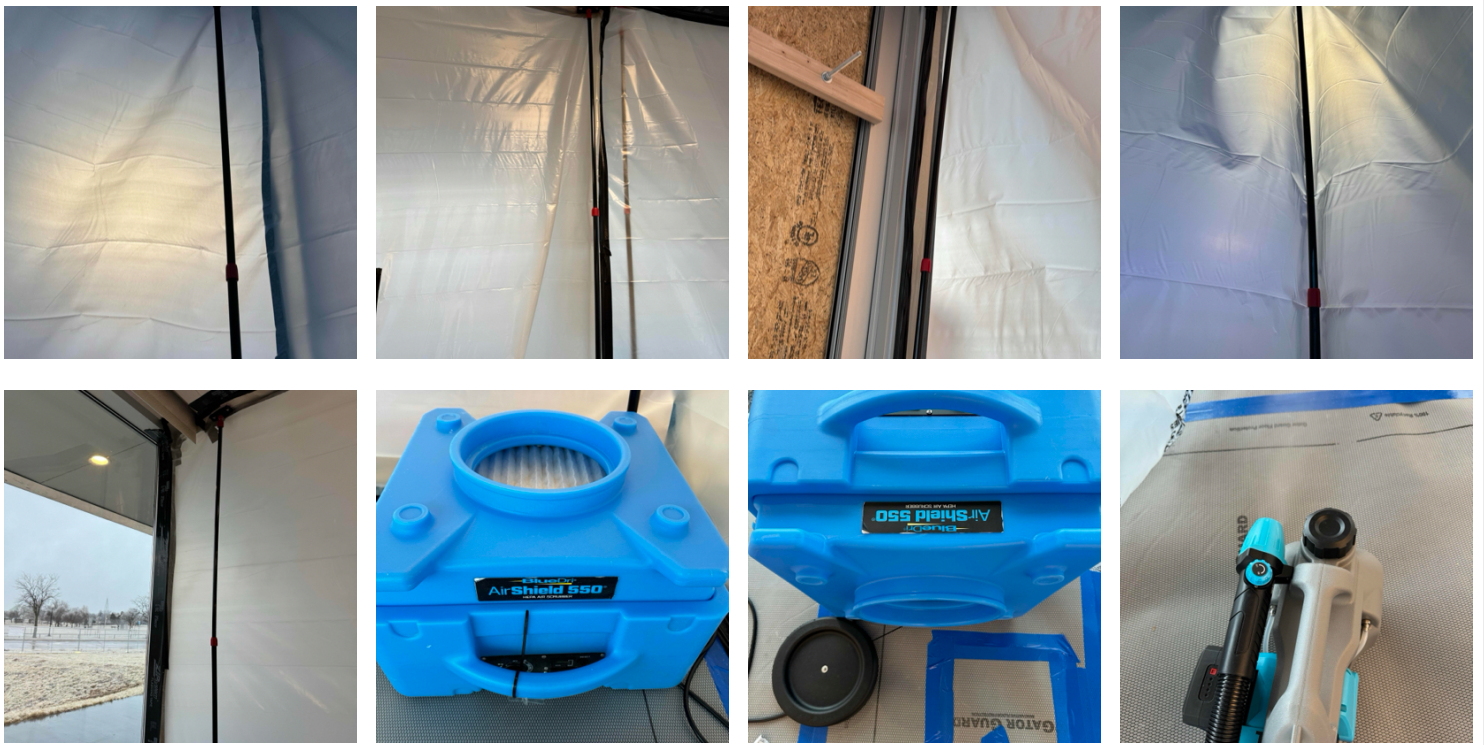
44. 149 Storytime: Equipment

5 - Zip Posts

2 - Air Scrubbers

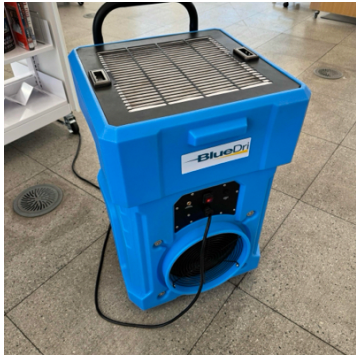
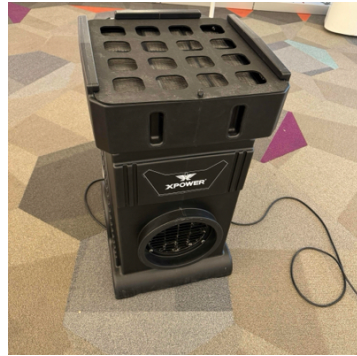
47. First Floor - Main Area: Equipment
2 - Air Scrubbers
