Date Tue 02/06/2024

Name	Description
Cavins Environmental	Cavins's technician arrived on site, suited up in proper PPE, changed all pre-filters in common and contained areas, temperature and humidity readings were recorded. Third floor stairwell wall, selective demo started. 149 Story time Phase two of cleaning with antimicrobial fog treatment was done. Microbial growth found on the third floor above the balcony.
Total

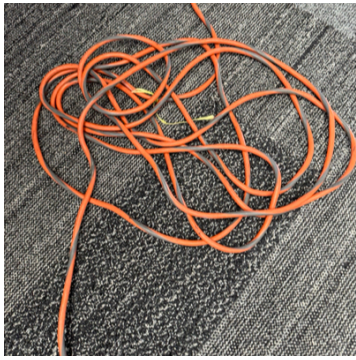
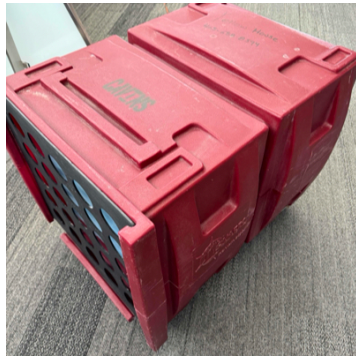
7. Third Floor - Main Area: Equipment

- 1 - Air Scrubber
- 1 - 50' Extension Cord

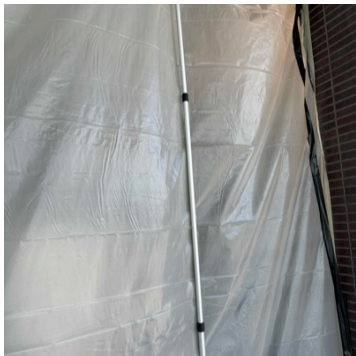
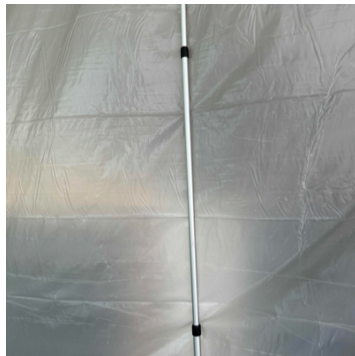
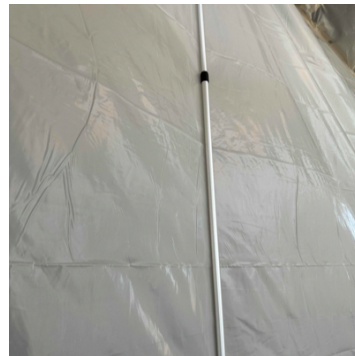
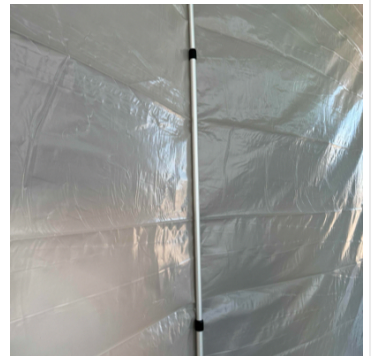
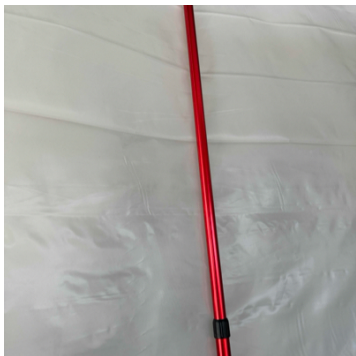
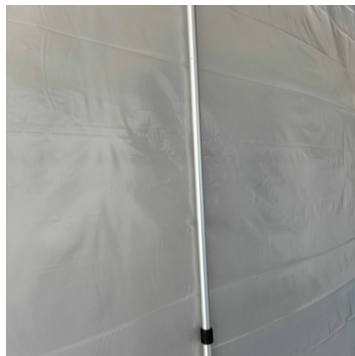
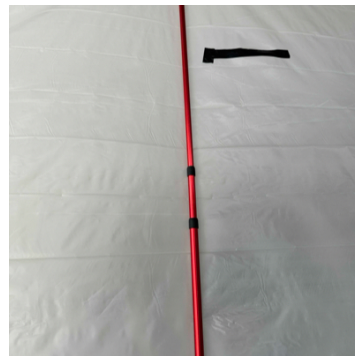
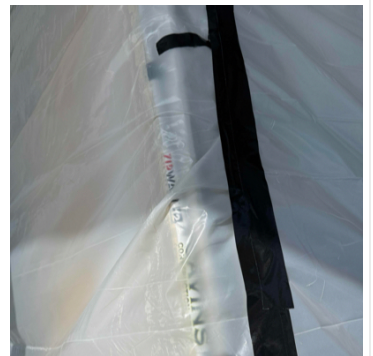
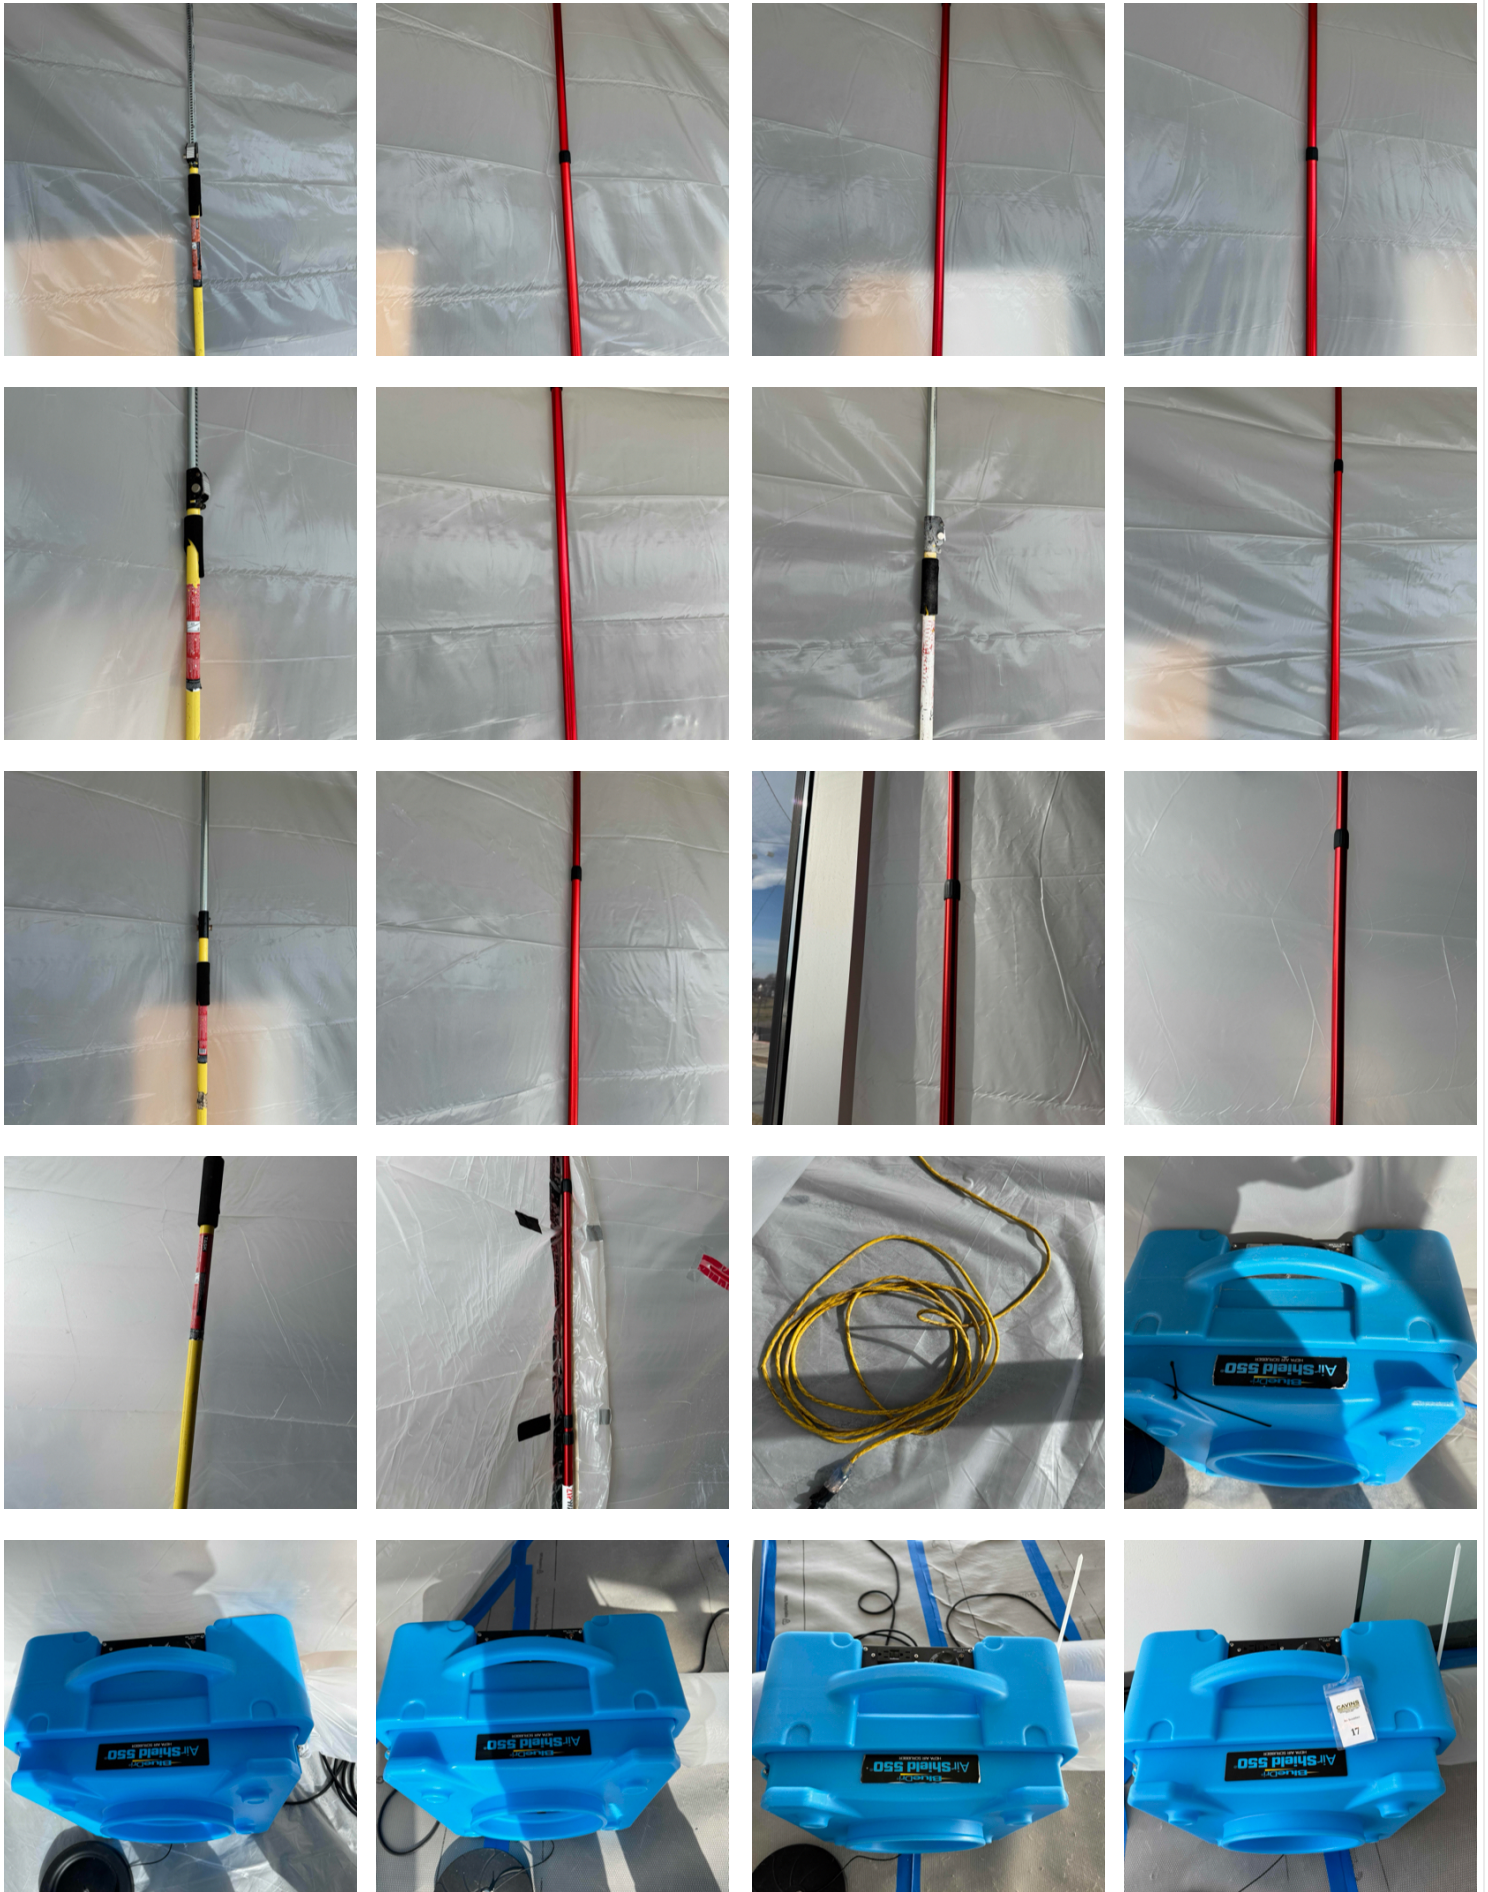
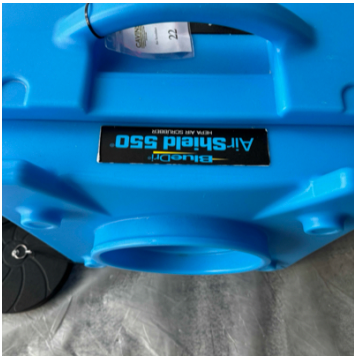
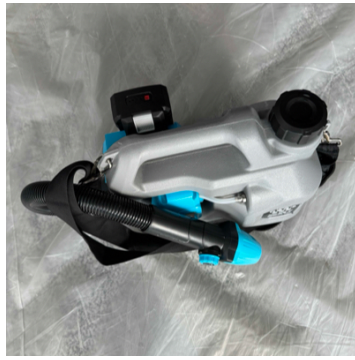
14. Second Floor - Southeast Corner: Equipment

- 22 - Zip Posts
- 6 - Air Scrubbers
- 1 - 50' Extension Cord
- 1 - Fogger

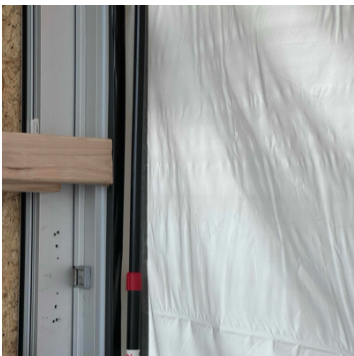
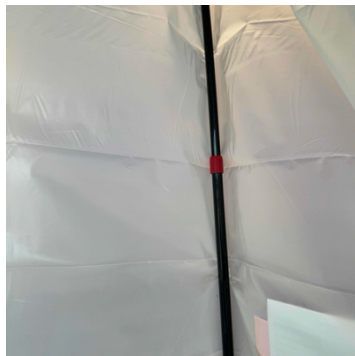
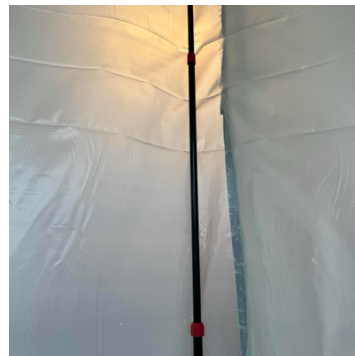
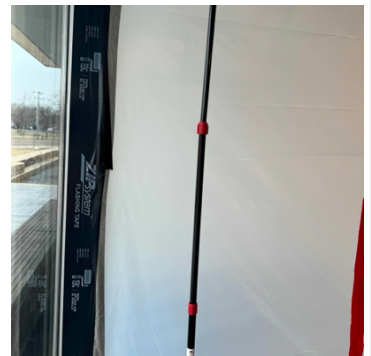
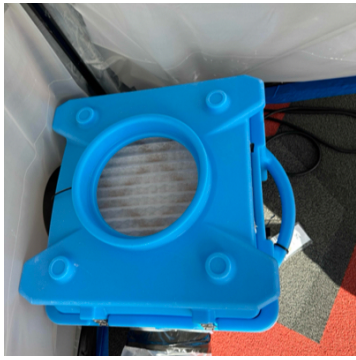
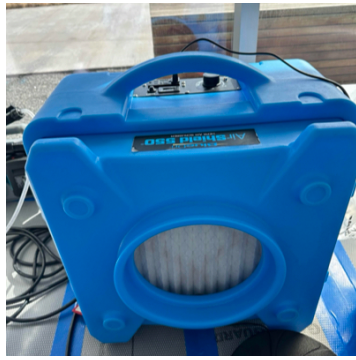
17. 149 Storytime: Equipment

- 5 - Zip Posts
- 2 - Air Scrubbers
- 1 - Hepa Vacuum
- 1 - Fogger
- 1 - 50' Extension Cord

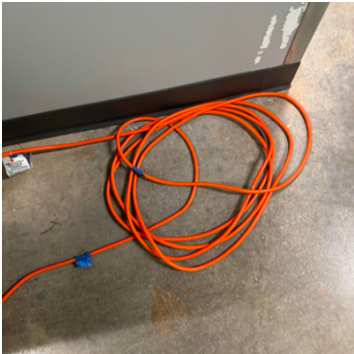
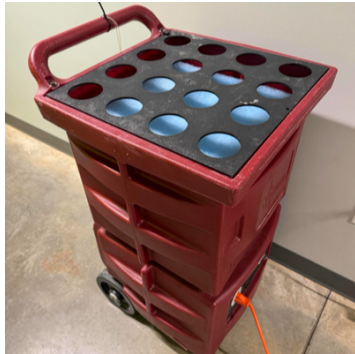
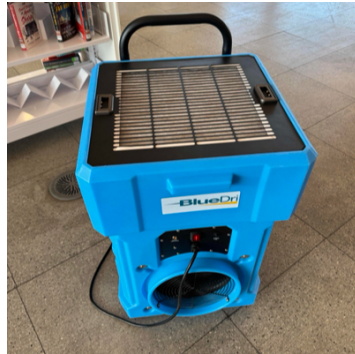
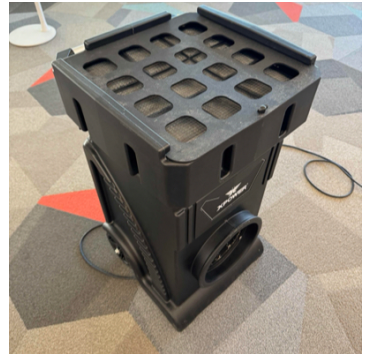
20. First Floor - Main Area: Equipment
3 - Air Scrubbers
1 - 25' Extension Cord

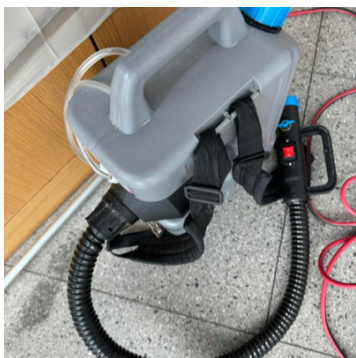
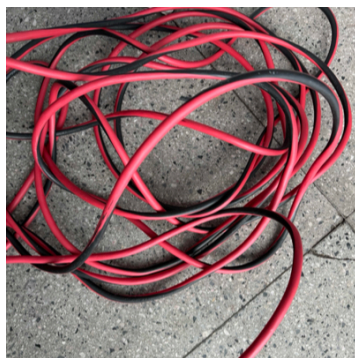
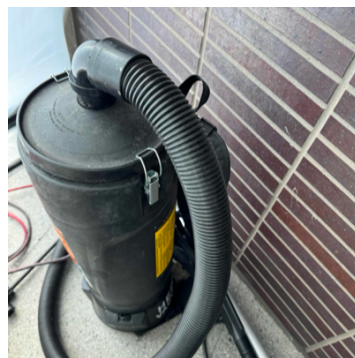
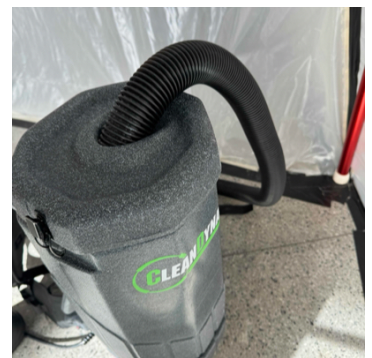
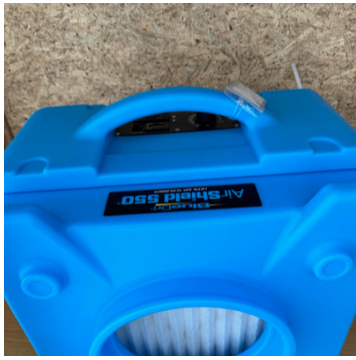
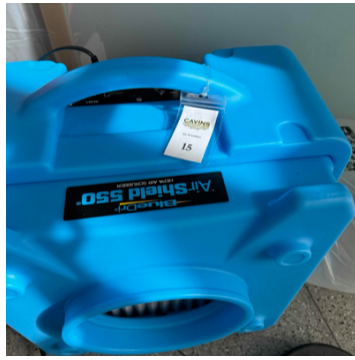
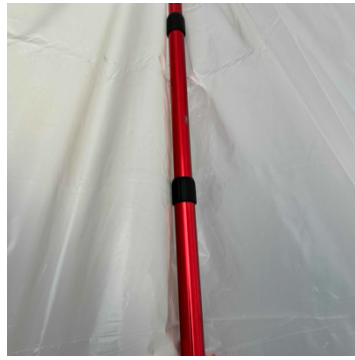
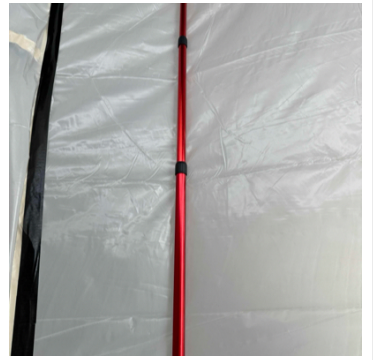
24. First Floor - Southwest Vestibule: Equipment

- 2 - Zip Posts
- 2 - Air Scrubbers
- 2 - Hepa Vacuums
- 1 - 50' Extension Cords
- 1 - Fogger
