Date Sun 08/11/2024

Name	Description
Cavins Environmental	On Sunday, August 11, 2024, Cavins Group monitored the Norman Public Library-Central after continuous hours of directional rain began early in the morning and continued intermittently throughout the day. Several affected areas were identified both visually and with the use of a thermal camera. Moisture readings were taken as needed, along with temperature, humidity, and drying standards, to set up structural drying equipment.
Total

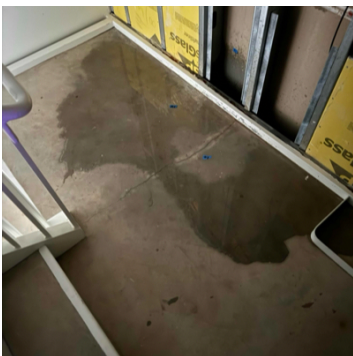
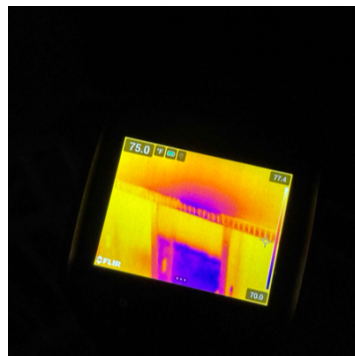
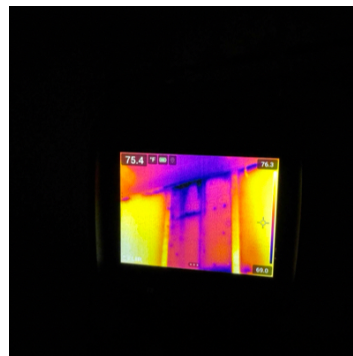
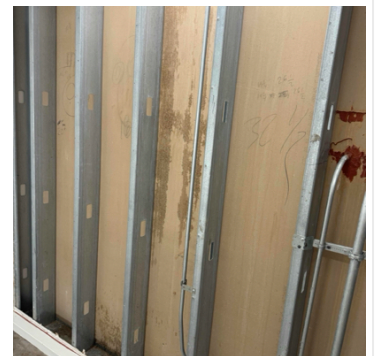
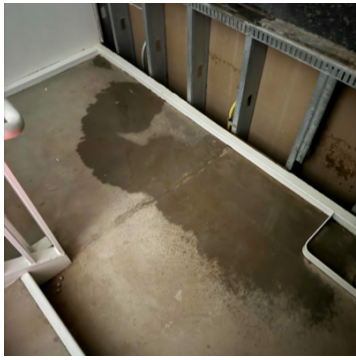
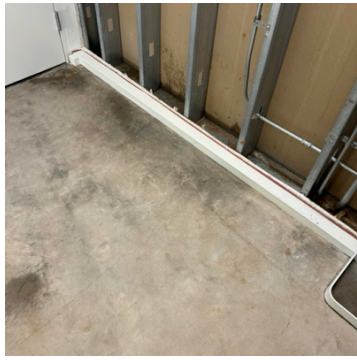
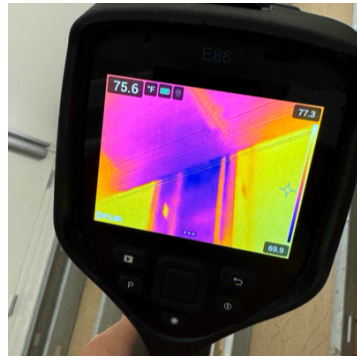
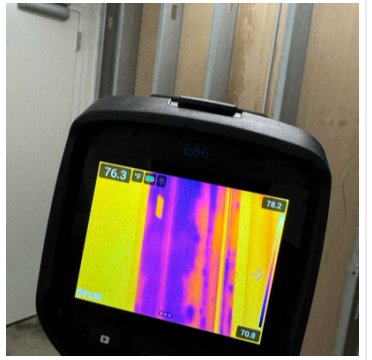
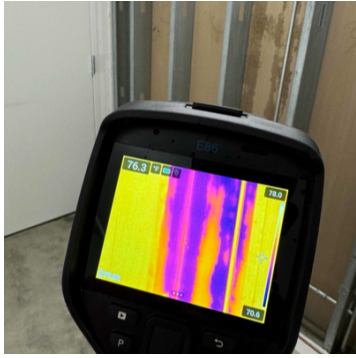
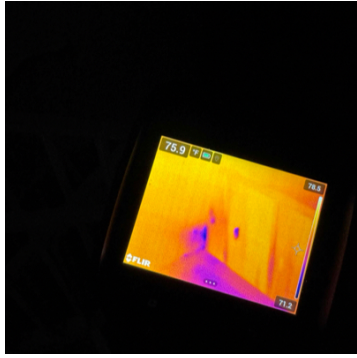
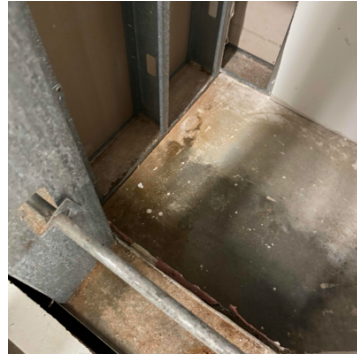
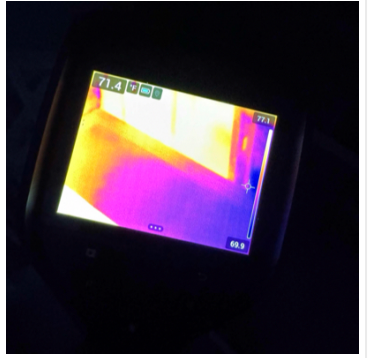
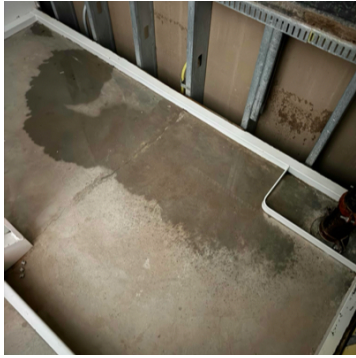
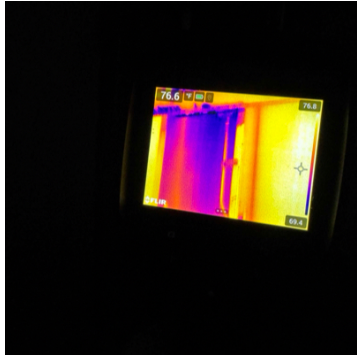
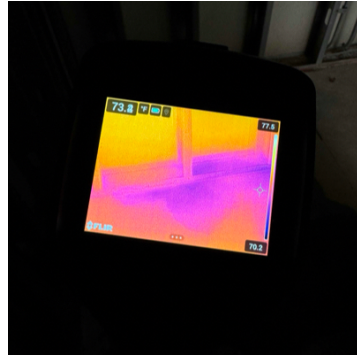
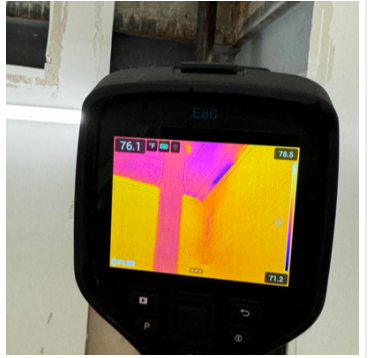
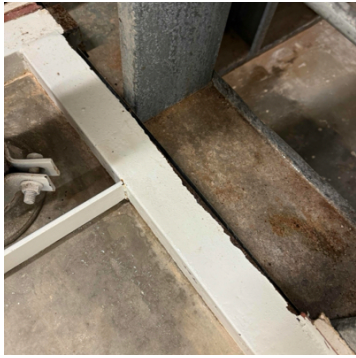
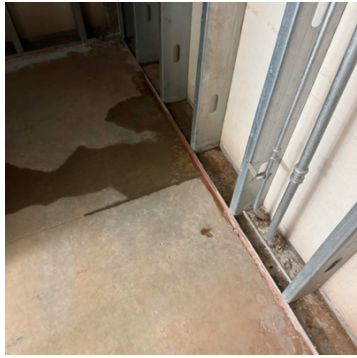
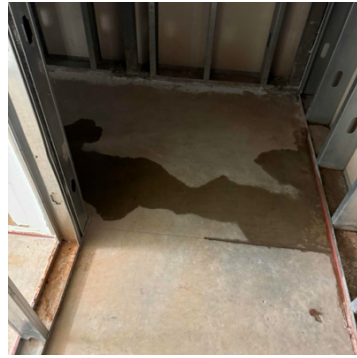
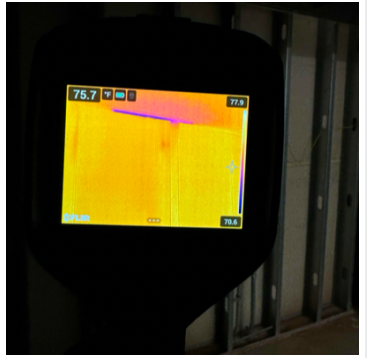
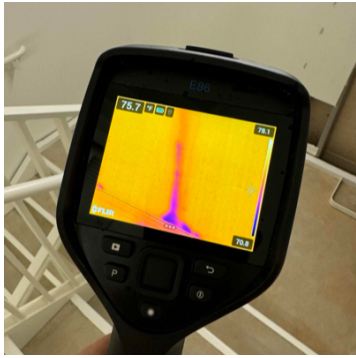
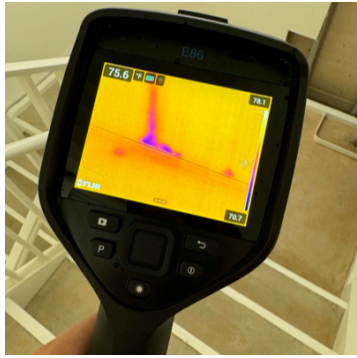
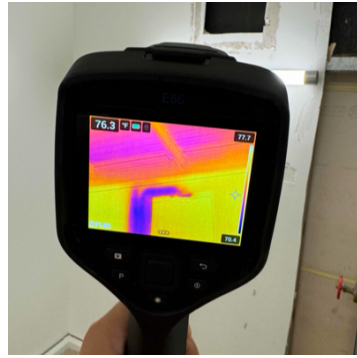
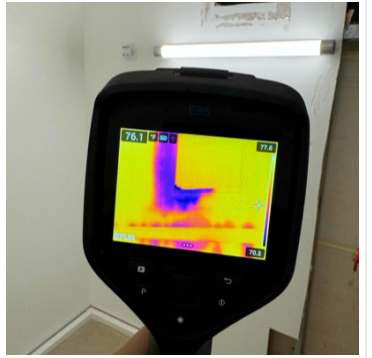
1. Stairway:

Thermal imaging and visual inspection show signs of residual water on all four stories and each landing facing north, as well as on the drywall.

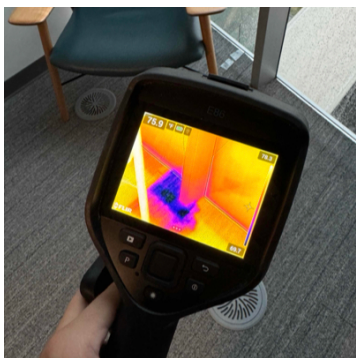
4. Literacy-307:

Thermal imaging and visual inspection show signs of residual water on the floor by the exterior window.

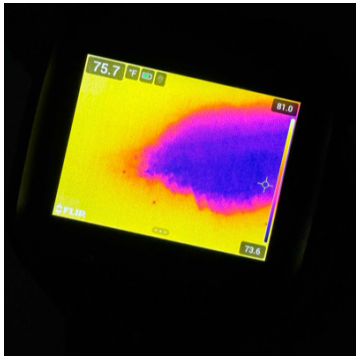
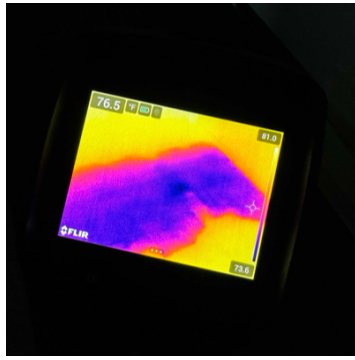
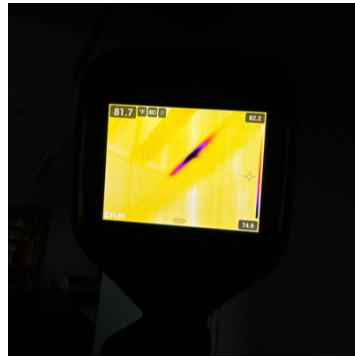
5. Research-314:

Thermal imaging and visual inspection show signs of residual water on the floor.

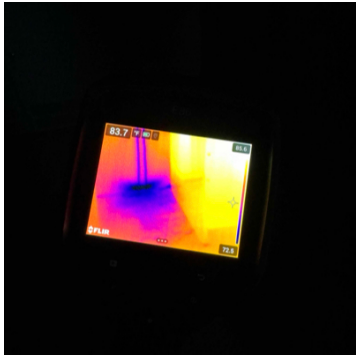
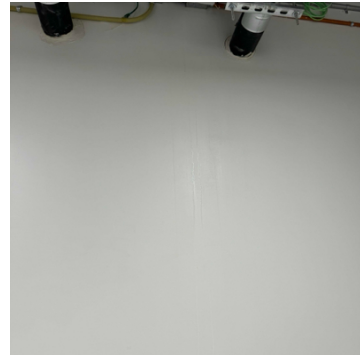
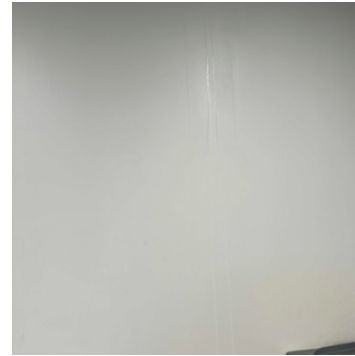
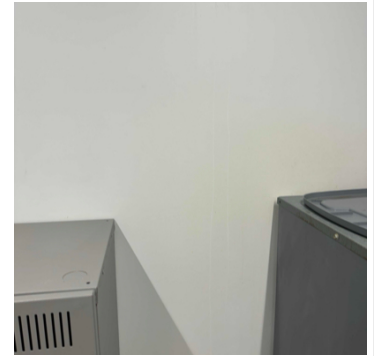
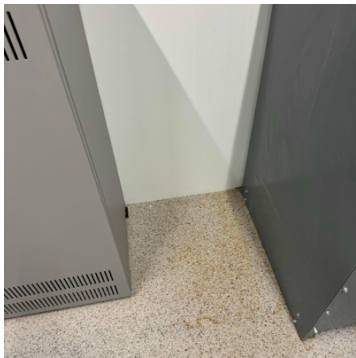
6. Electrical-313:

Thermal imaging and visual inspection show signs of residual water on the floor as well as on the drywall.

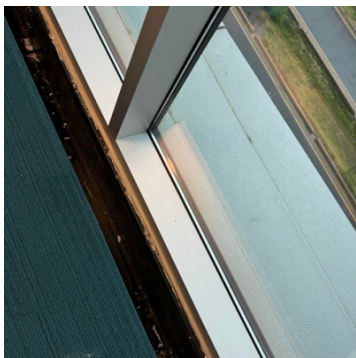
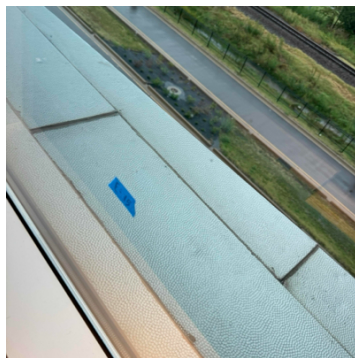
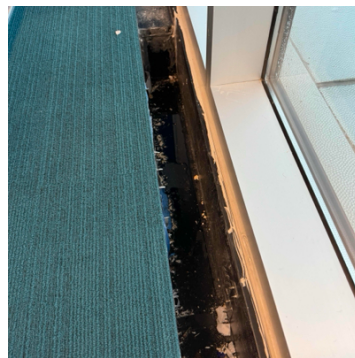
7. Study Room-233:

Thermal imaging and visual inspection show signs of residual water on HVAC vent.

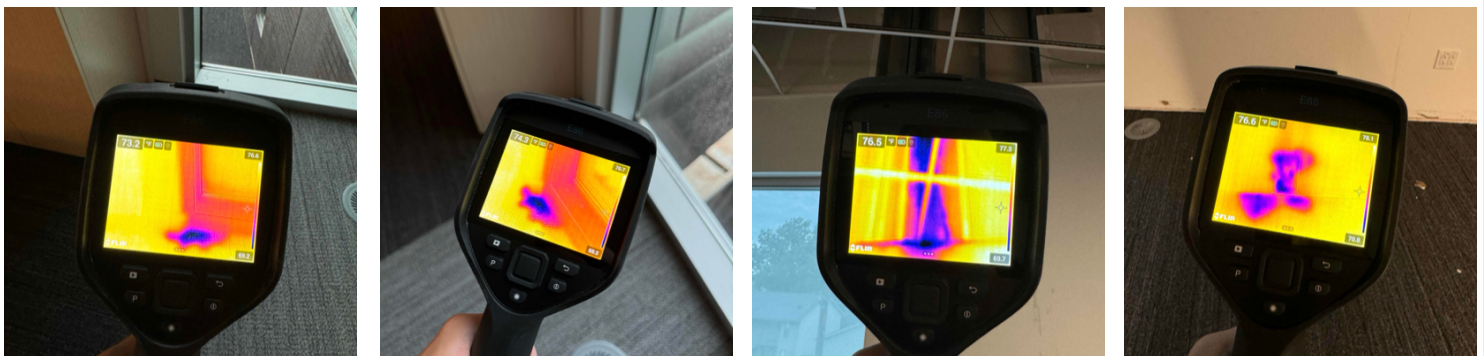
11. Staff Only - 201A:

Thermal imaging and visual inspection show signs of residual water on the floor by the north exterior wall, on the drywall in the southwest corner, and at the base of the column next to the south door access.

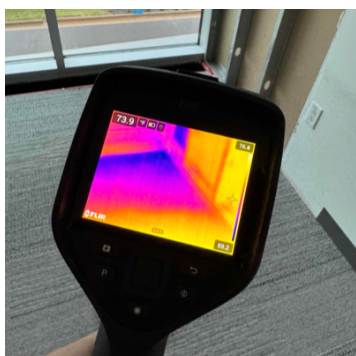
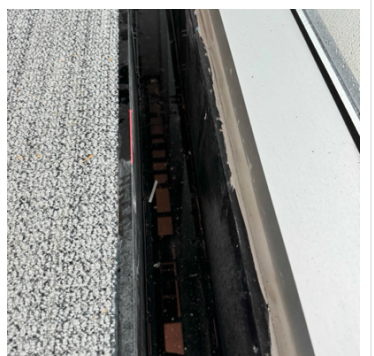
12. Second Floor Common Area:

Thermal imaging and visual inspection show signs of residual water actively collecting inside the HVAC cavity and on the diversion tarp due to active leaks from the uncovered ceilings. Dripping water has also affected the adjacent carpet.

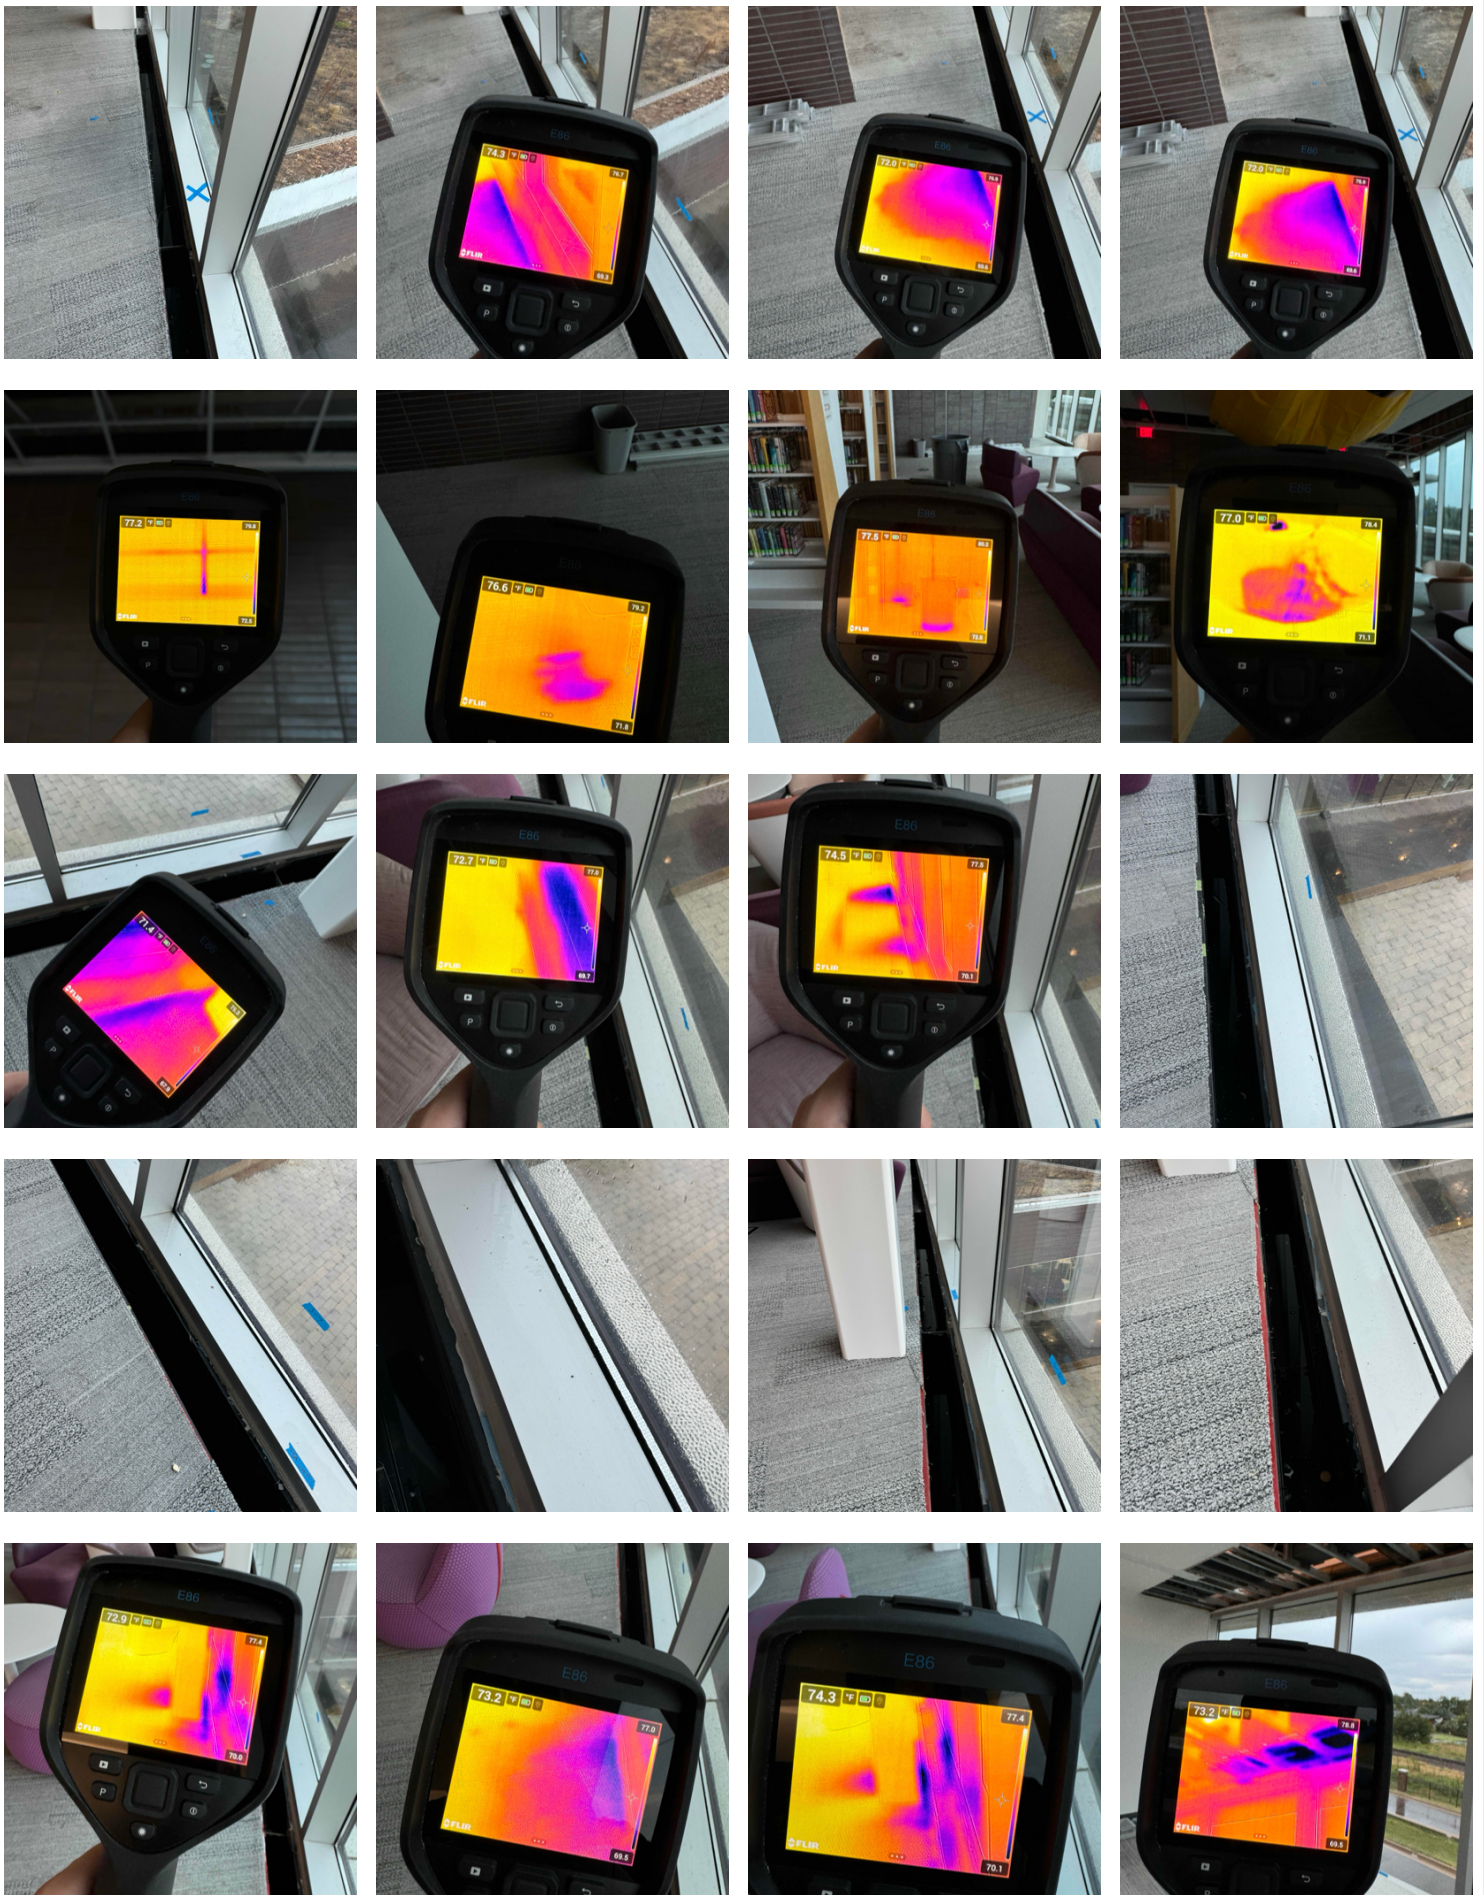
13. Study room-231:
Thermal imaging and visual inspection show signs of residual water actively collecting inside the HVAC

cavity. Dripping water has also affected the adjacent floor.

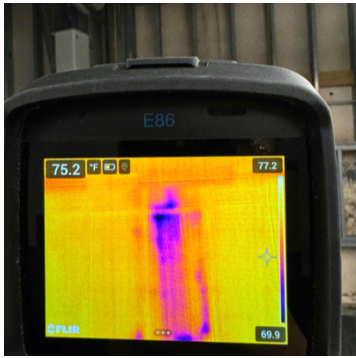
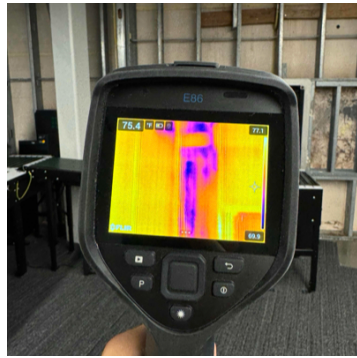
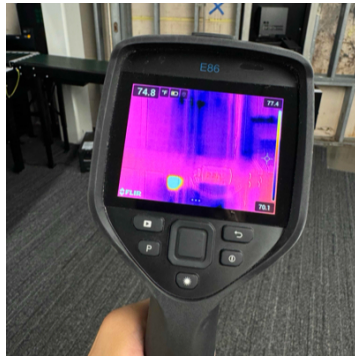
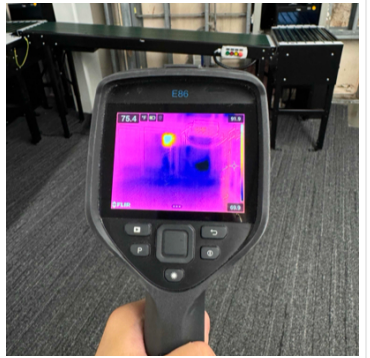
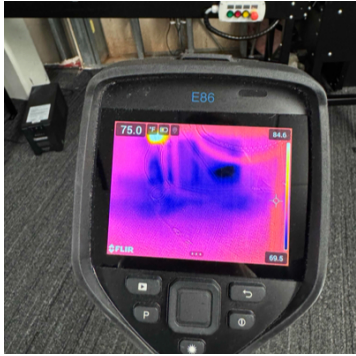
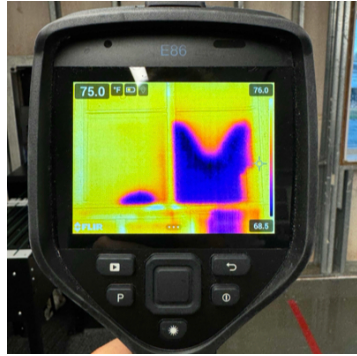
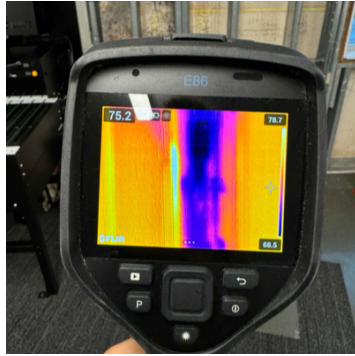
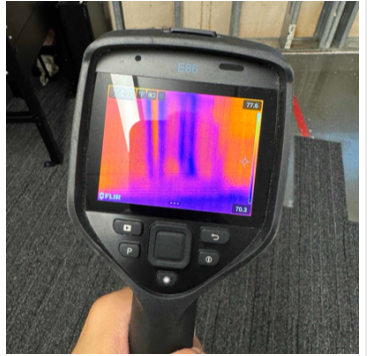
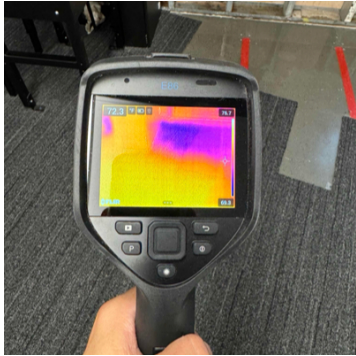
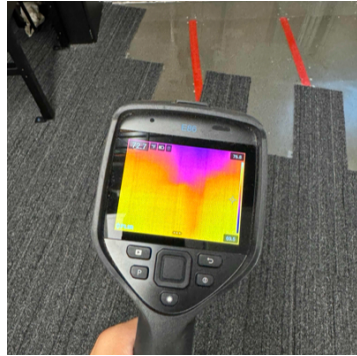
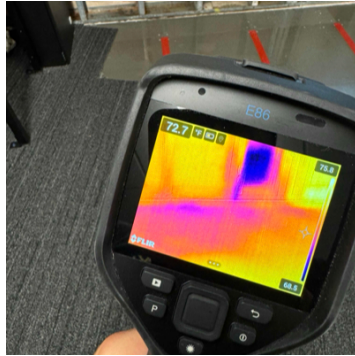
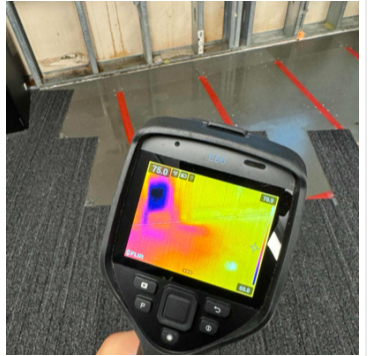
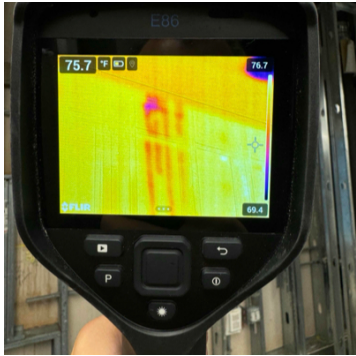
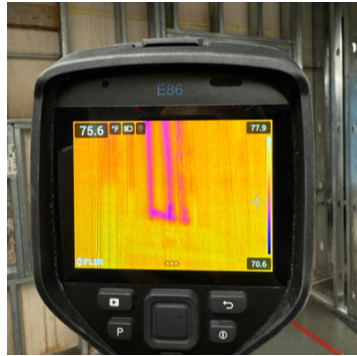
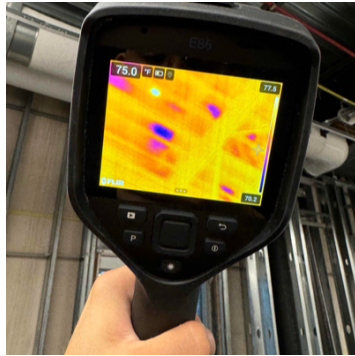
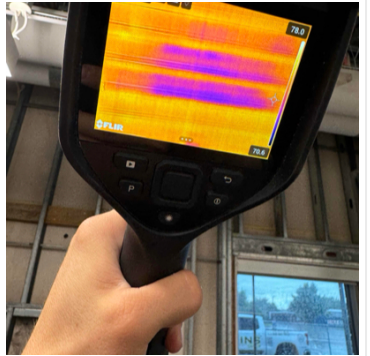
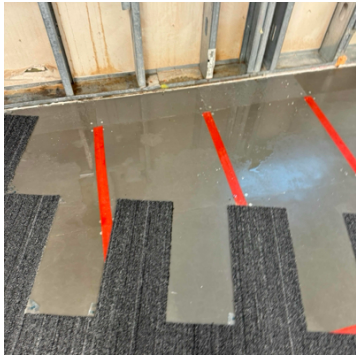
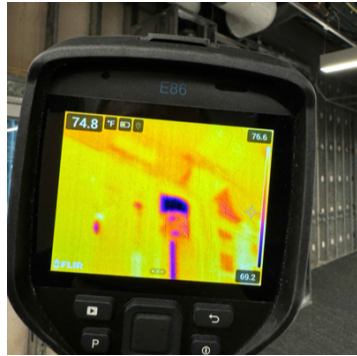
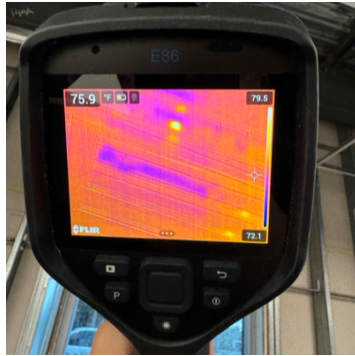
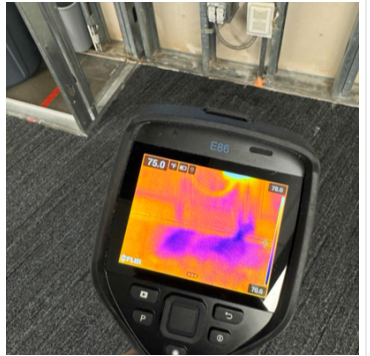
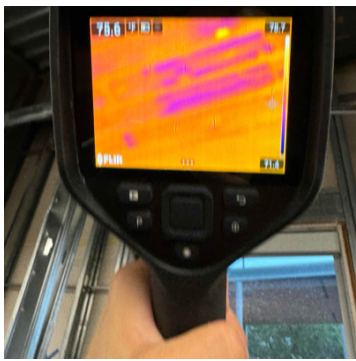
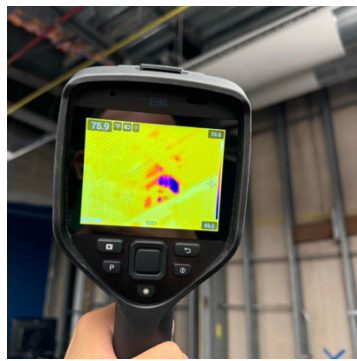
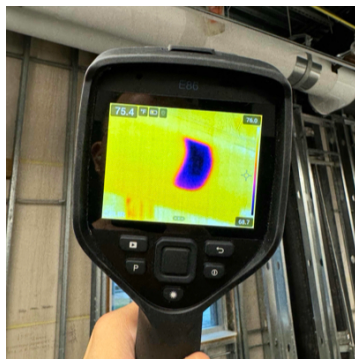
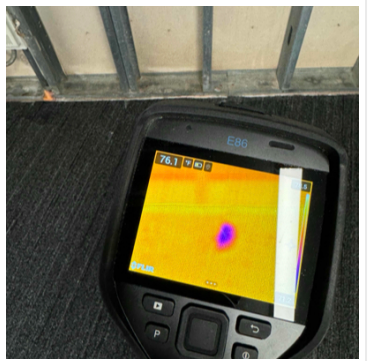
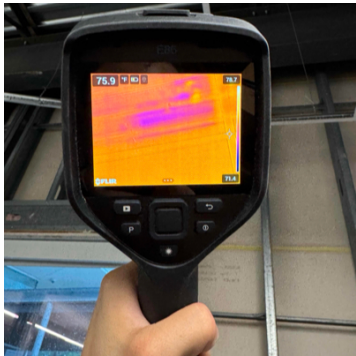
Thermal imaging and visual inspection show signs of residual water on the floor as well as on the drywall on the west side wall, several ceiling tiles show signs of moisture.

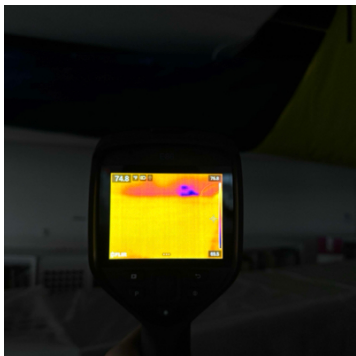
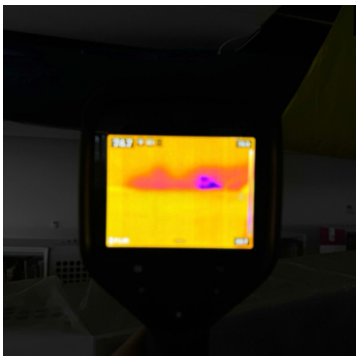
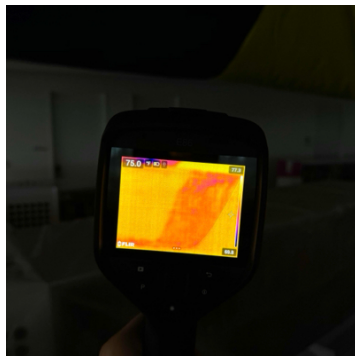
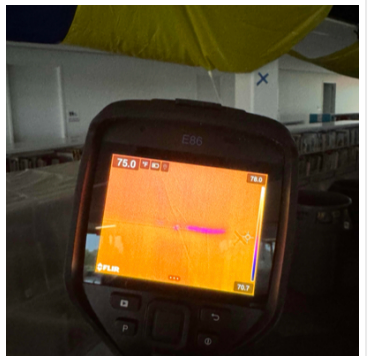
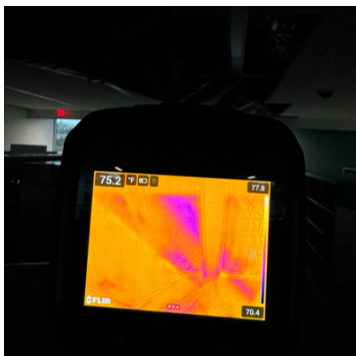
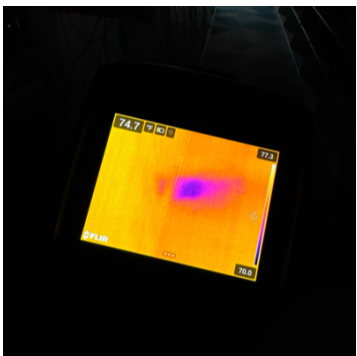
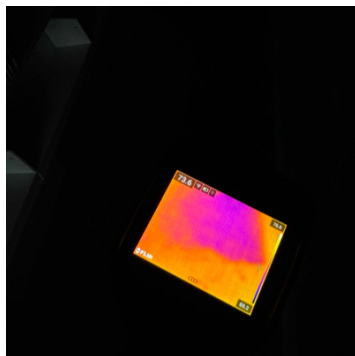
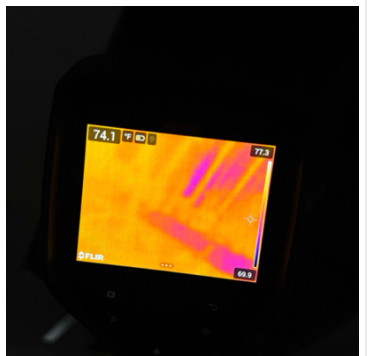
16. Children's area:

Thermal imaging and visual inspection show signs of residual water on diversion tarps and on several spots along the carpeted floors and furniture as well as in the fur out wall over the south side of the area.

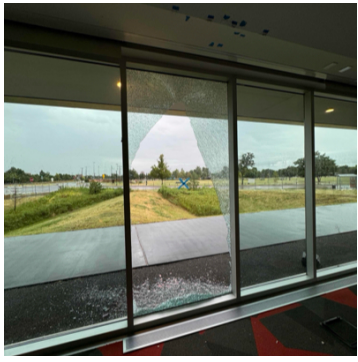
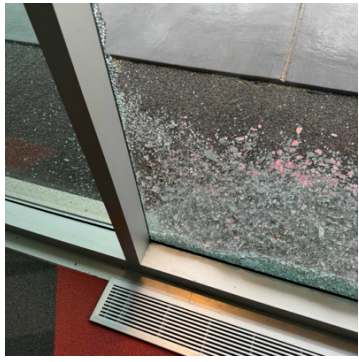
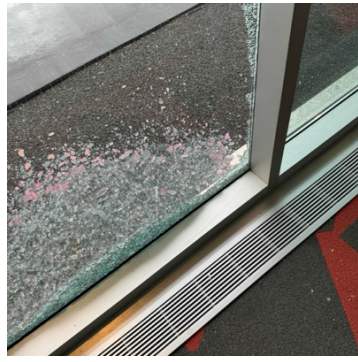
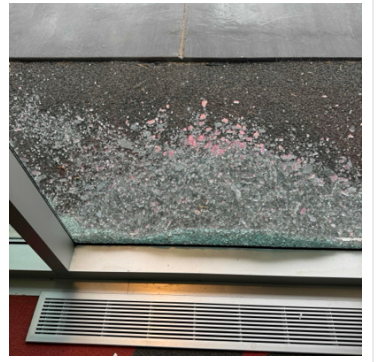
18. Story time - /Window:
Middle glass panel was shattered from the outside.
