Date Mon 12/04/2023

Name	Description
Cavins Environmental	Cavins Group inspected all equipment and containments and changed all air scrubber filters. Humidity and temperature readings were checked on all three floors in the main area and one exterior reading. Remediation of 305 Pioneer continued—continued cleaning and documentation of SO 115.
Total

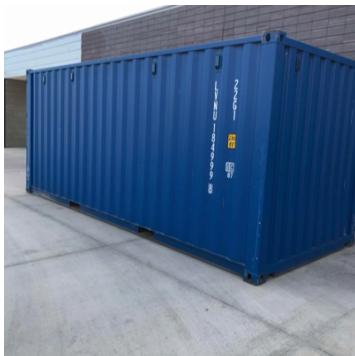
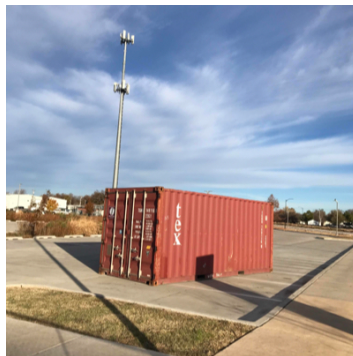
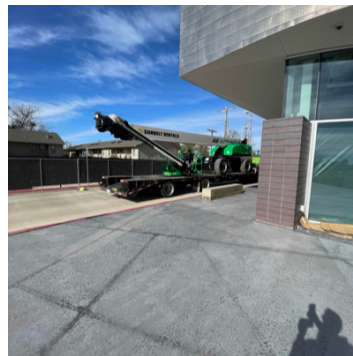
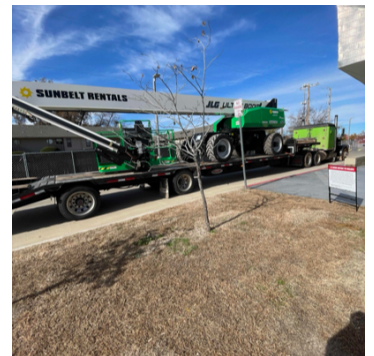
### 1. Exterior: Equipment On-site

2 - 20' Conex Boxes

1 - 150' Boom Lift with a Jib

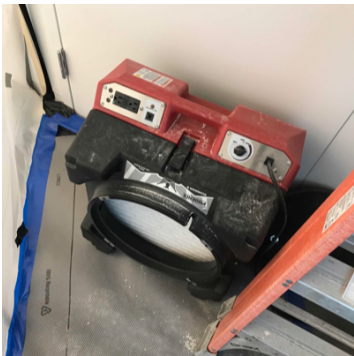
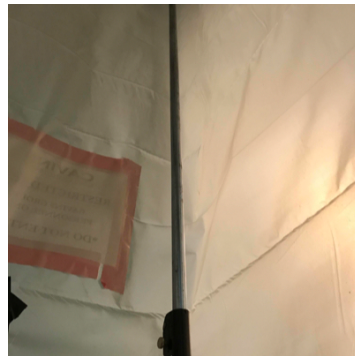
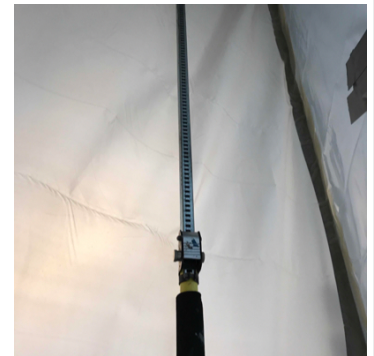
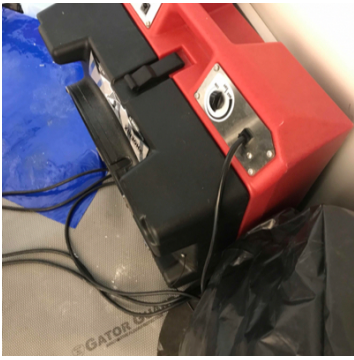
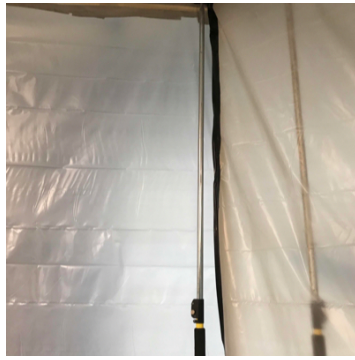
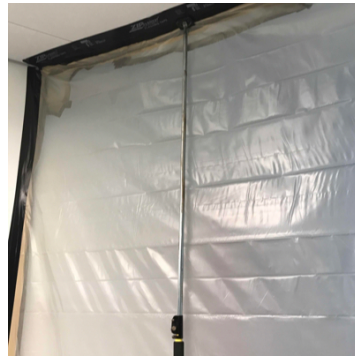
**5. 305 Pioneer: Equipment On-site**

- 2 - Air Scrubbers
- 4 - Zip Posts

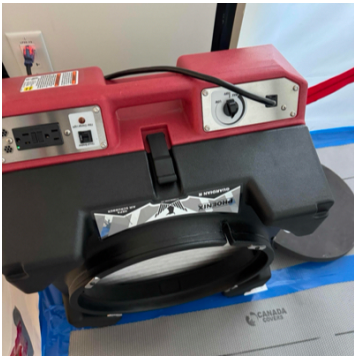
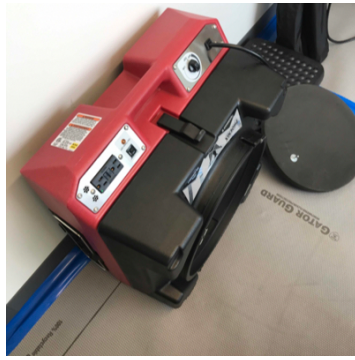
**8. 311 Local History: Equipment On-site**

2 - Air Scrubbers

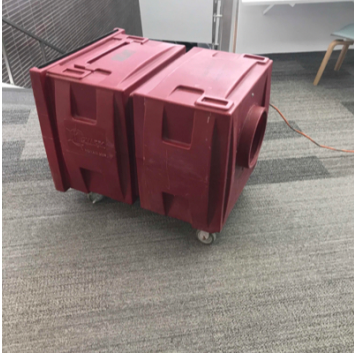
**9. Third Floor - Main Area: Equipment On-site**

1 - Air Scrubber

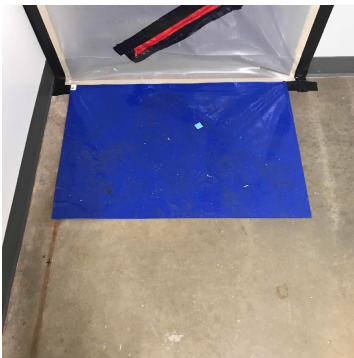
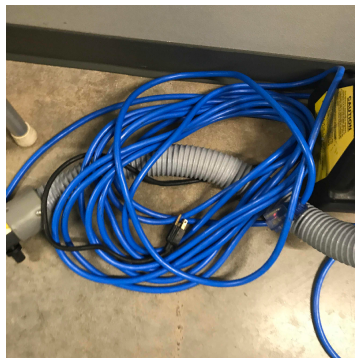
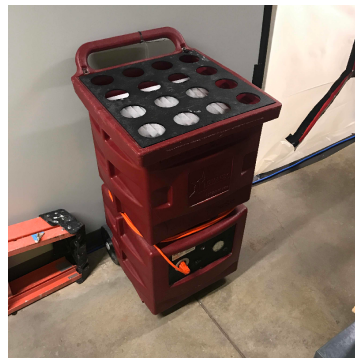
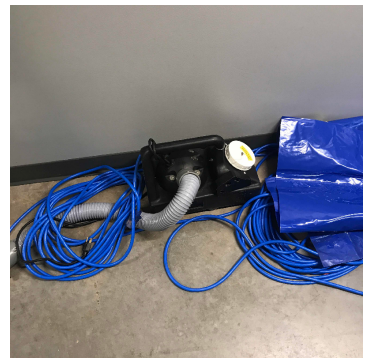
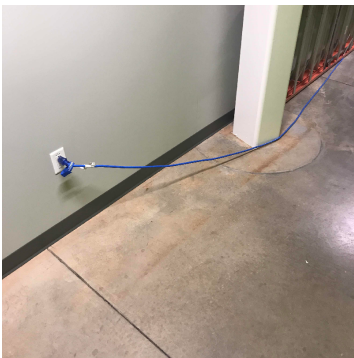
**10. Garage: Equipment On-site**

- 4 - Air Scrubbers
- 2 - 50' Extension Cord
- 2 - 25' Extension Cords

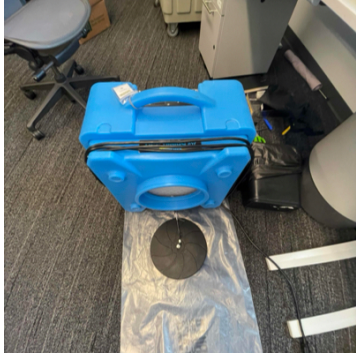
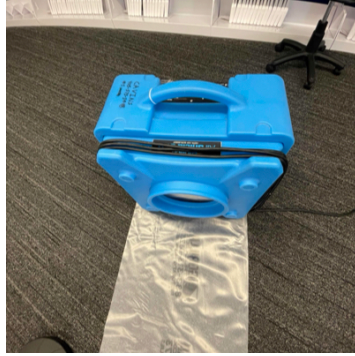
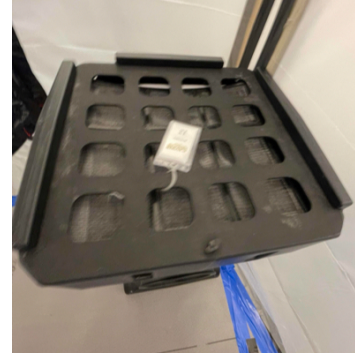
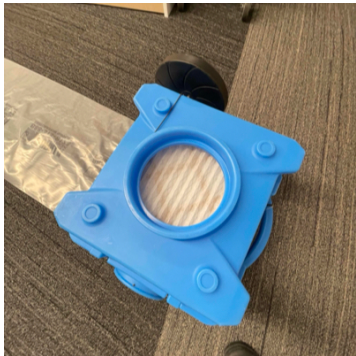
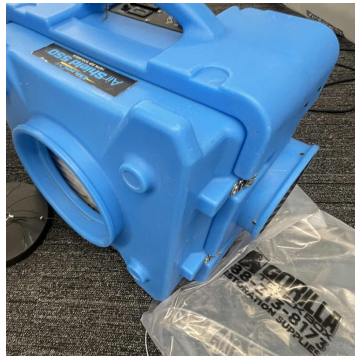
11. SO 115: Equipment On-site

6 - Air Scrubbers

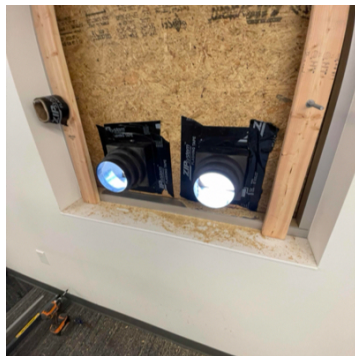
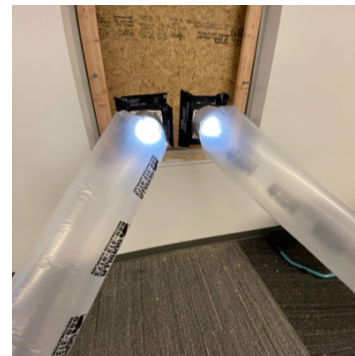
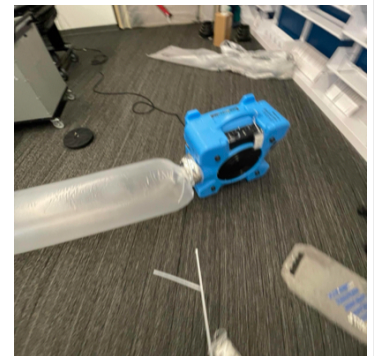
12. SO 115: Containment Set Up

Set up negative air ductwork for the air scrubbers.

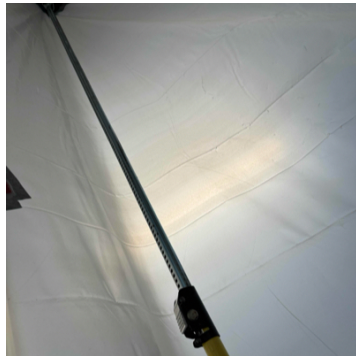
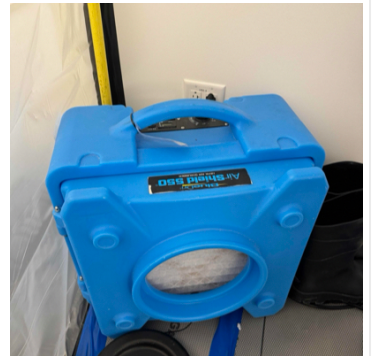
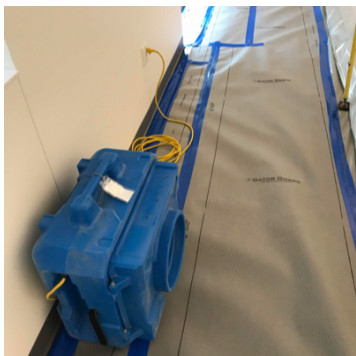
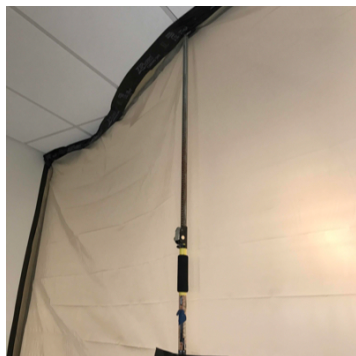
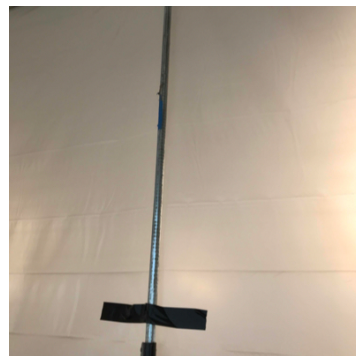
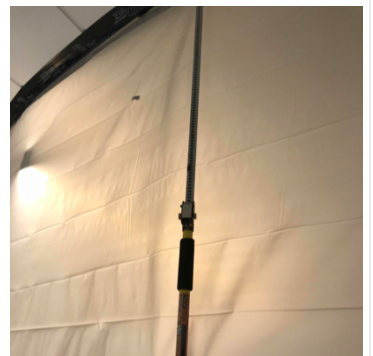
15. SO 201A: Equipment On-site

- 3 - Air Scrubbers
- 10 - Zip Posts

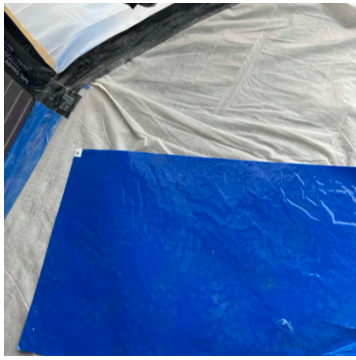
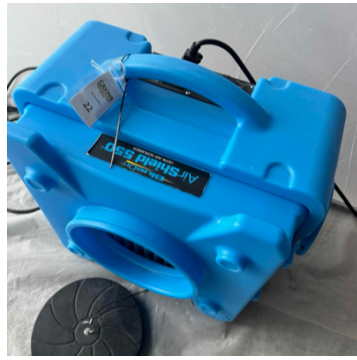
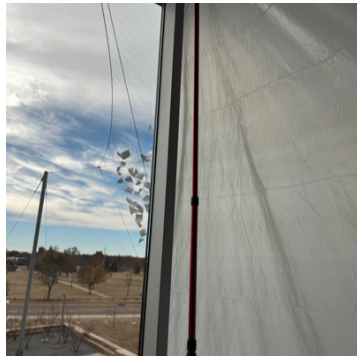
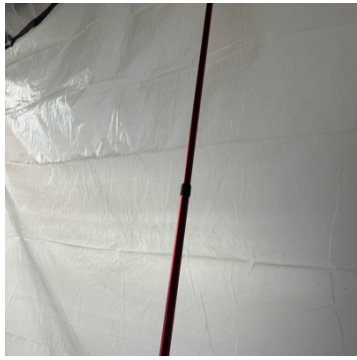
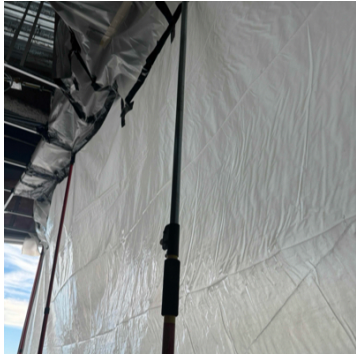
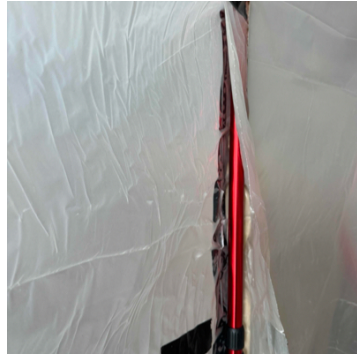
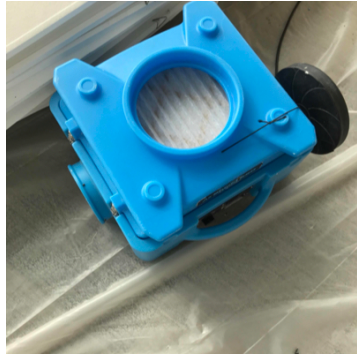
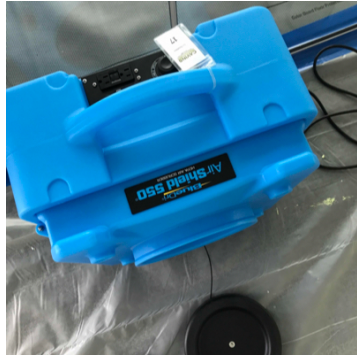
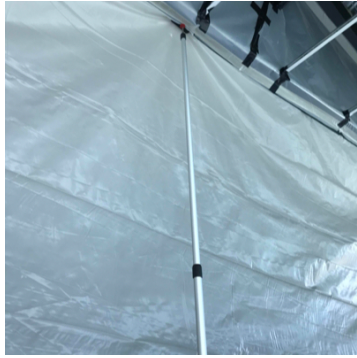
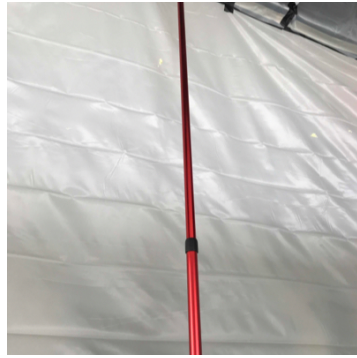
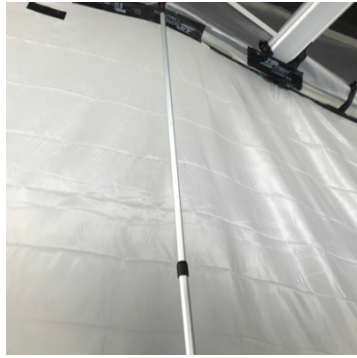
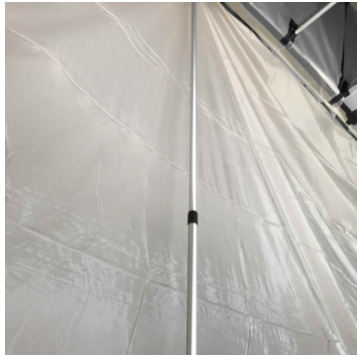
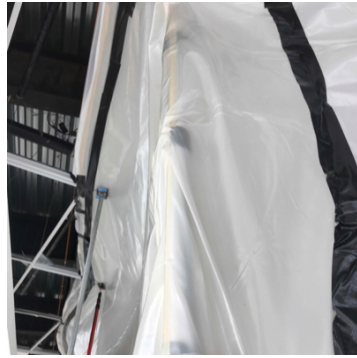
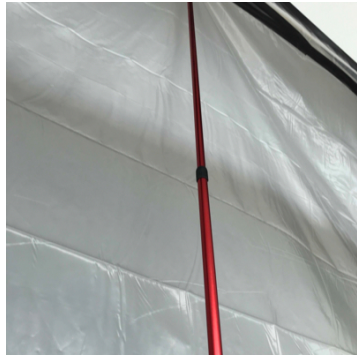
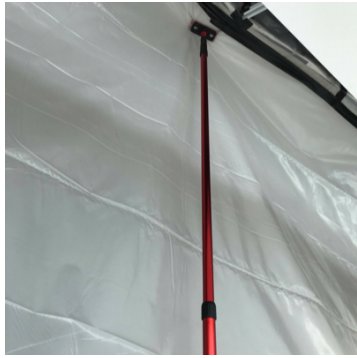
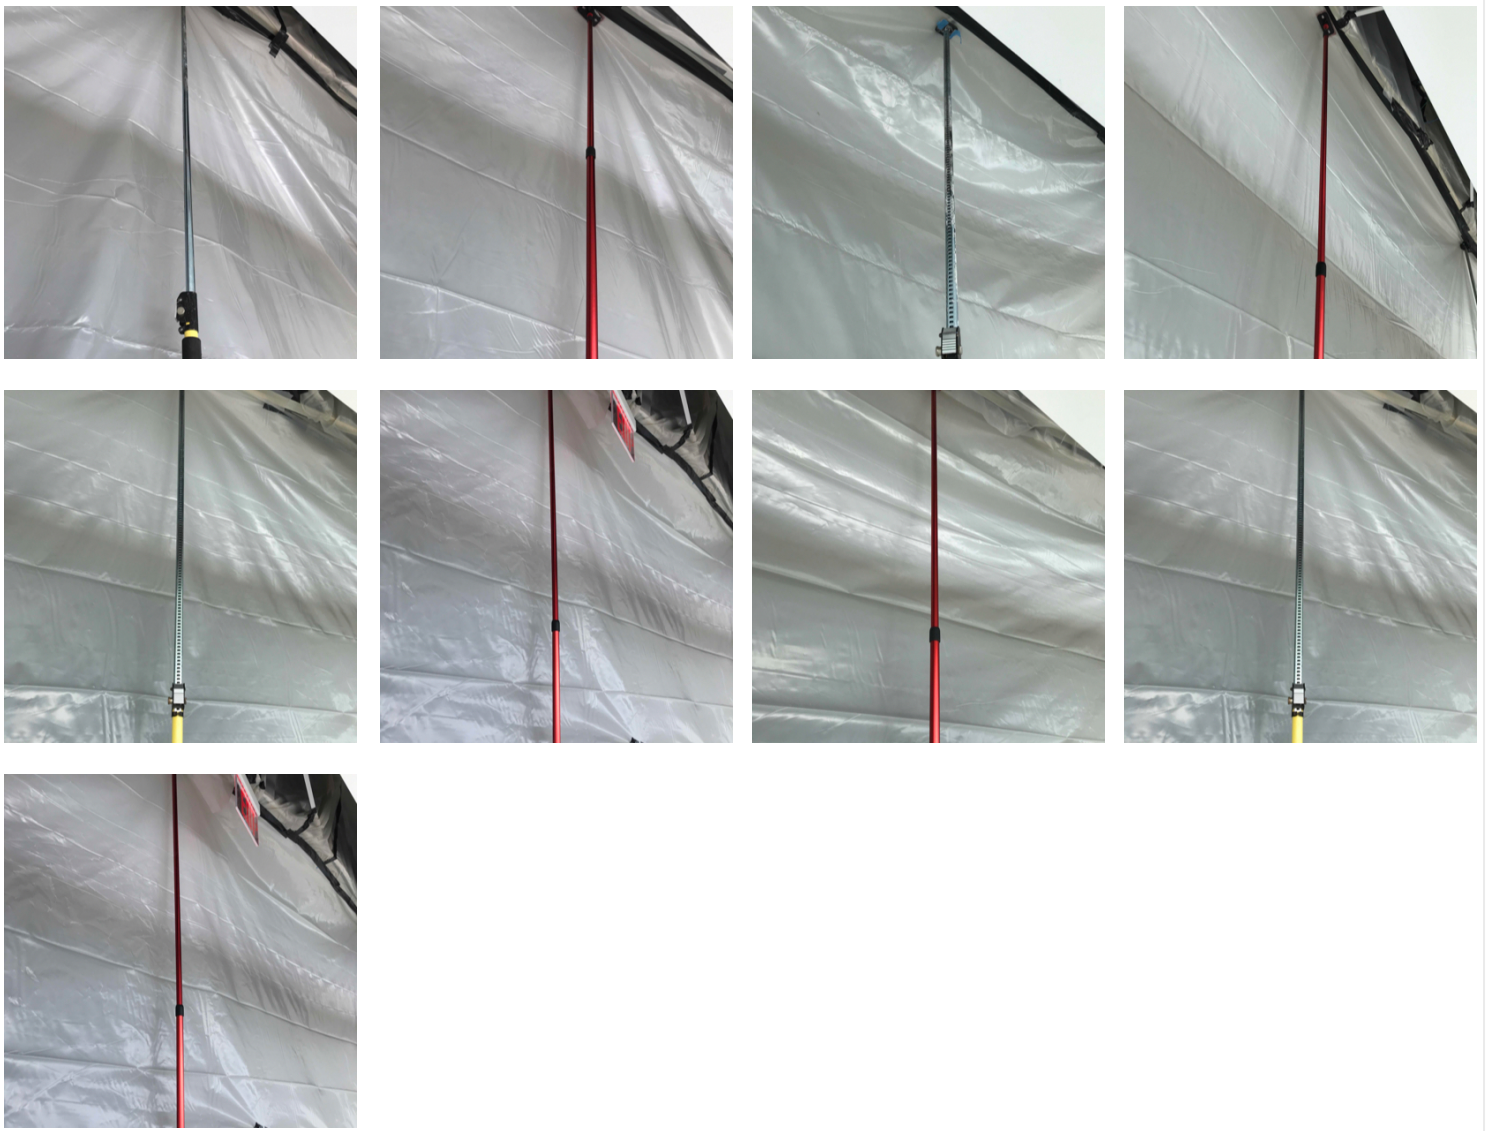
**17. Second Floor - Southeast Corner: Equipment On-site**

- 22 - Zip Posts
- 6 - Air Scrubbers

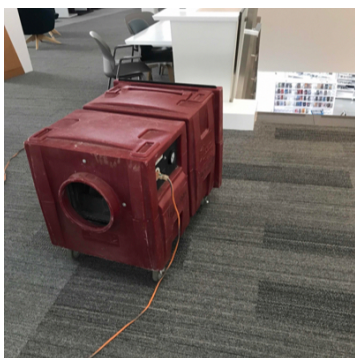
**19. Second Floor - Main Area: Equipment On-site**

**1 - Air Scrubber**

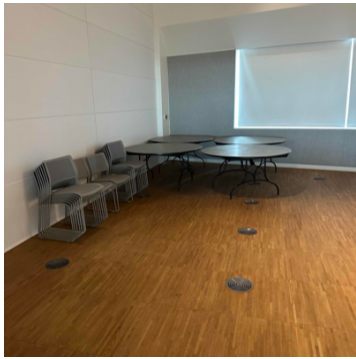
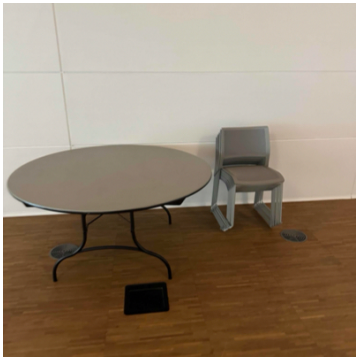
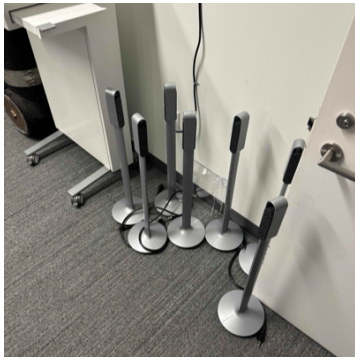
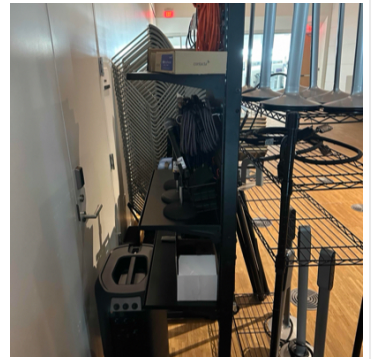
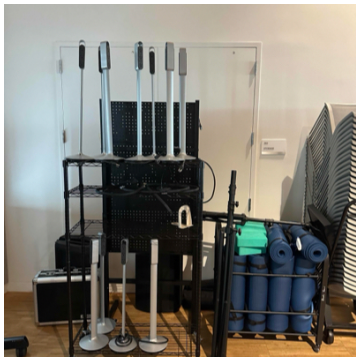
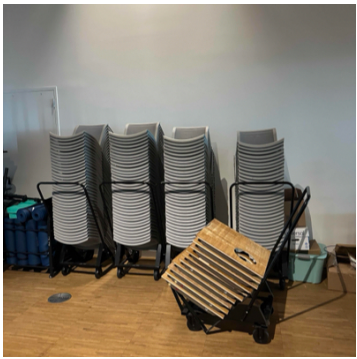
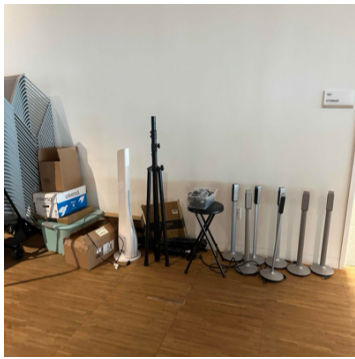
## 21. Storage Room 303: Containment Expansion

Moved everything that was stored in the storage room to office 302 Redbud.

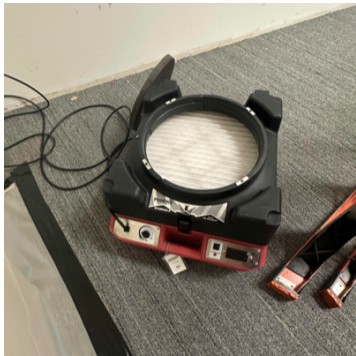
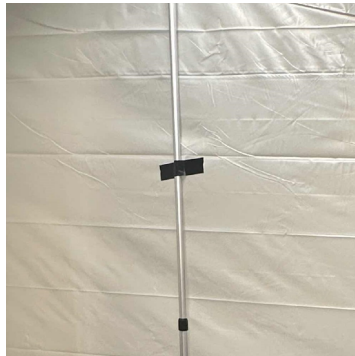
**23. Storage Room 303: Equipment On-site**

- 1 - Air Scrubber
- 2 - Zip Posts

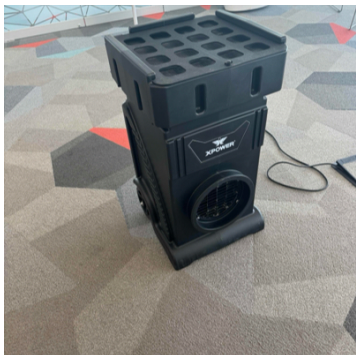
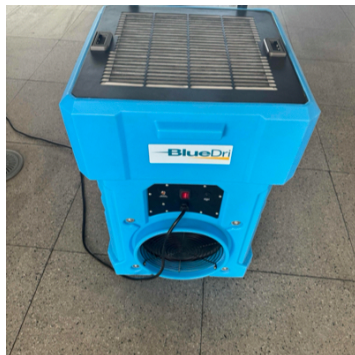
**24. First Floor - Main Area: Equipment On-site**

- 2 - Air Scrubbers

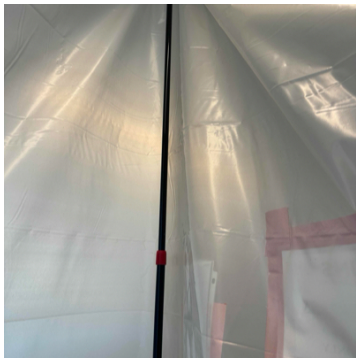
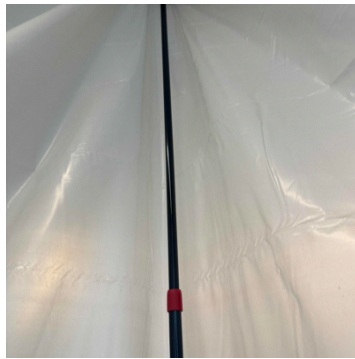
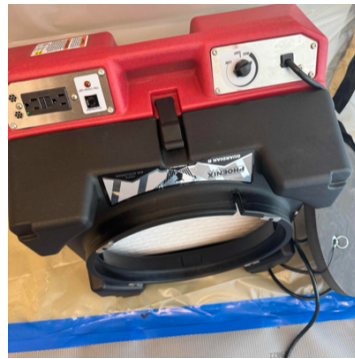
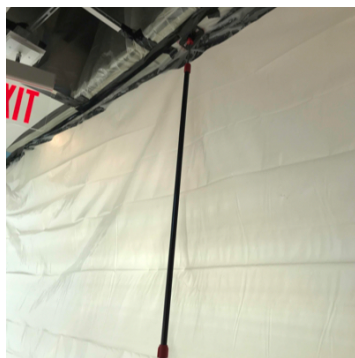
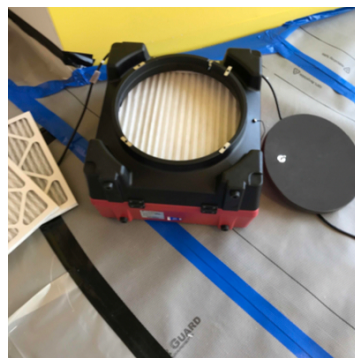
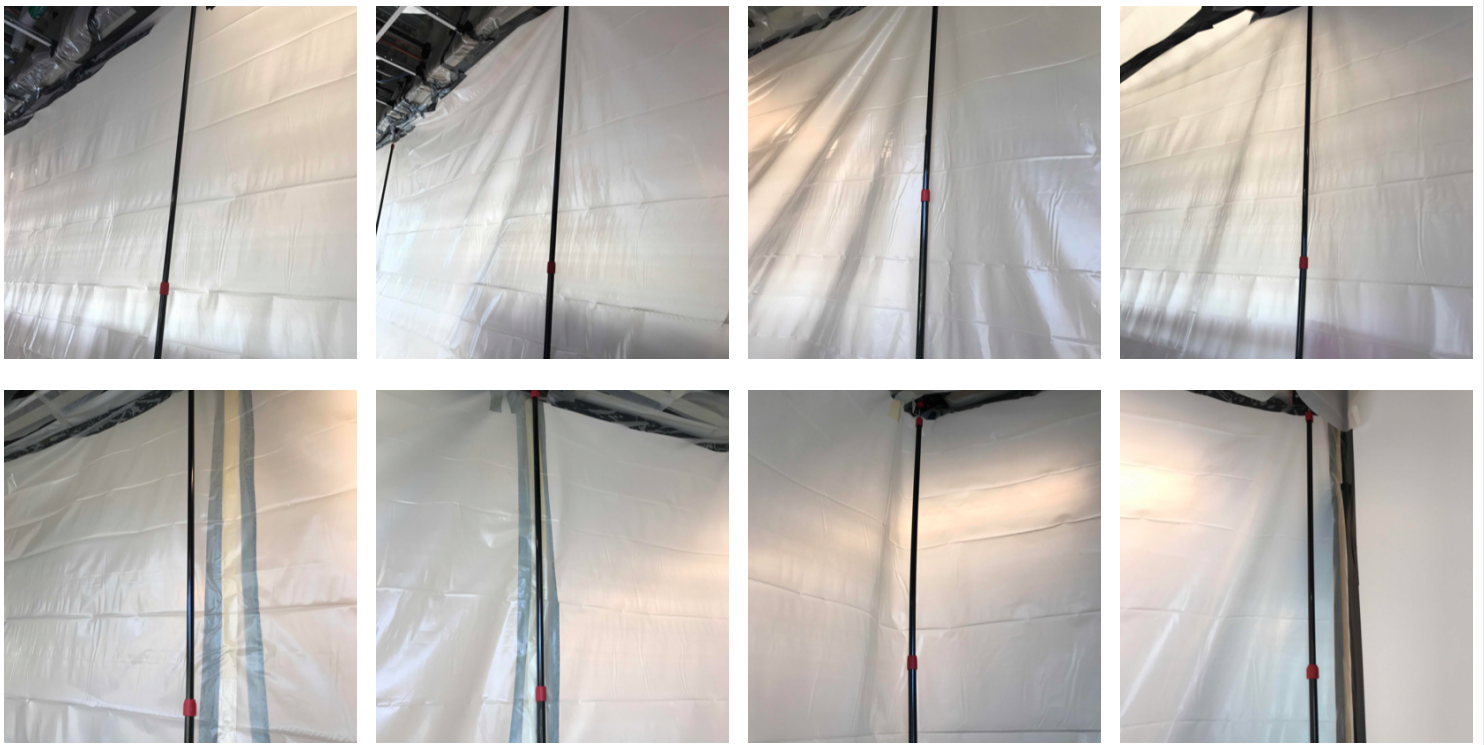
**27. First Floor - Bay Windows (Children's Area): Equipment On-site**

- 12 - Zip Posts
- 3 - Air Scrubbers

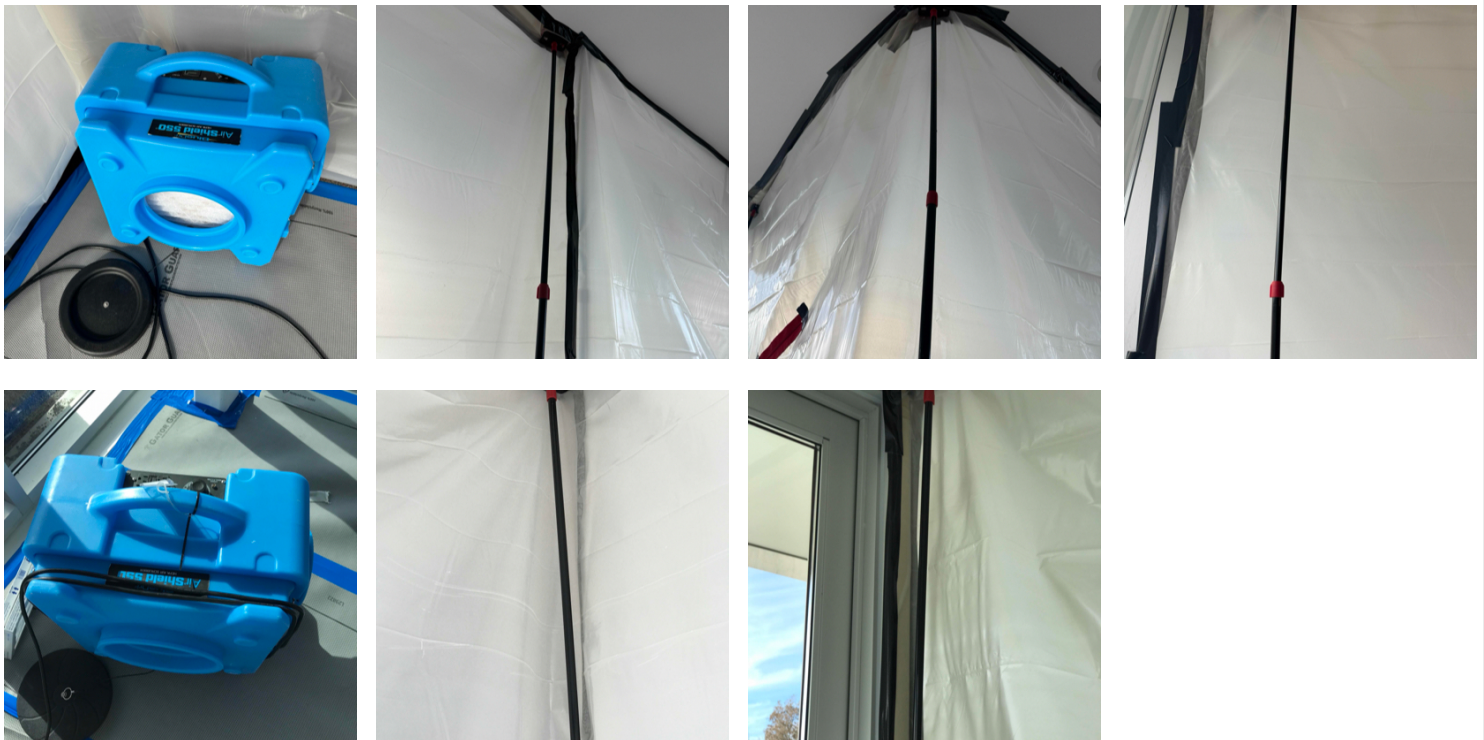
**28. First Floor - 149 Storytime: Equipment On-site**

- 5 - Zip Posts
- 2 - Air Scrubbers

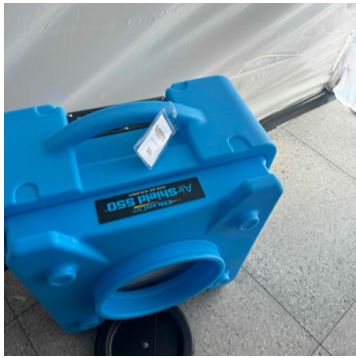
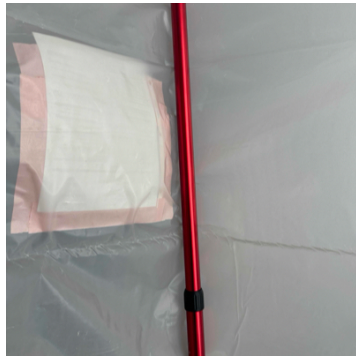
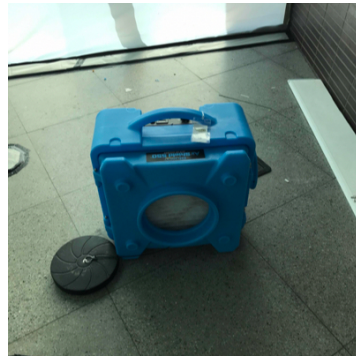
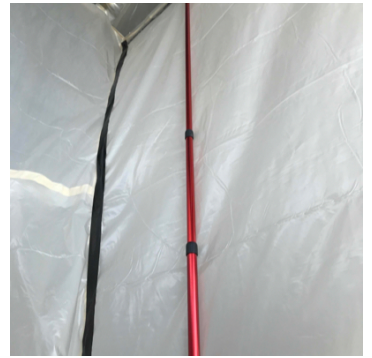
**34. First Floor- Southwest Vestibule: Equipment On-site**

- 2 - Zip Posts
- 2 - Air Scrubbers
