Date Tue 12/05/2023

Work Logs

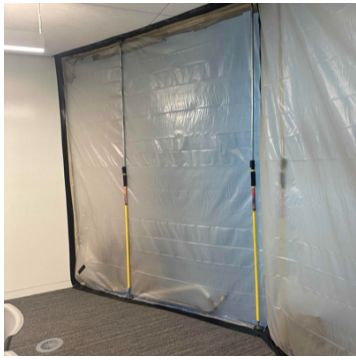
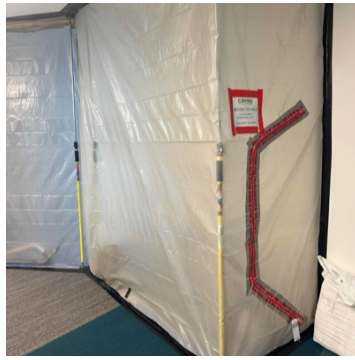
1. 305 Pioneer - Containment Upon Arrival/Departure

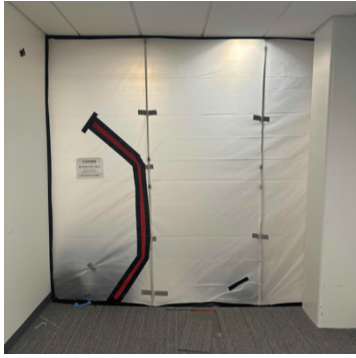
2. Storage Room 303: Containment Upon Arrival/Departure

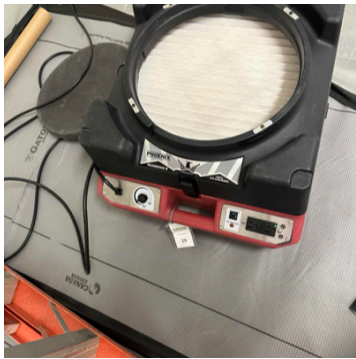
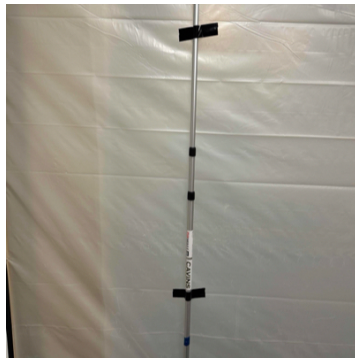
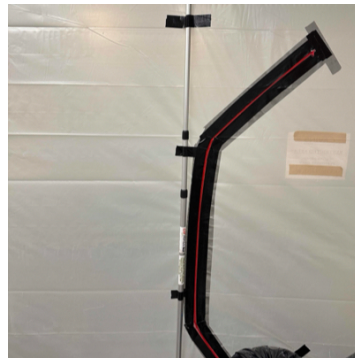
3. Storage Room 303: Equipment On-site

- 1 - Air Scrubber
- 2 - Zip Posts

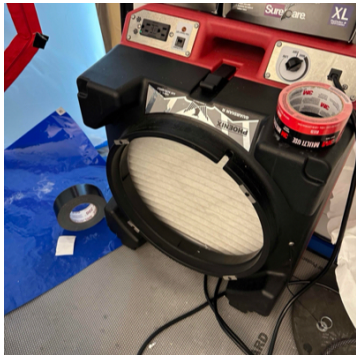
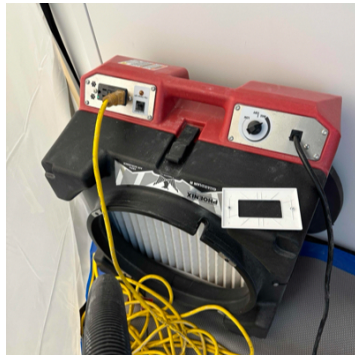
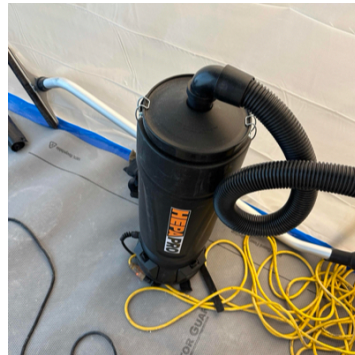
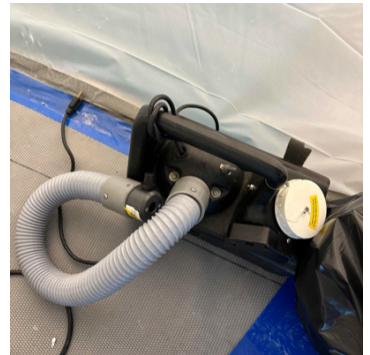
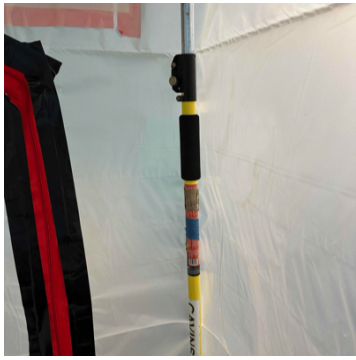
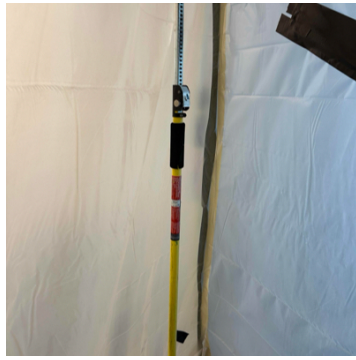
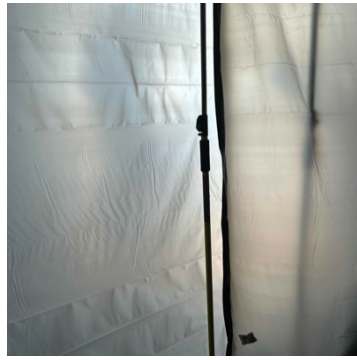
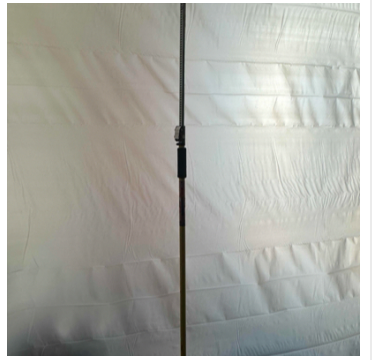
4. 305 Pioneer: Equipment On-site

- 4 - Zip Posts
- 2 - Air Scrubbers

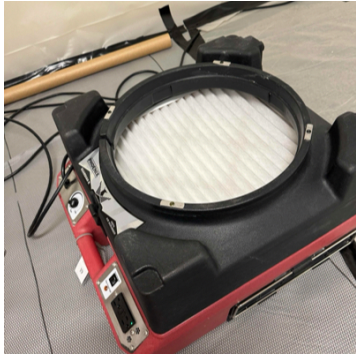
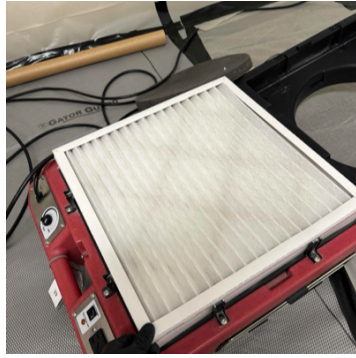
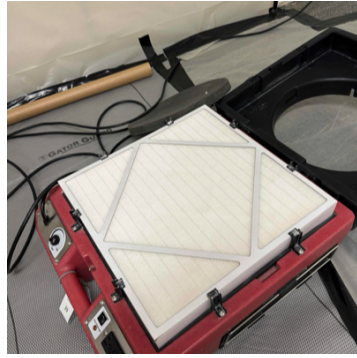
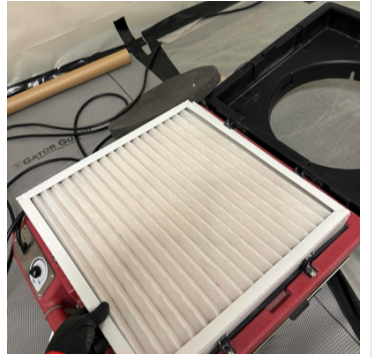
5. Storage Room 303: Filter Change

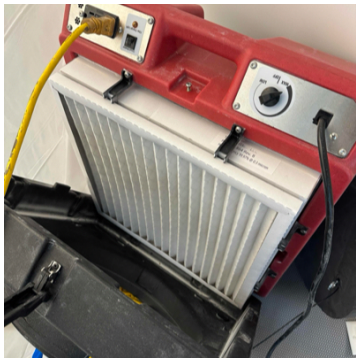
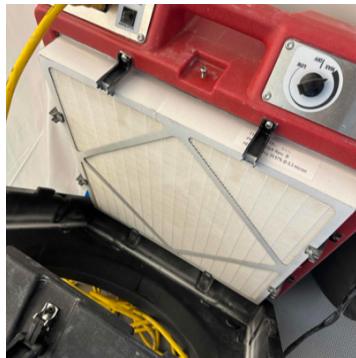
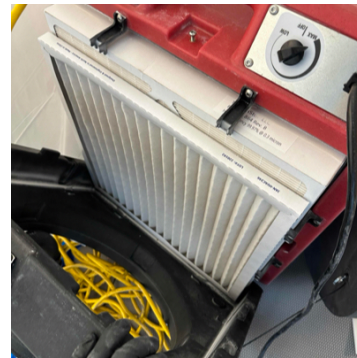
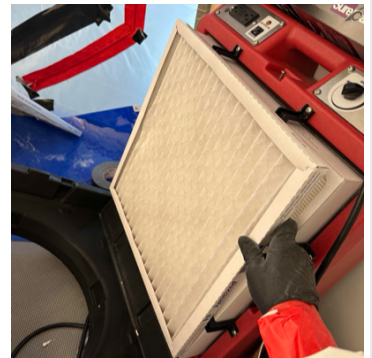
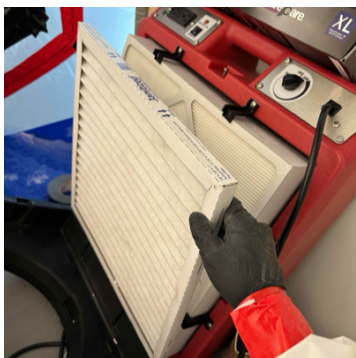
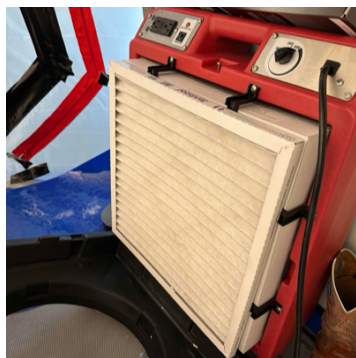
6. 305 Pioneer: Filter Change

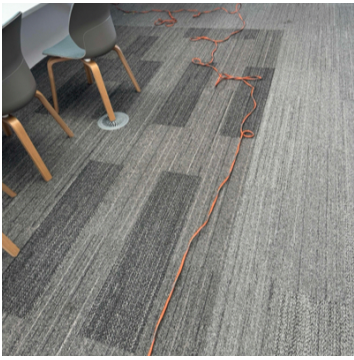
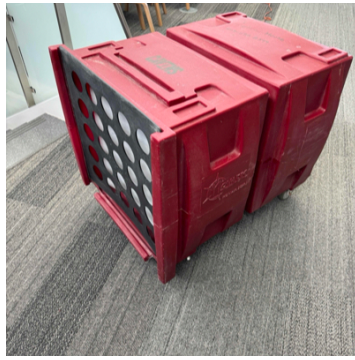
7. Third Floor - Main Area: Equipment On-site

- 1 - Air Scrubber
- 1 - 50' Extension Cord

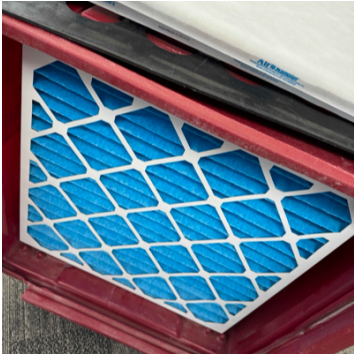
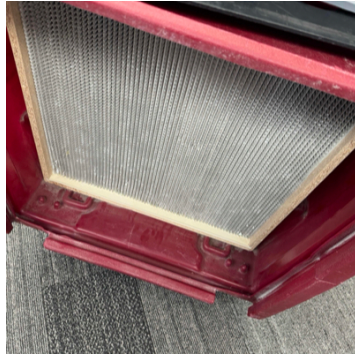
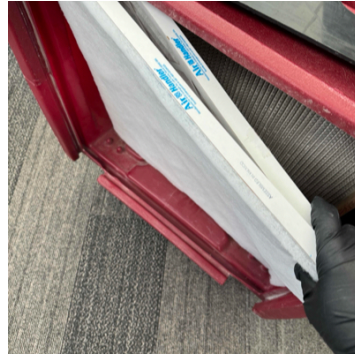
8. Third Floor - Main Area: Filter Change

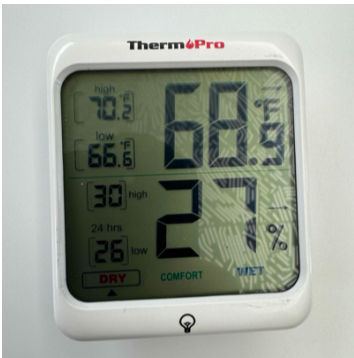
9. Third Floor - Main Area: Humidity and Temperature

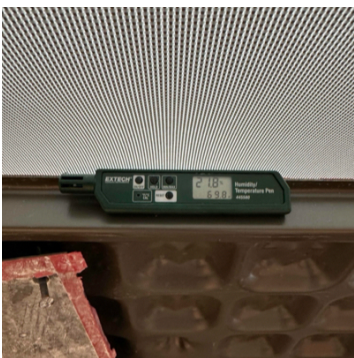
10. 305 Pioneer: Temperature and Humidity

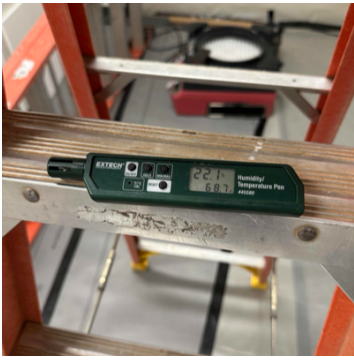
11. Storage Room 303: Humidity and Temperature

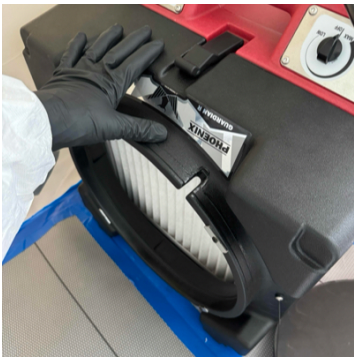
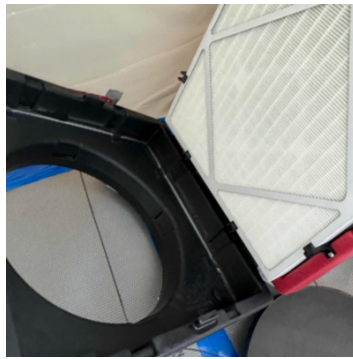
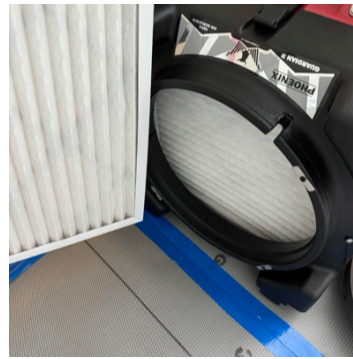
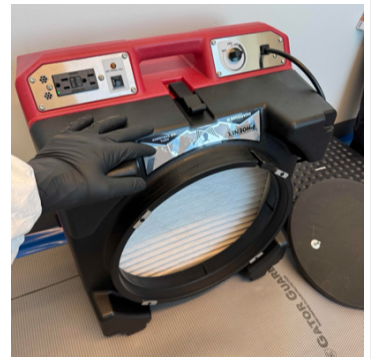
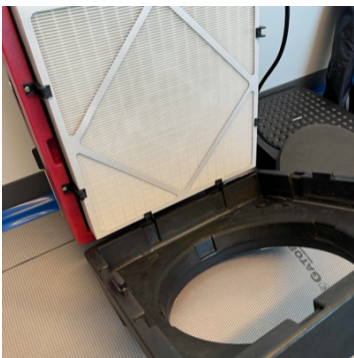
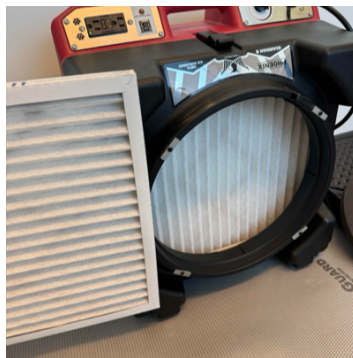
12. 311 Local History: Filter Change

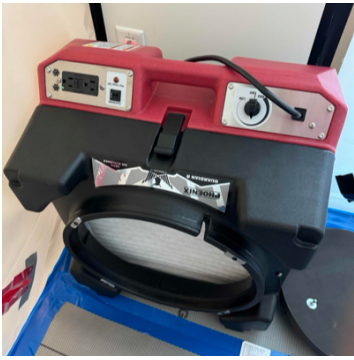
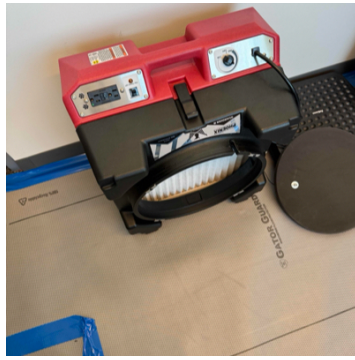
14. 311 Local History: Equipment On-site

2 - Air Scrubbers

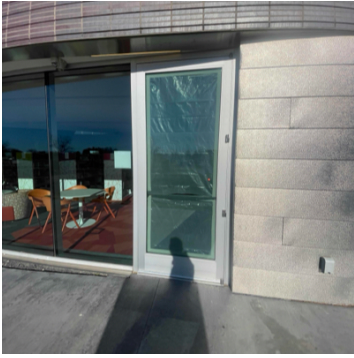
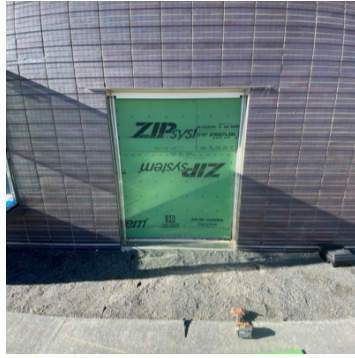
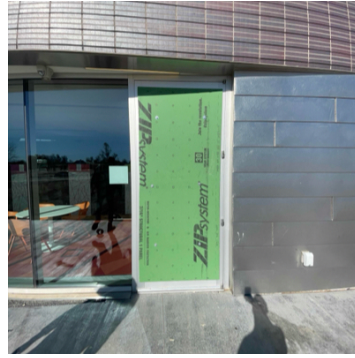
15. First Floor bay windows: Zip sheathing install on East Window

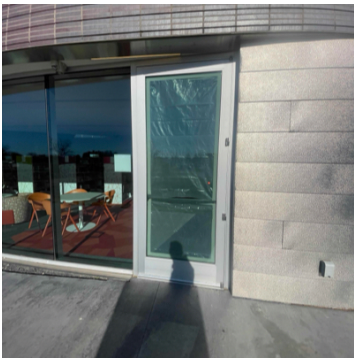
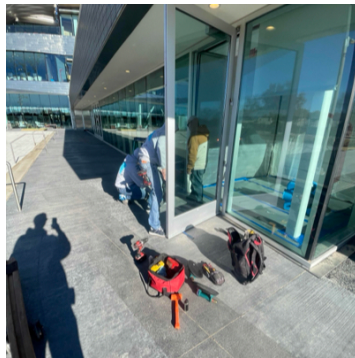
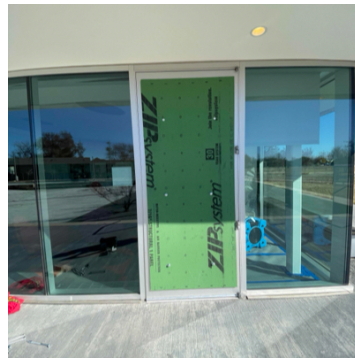
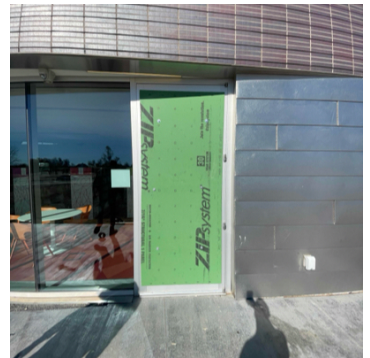
16. First Floor - 149 Storytime: Window Removal for Negative Air Ducts

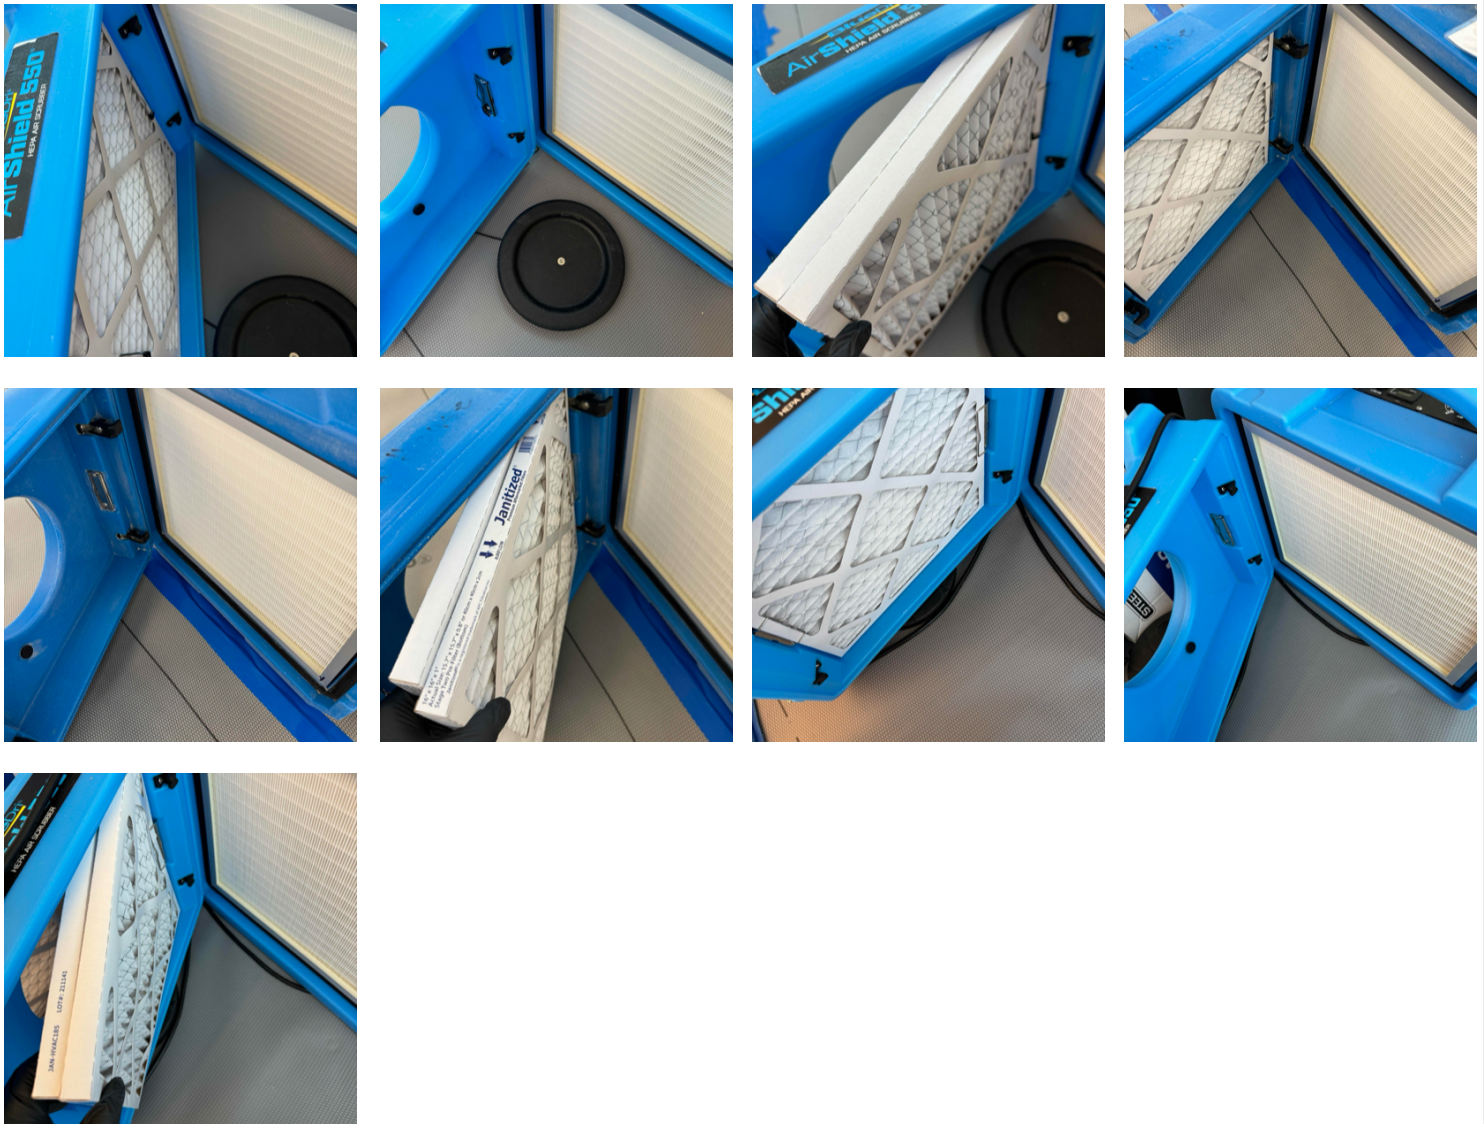
19. SO 201A - Filter Change

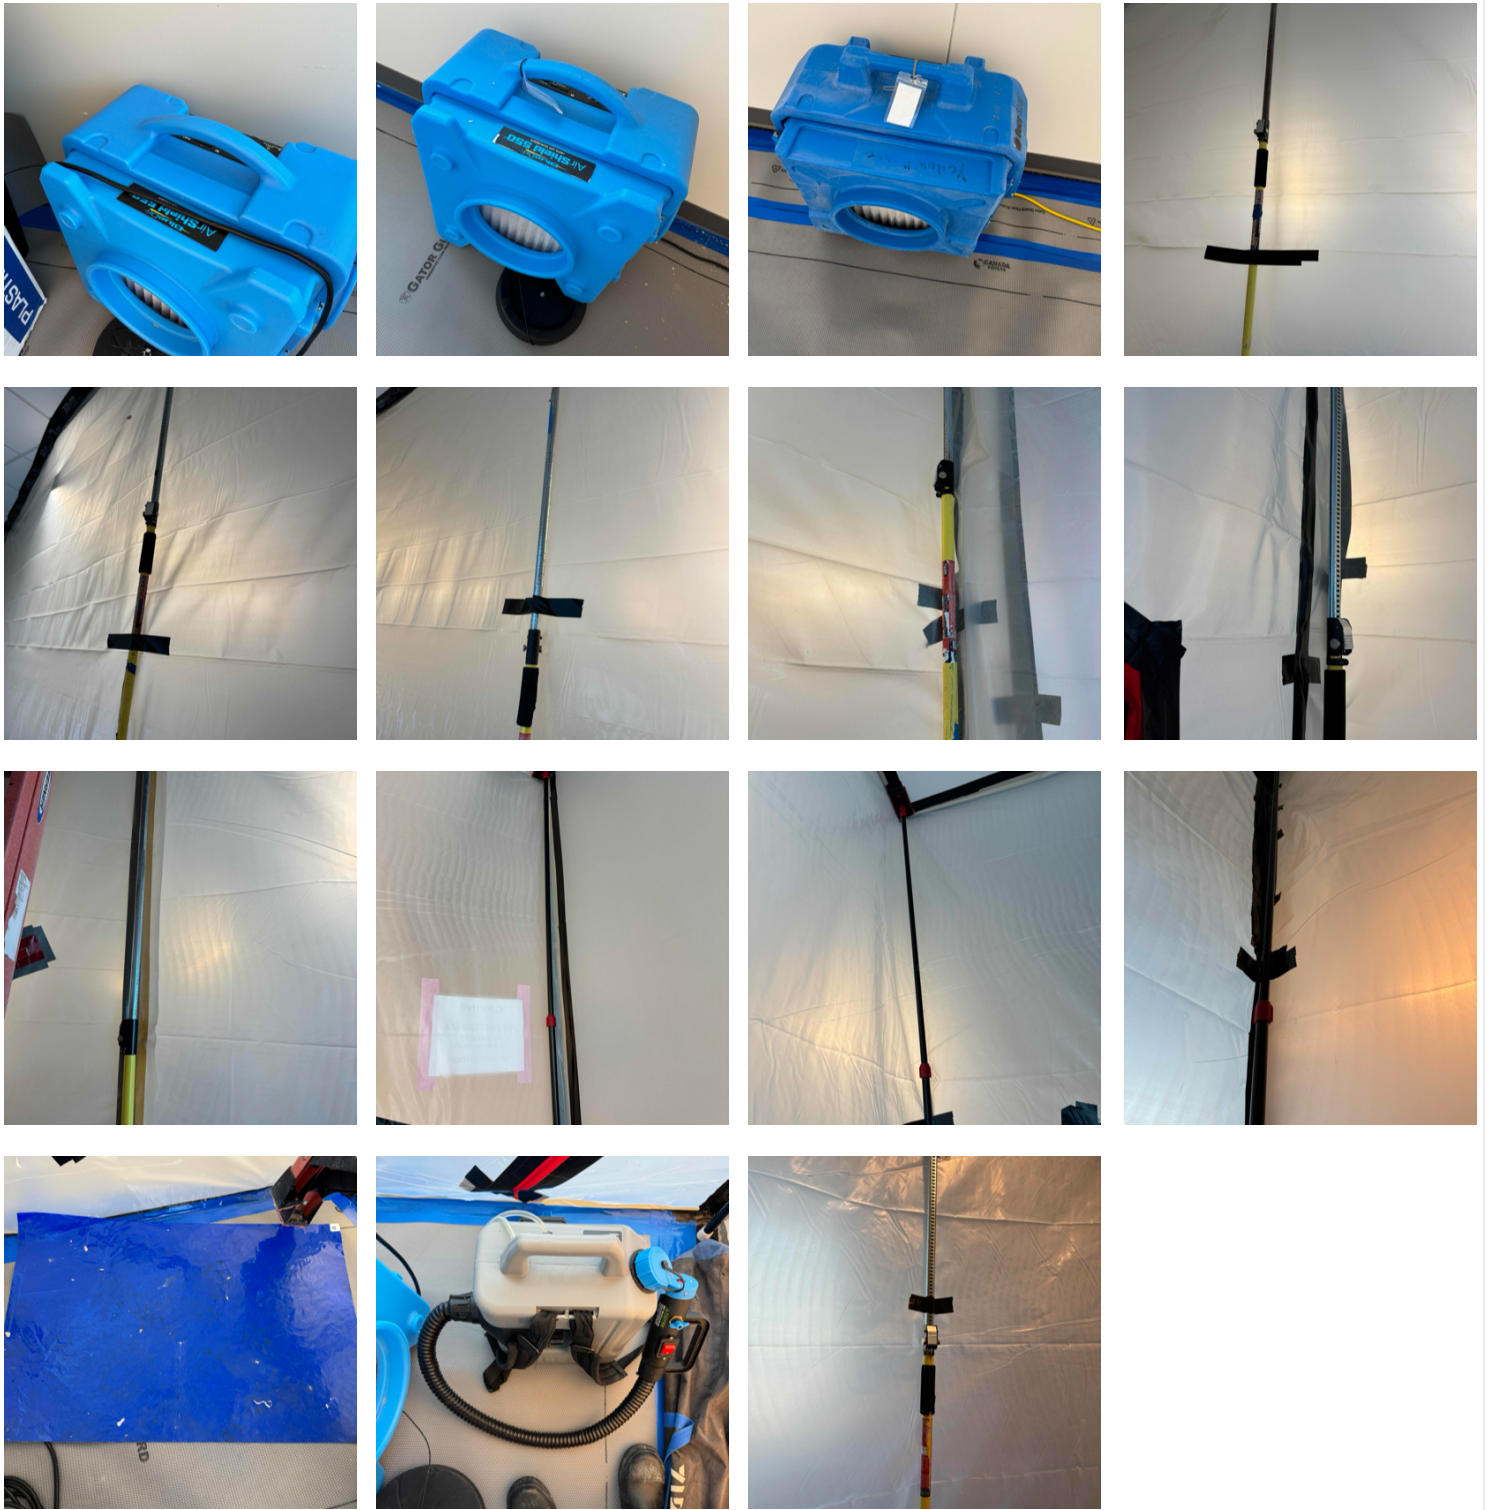
20. SO 201A: Equipment On-site

- 10 - Zip Posts
- 3 - Air Scrubbers

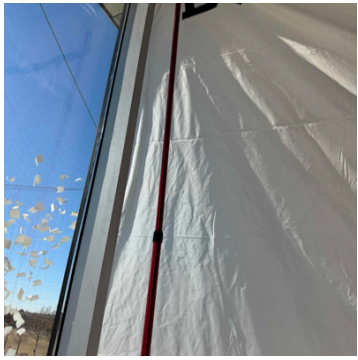
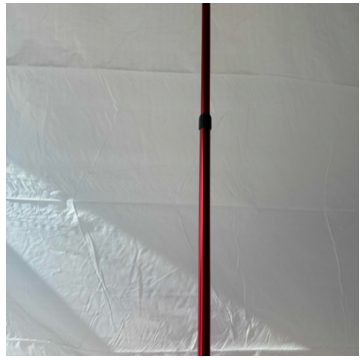
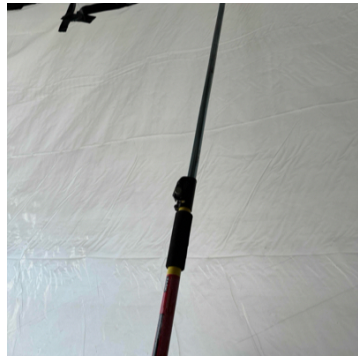
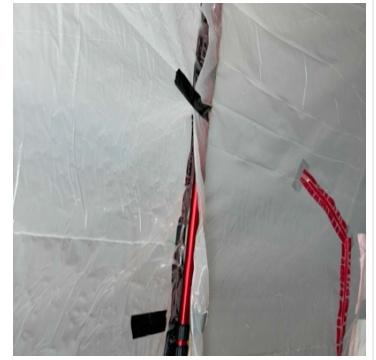
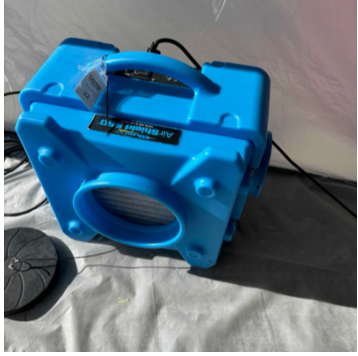
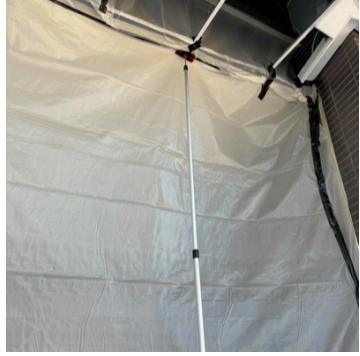
24. Second Floor - Southeast Corner: Equipment On-site

- 22 - Zip Posts
- 6 - Air Scrubbers
- 1 - 50' Extension Cord

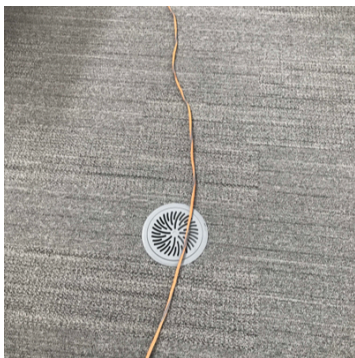
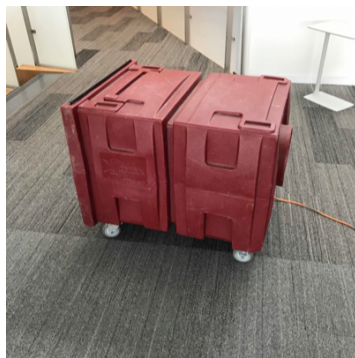
25. Second Floor - Main Area: Equipment On-site

- 1 - Air Scrubber
- 1 - 25' Extension Cord

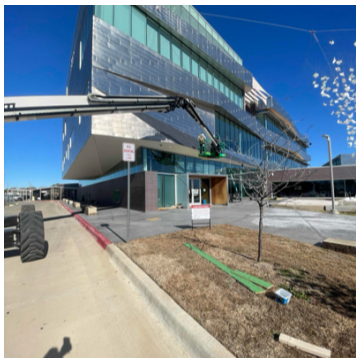
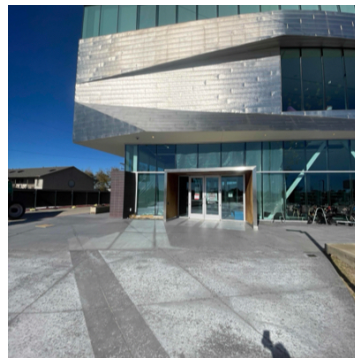
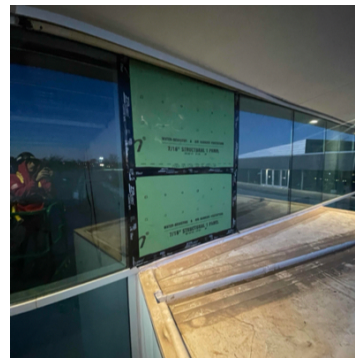
34. First Floor - Southwest Vestibule: Negative Air Set Up

Windows were removed in and near containments for the negative air setup.

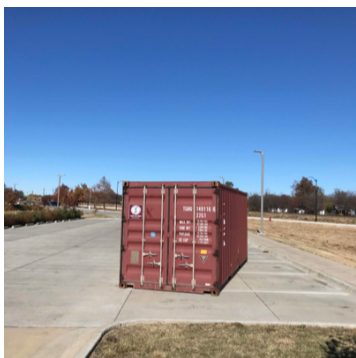
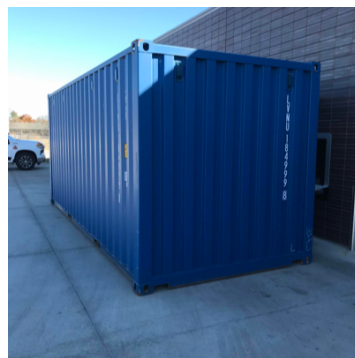
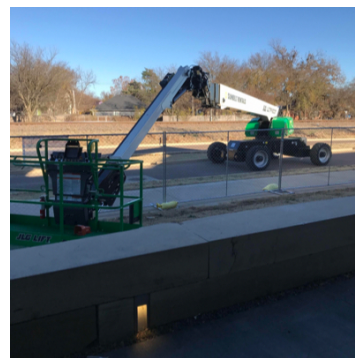
35. Exterior: Equipment On-site

- 2 - 20' Conex Boxes
- 1 - 150' Boom Lift with a Jib

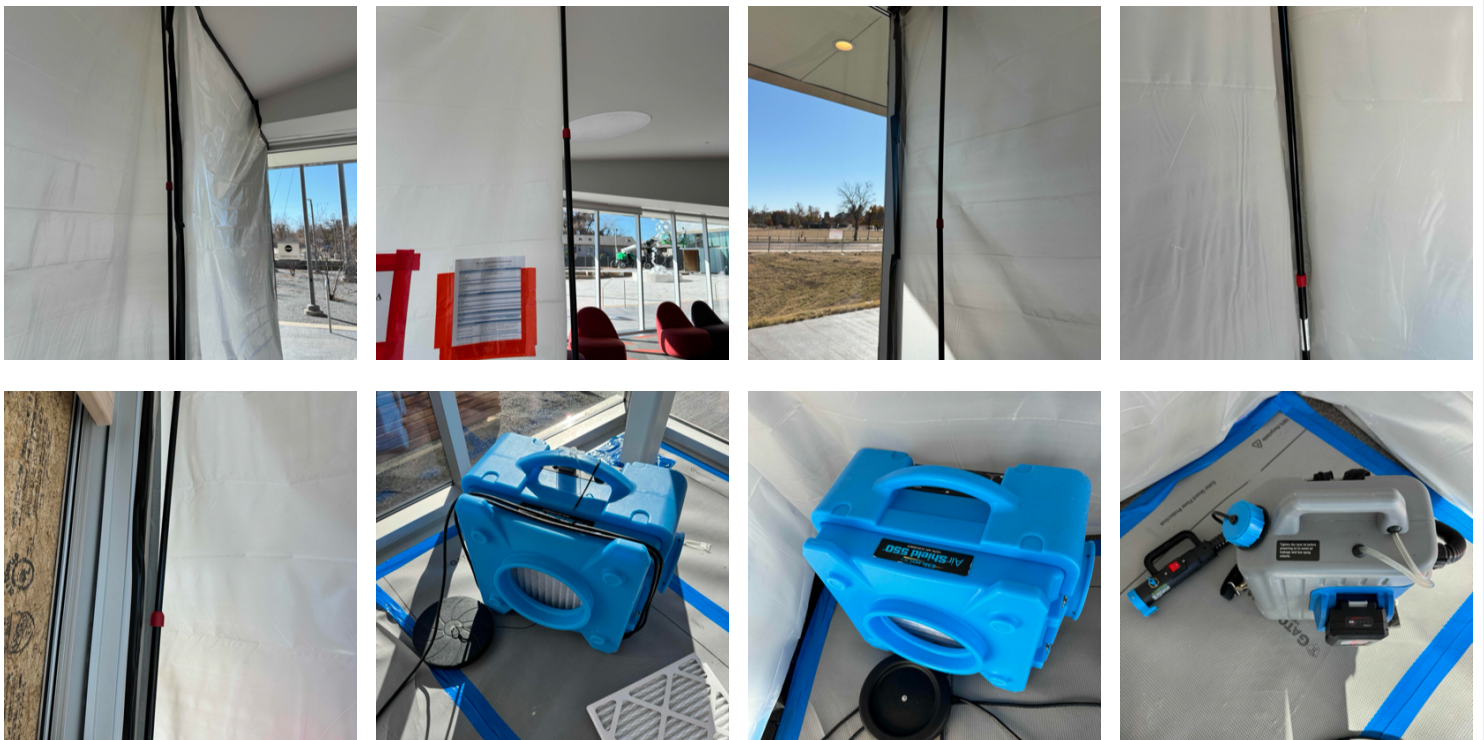
39. First Floor - 149 Storytime: Equipment On-site

- 5 - Zip Posts
- 2 - Air Scrubbers

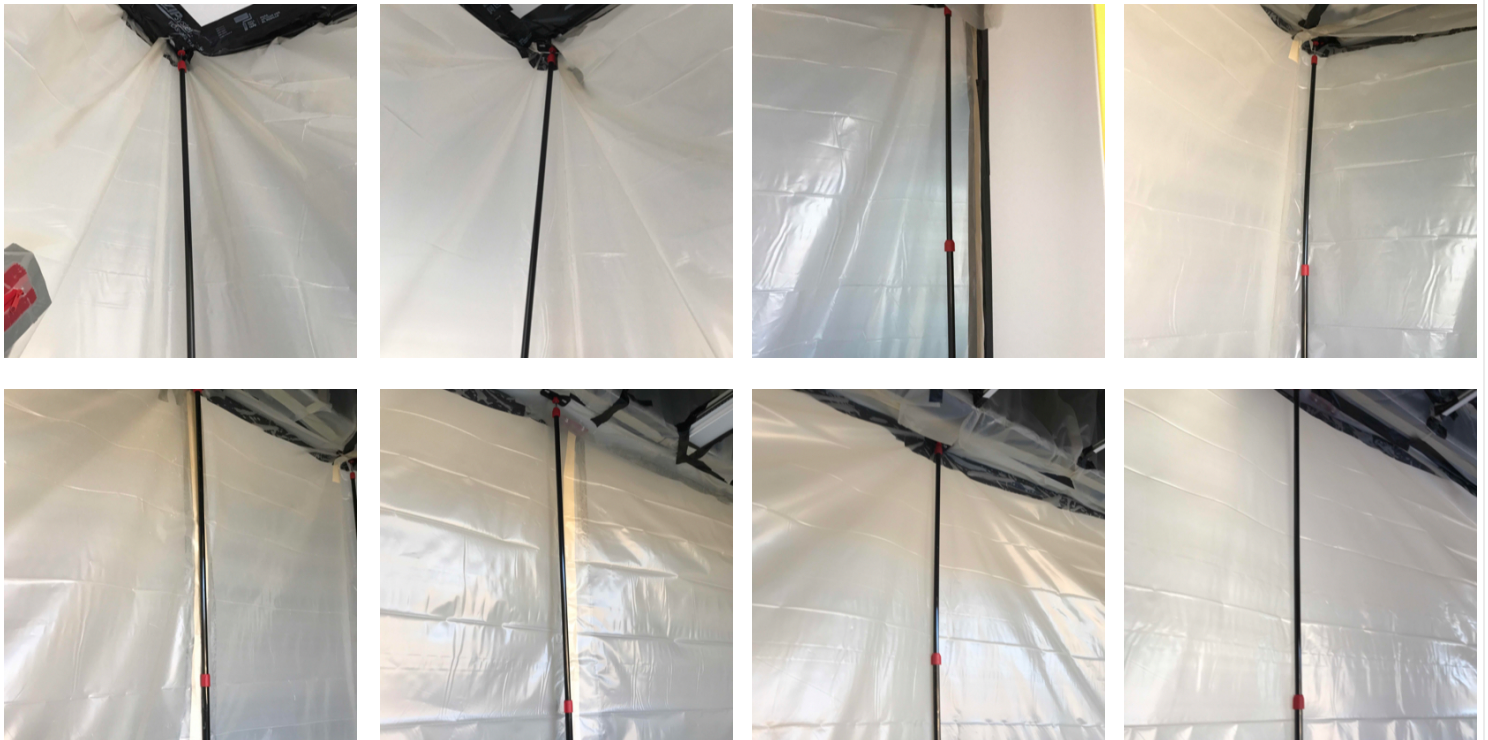
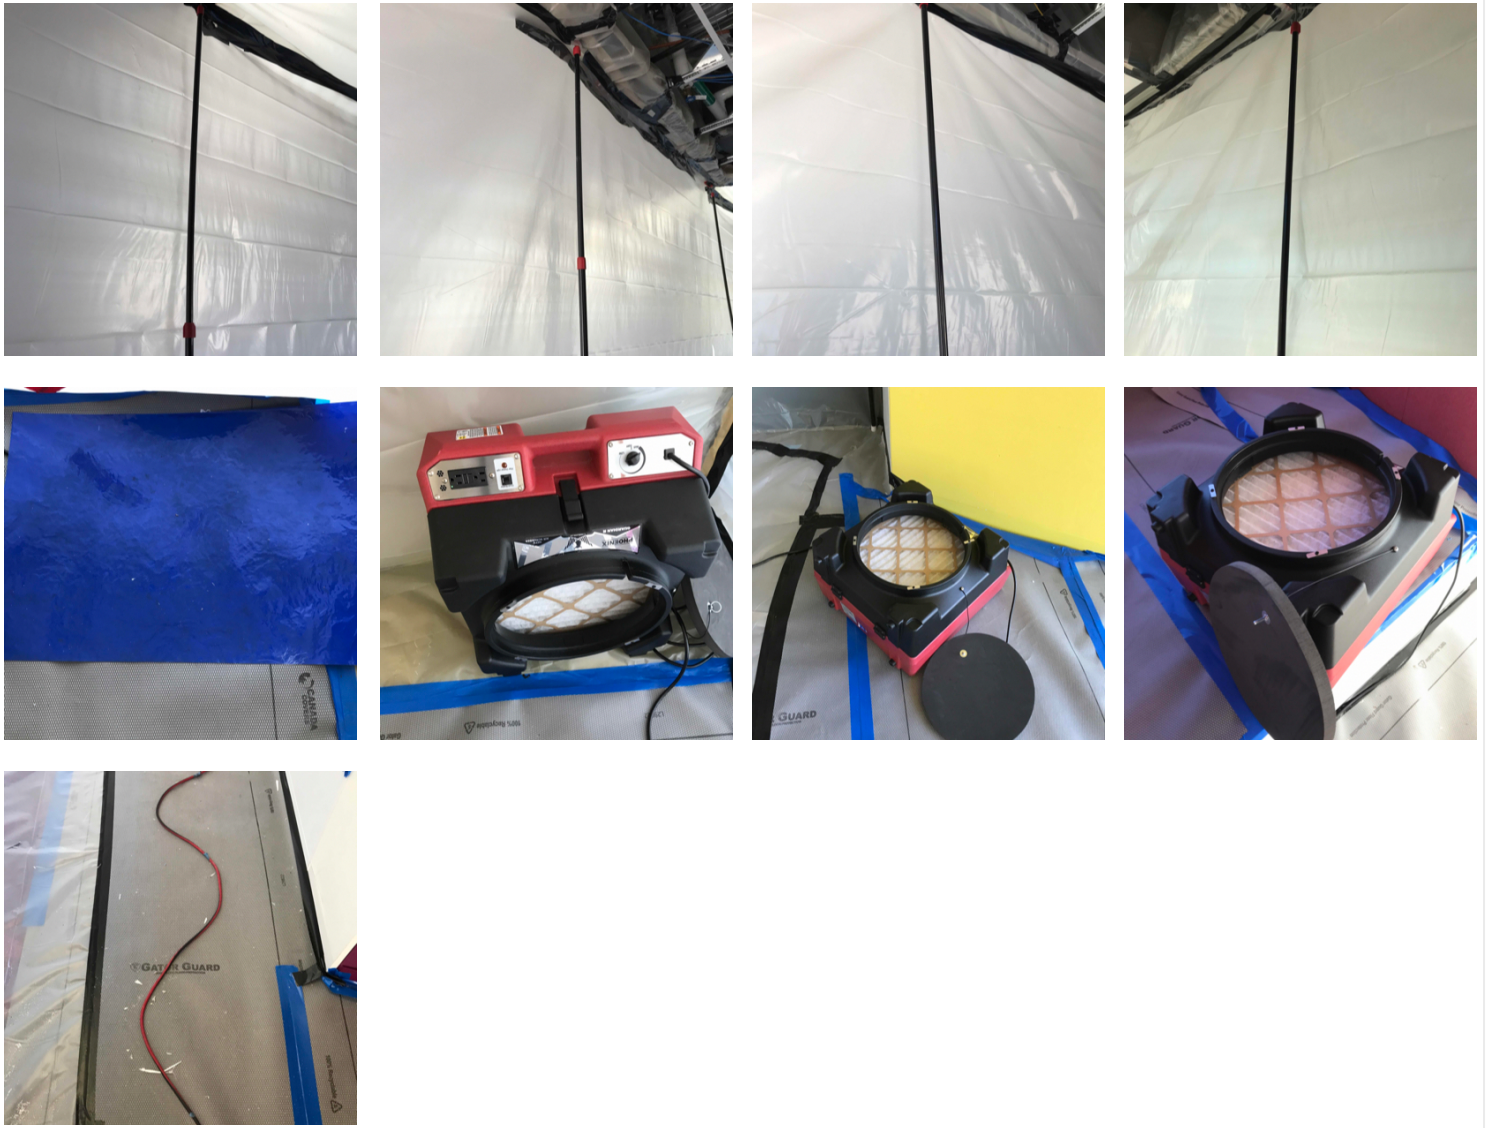
41. First Floor - Bay Windows (Children's Area): Equipment On-site

- 12 - Zip Posts
- 3 - Air Scrubbers
- 1 - 50' Extension Cord

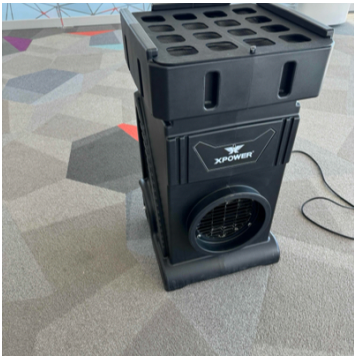
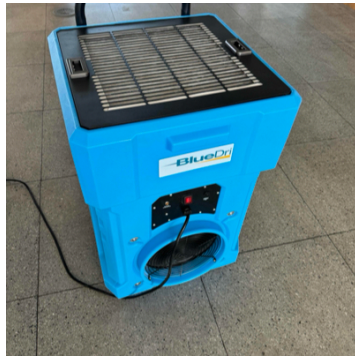
46. First Floor - Main Area: Equipment On-site

2 - Air Scrubbers

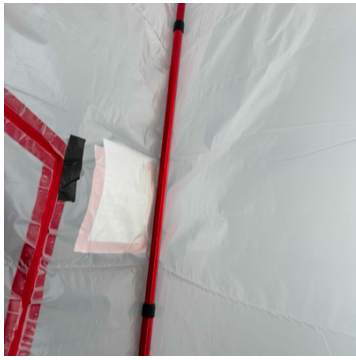
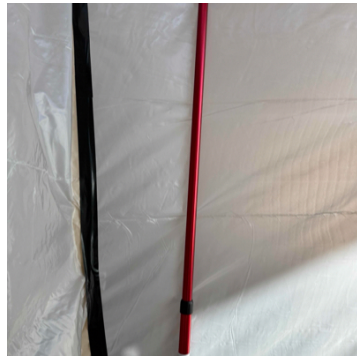
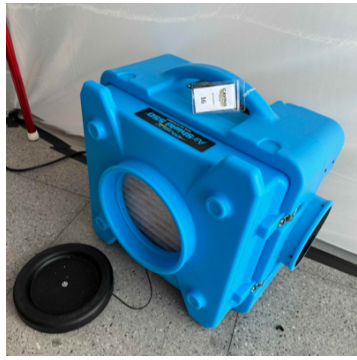
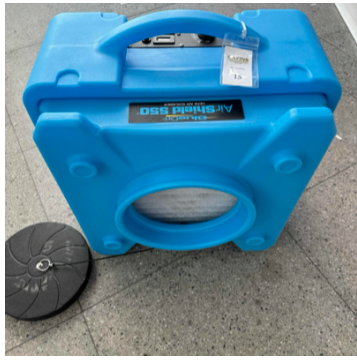
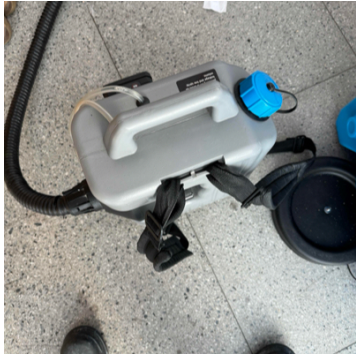
49. First Floor - Southwest Vestibule: Equipment On-site

- 2 - Zip Posts
- 2 - Air Scrubbers

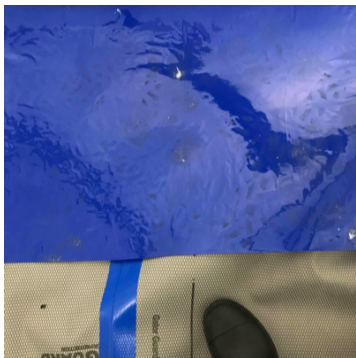
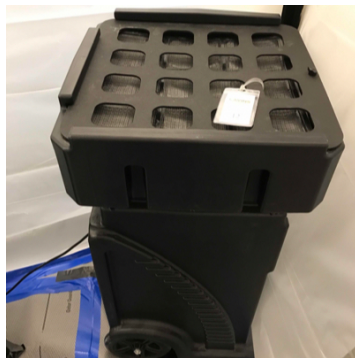
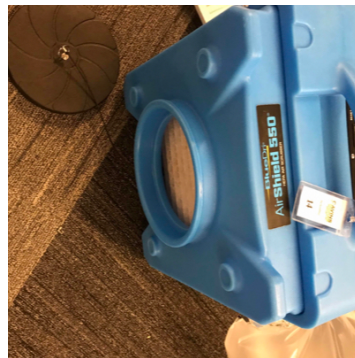
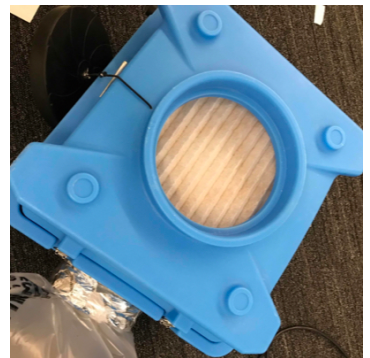
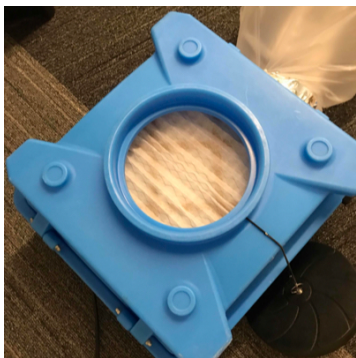
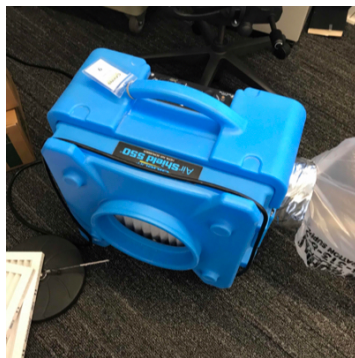
53. SO 115: Equipment On-site

6 - Air Scrubbers

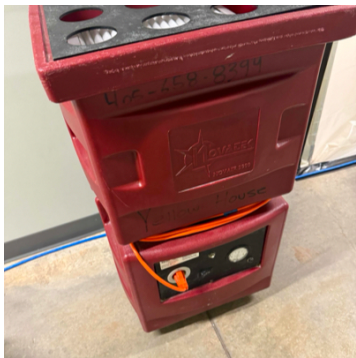
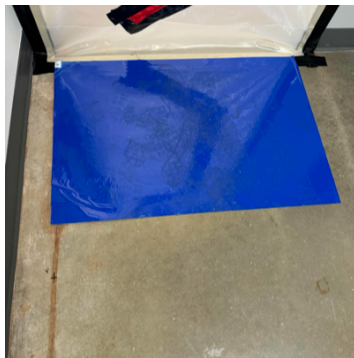
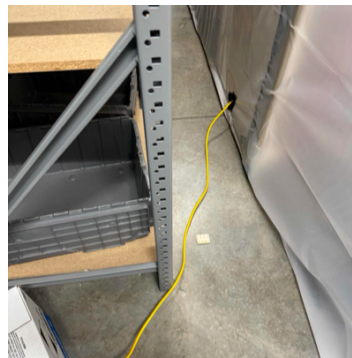
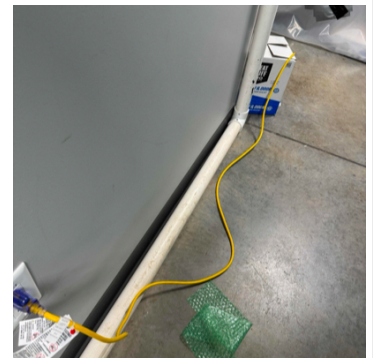
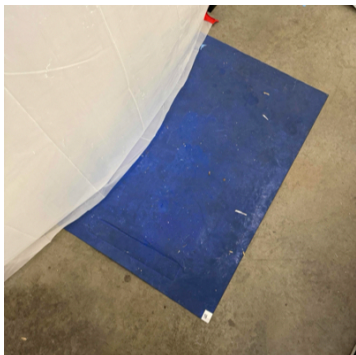
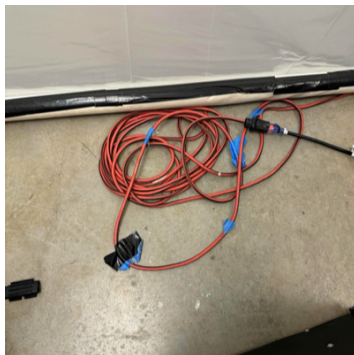
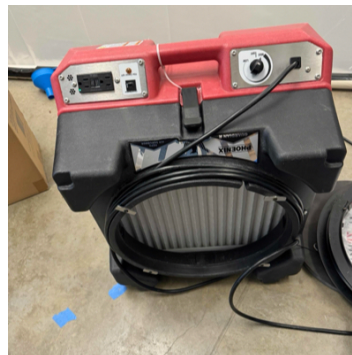
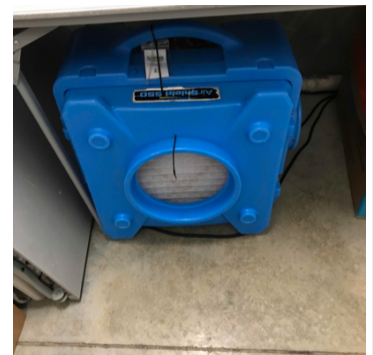
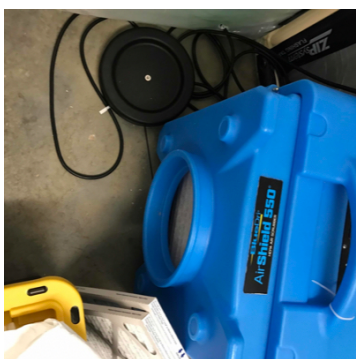
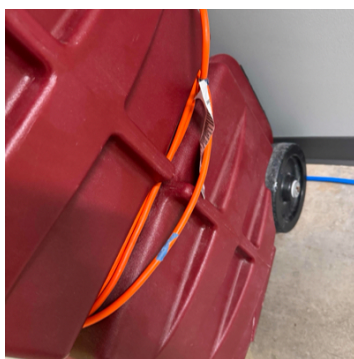
56. Garage: Equipment On-site

- 4 - Air Scrubbers
- 3 - 25' Extension Cords

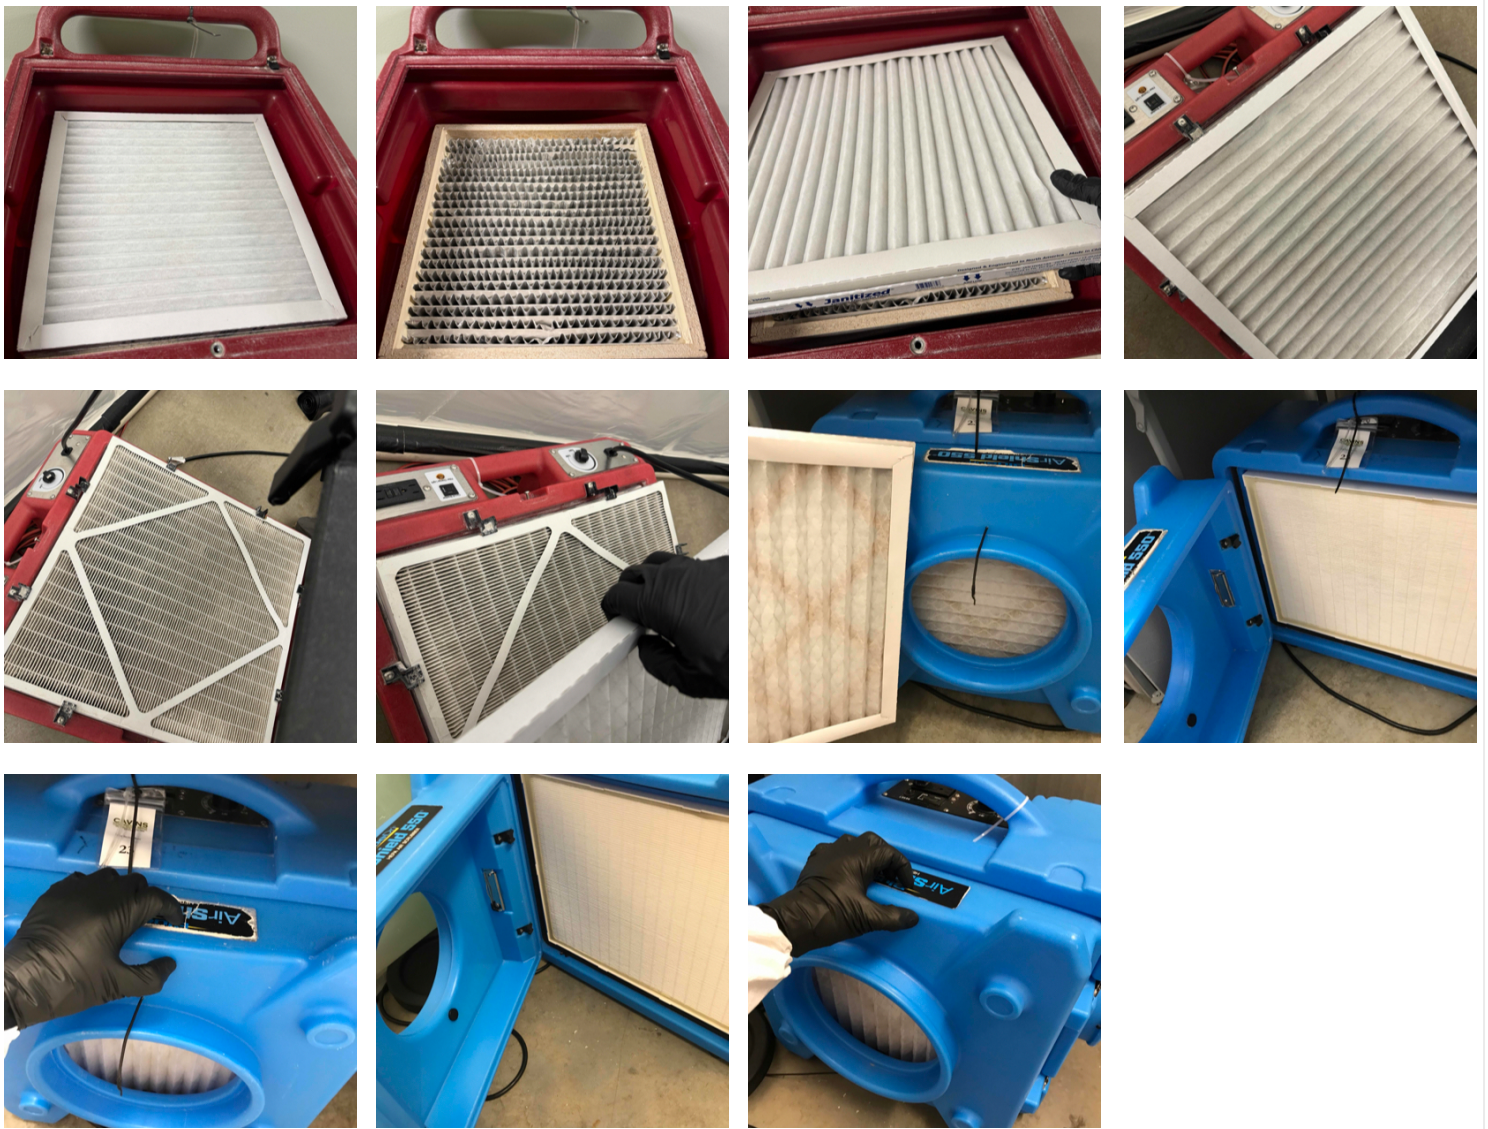
57. Garage: Filter Change

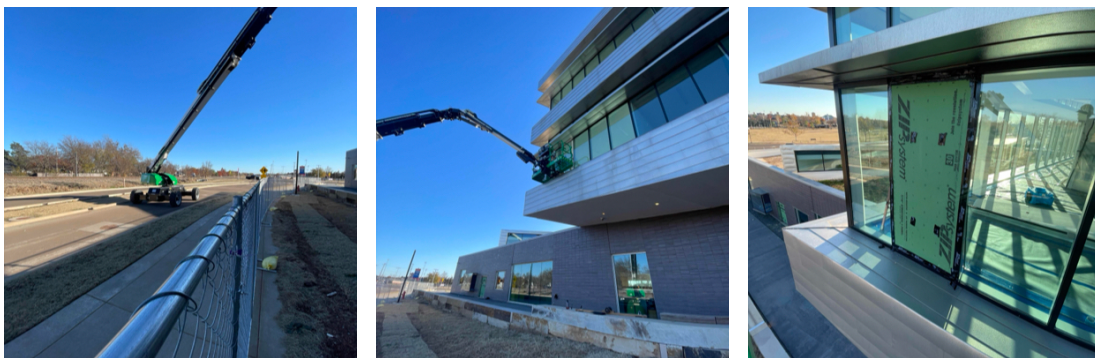
58. Second Floor - Southeast Corner: Window Removal for Negative Air Ducts

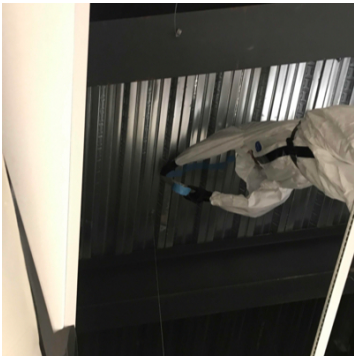
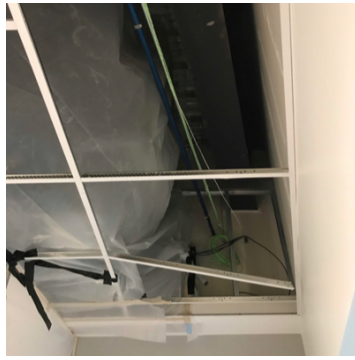
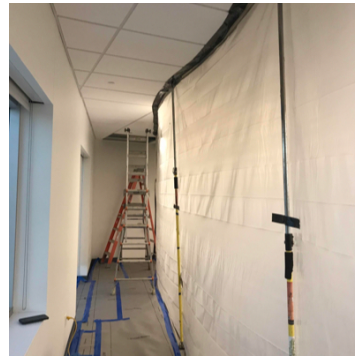
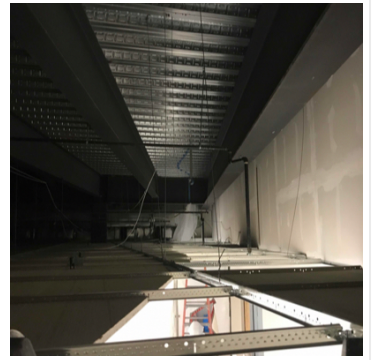
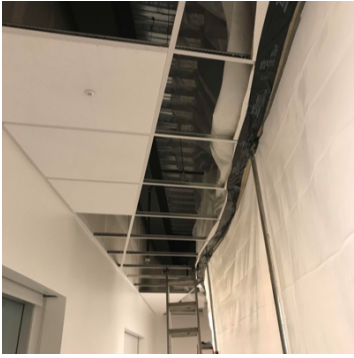
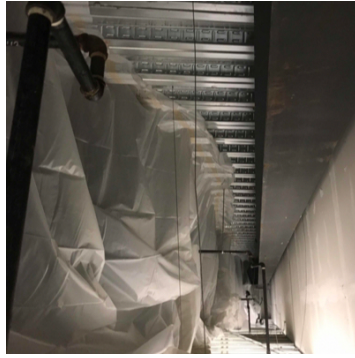
59. SO 201A: Containment Modifications

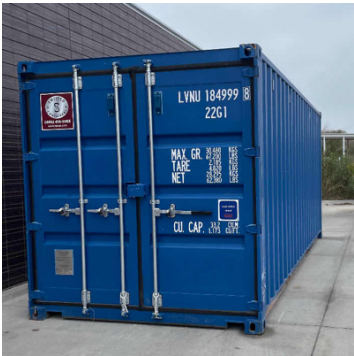
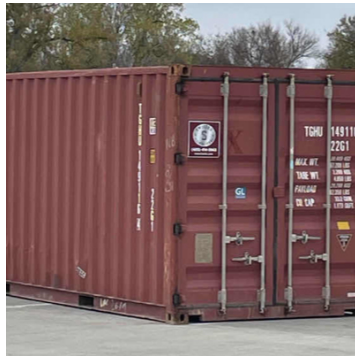
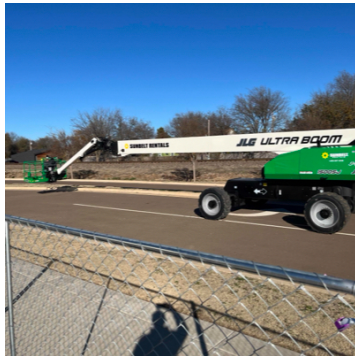
60. Exterior Equipment on Site:

- 2 - 20' Conex Boxes
- 1 - 50' Boom Lift with a Jib

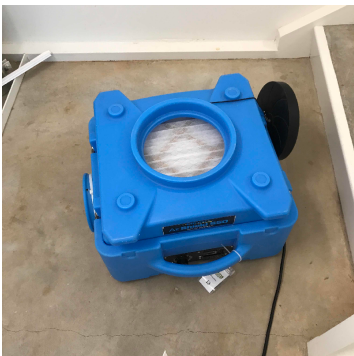
61. Southwest Exit Stairwell: Equipment On-site

- 1 - Air Scrubber
