Date Sun 12/03/2023

Name	Description
Cavins Environmental	Cavins Group inspected all equipment and containments and changed all air scrubber filters. Humidity and temperature readings were checked on all three floors in the main area and one exterior reading.
Total

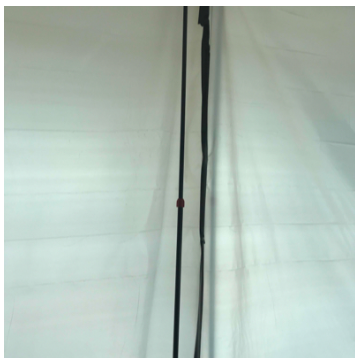
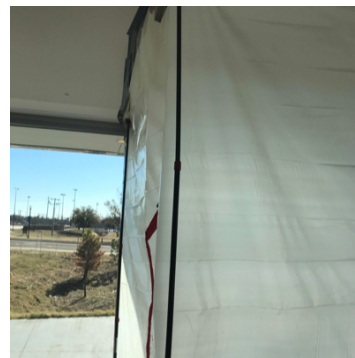
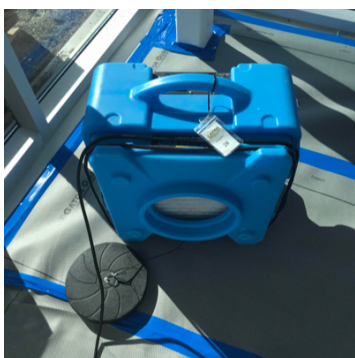
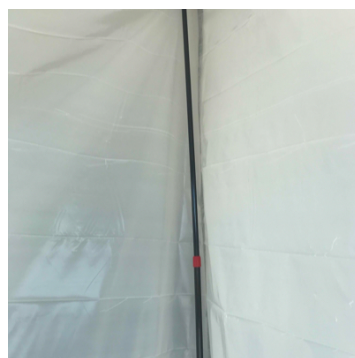
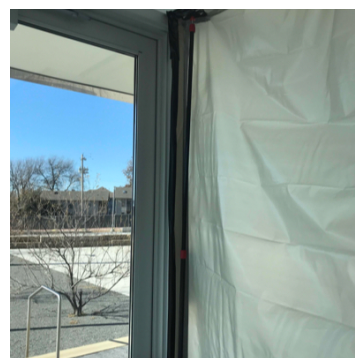
4. First Floor - 149 Storytime: Equipment On-site

- 2 - Air scrubbers
- 5 - Zip Posts

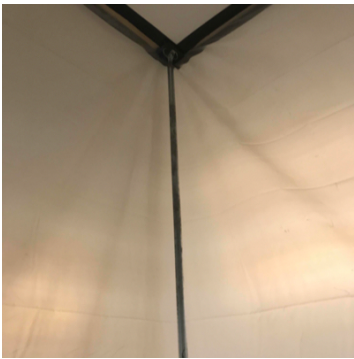
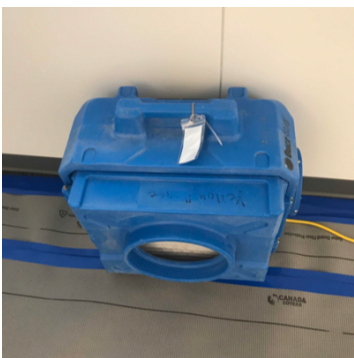
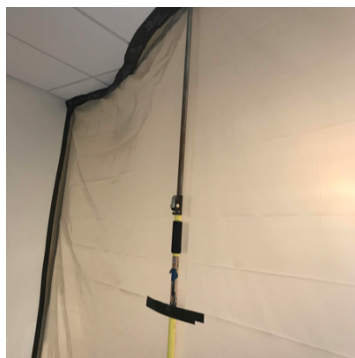
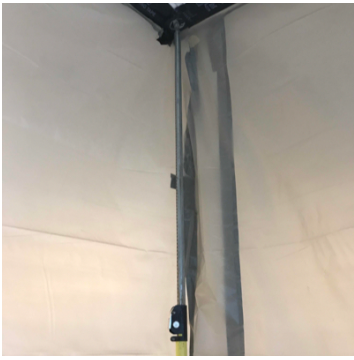
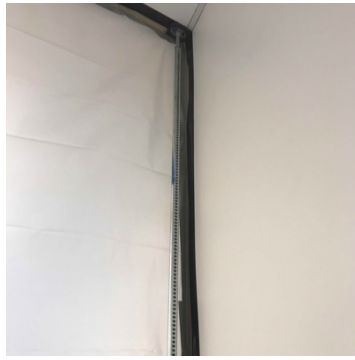
7. SO 201A: Equipment On-site

- 7 - Zip Posts
- 2 - Air Scrubbers

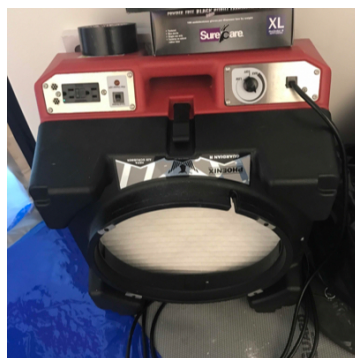
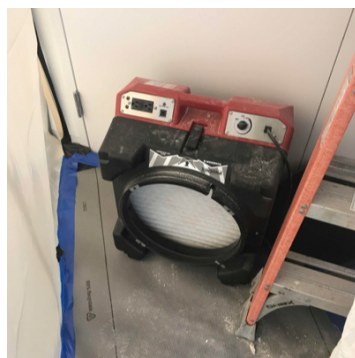
11. 305 Pioneer: Equipment On-site

- 4 - Zip Posts
- 2 - Air Scrubbers

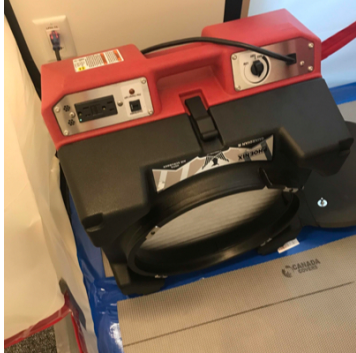
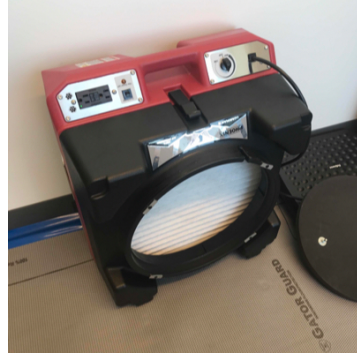
13. 311 Local History: Equipment On-site

2 - Air Scrubbers

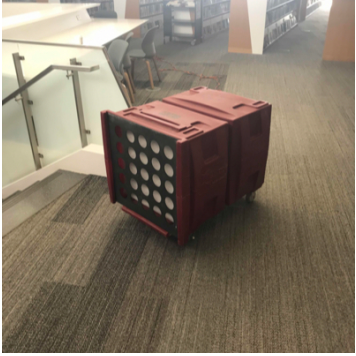
18. Third Floor - Main Area - Equipment On-site

1 - Air Scrubber

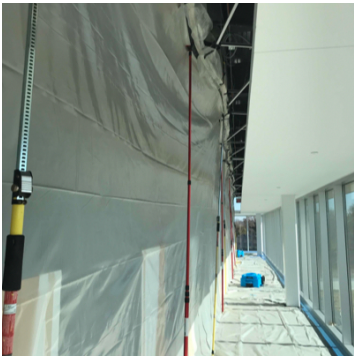
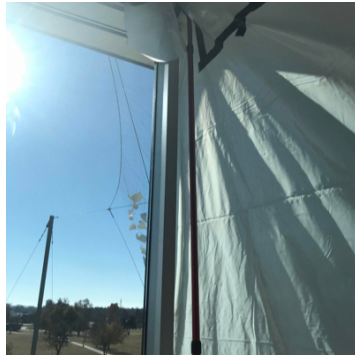
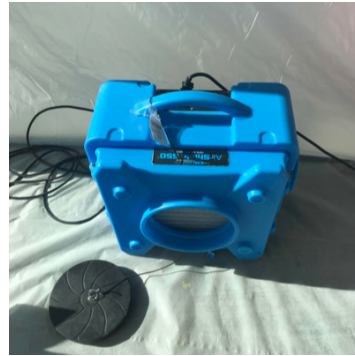
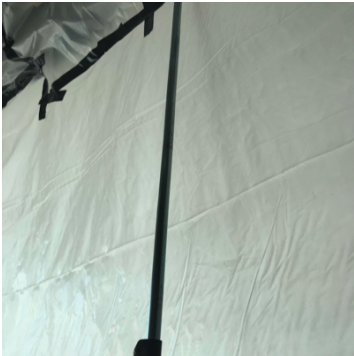
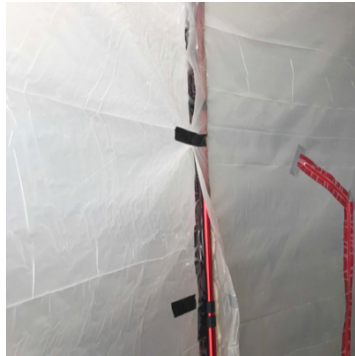
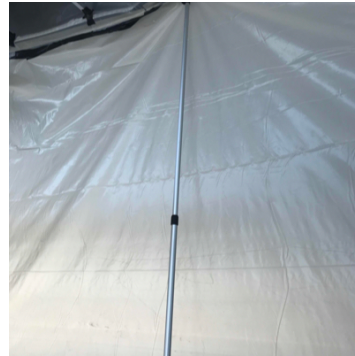
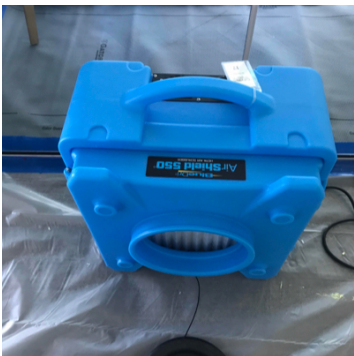
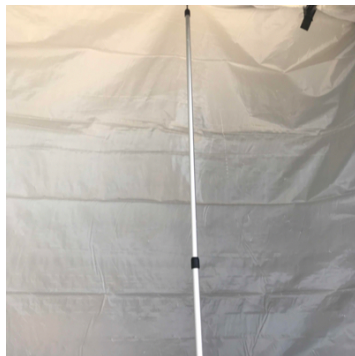
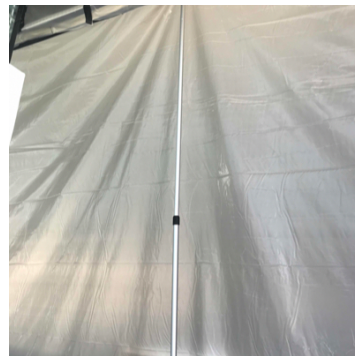
25. Second Floor - Southeast Corner: Equipment On-site

- 22 - Zip Posts
- 6 - Medium Air Scrubbers
- 1 - 25' yellow extension cord

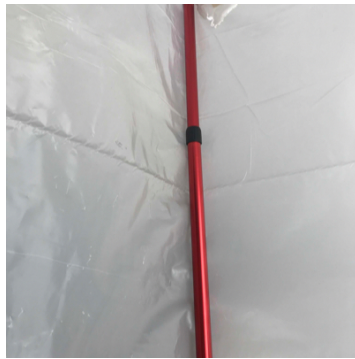
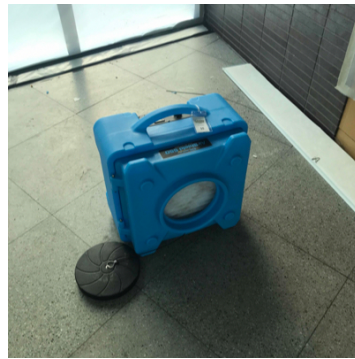
31. First Floor - Southwest Vestibule: Equipment On-site

- 2 - Air Scrubbers
- 2 - Zip Posts

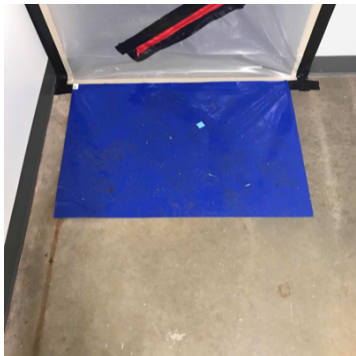
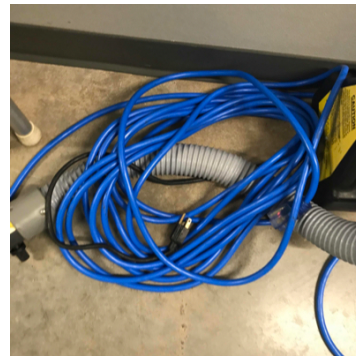
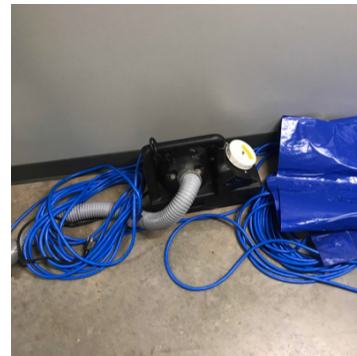
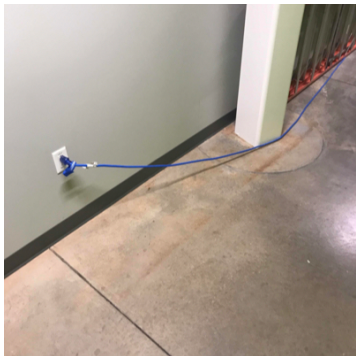
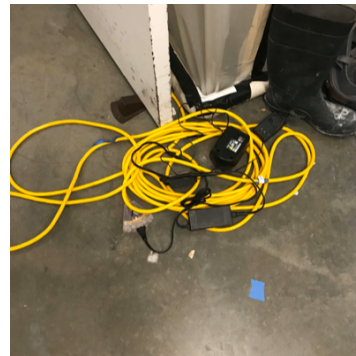
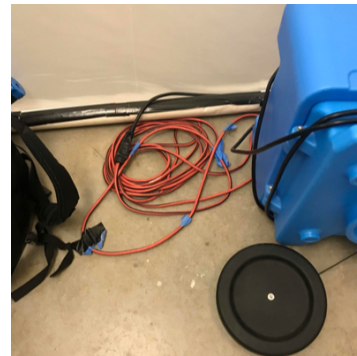
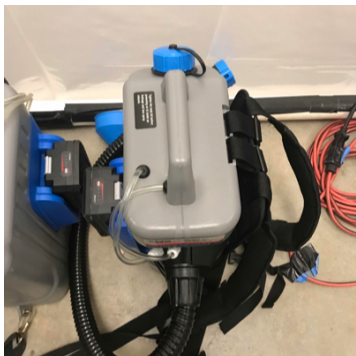
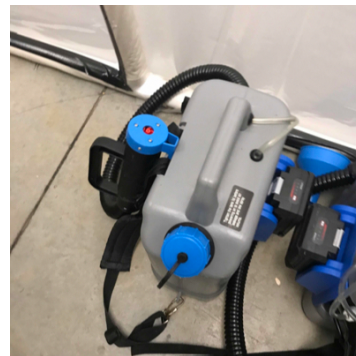
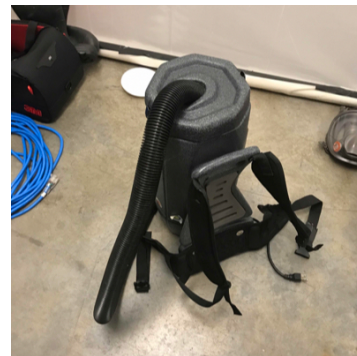
34. Garage: Equipment On-site

- 4 - Air Scrubbers
- 2 - 50' Extension Cord
- 2 - 25' Extension Cords

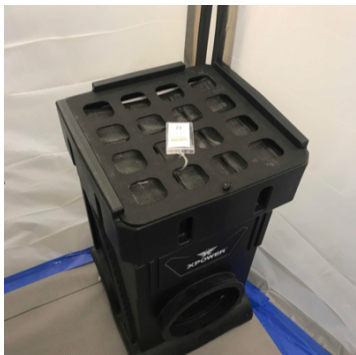
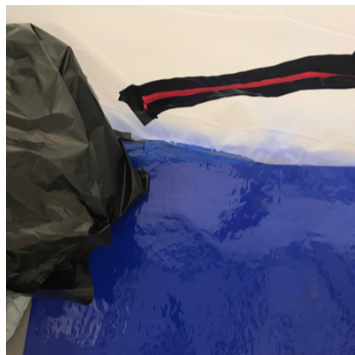
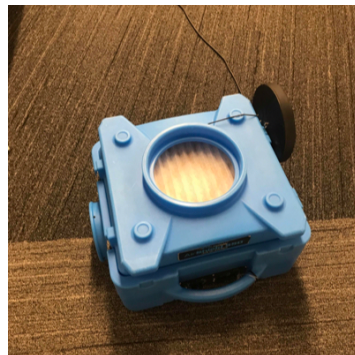
37. SO 115: Equipment On-site

3 - Air Scrubbers
