Norman Public Library Central - Mold

103 W Acres St Norman, OK 73069

Date Sat 12/02/2023

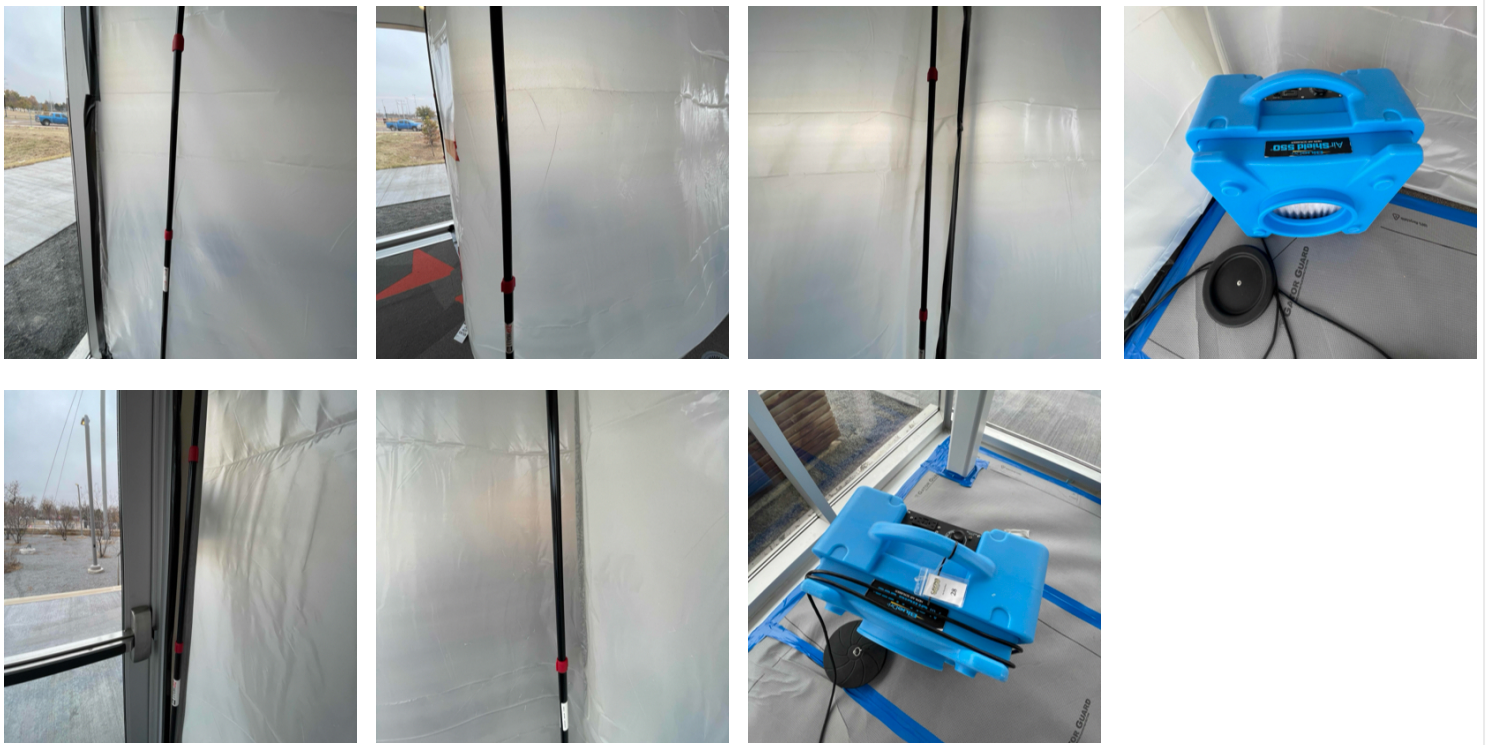
2. First Floor - 149 Storytime: Equipment On-site

- 2 - Air Scrubbers
- 5 - Zip Posts

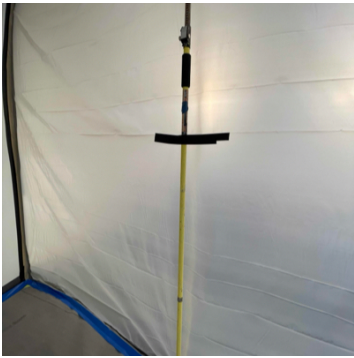
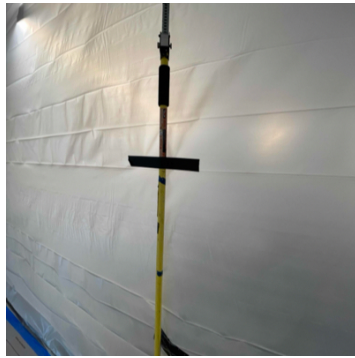
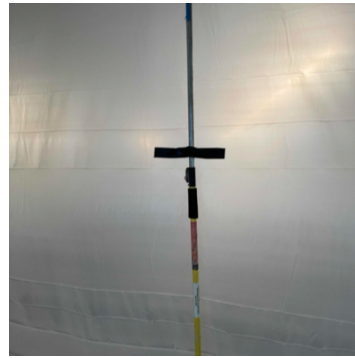
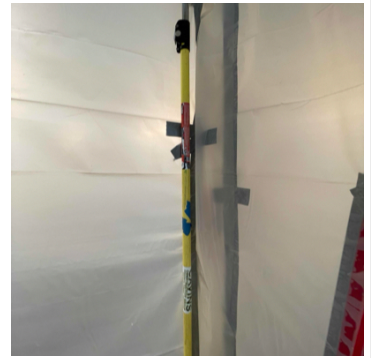
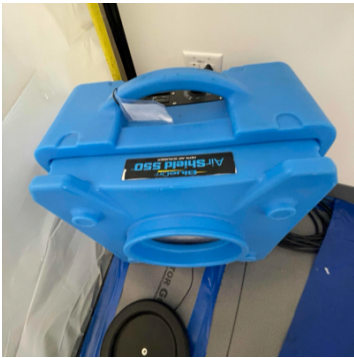
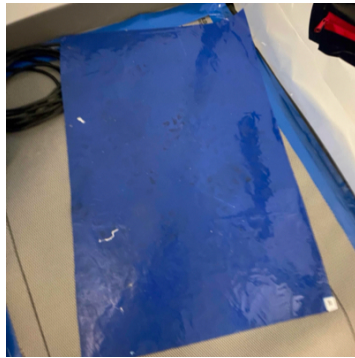
5. SO 201A: Equipment On-site

- 7 - Zip Posts
- 2 - Air Scrubbers

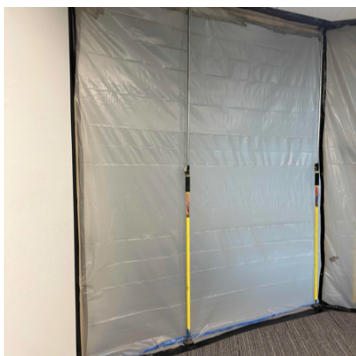
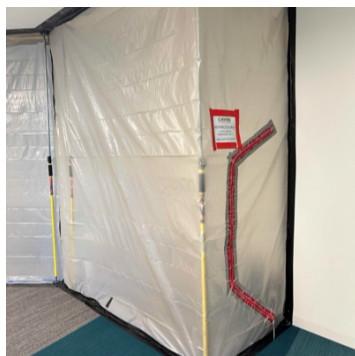
8. 305 Pioneer: Containment Upon Arrival/Departure

Based on the measurements from the containments in the rooms above (305 Pioneer and Storage Room 303), the containment will need to be expanded, possibly into the adjacent space, the I.T. lab closet. There are signs of water intrusion coming from the third floor, staining the ceiling tiles on the second floor in these areas. On the first floor, there are water trails around the same area, which means there is potential for microbial growth in the floor between the second and first floors. It will be known once the remediation process has begun in 201A.

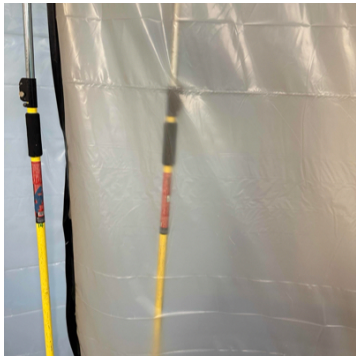
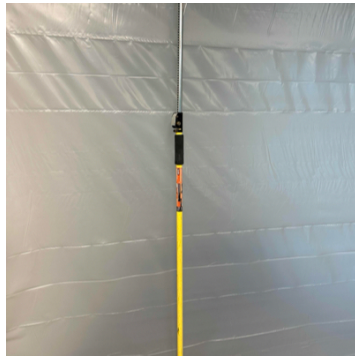
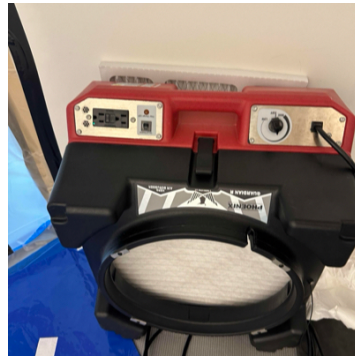
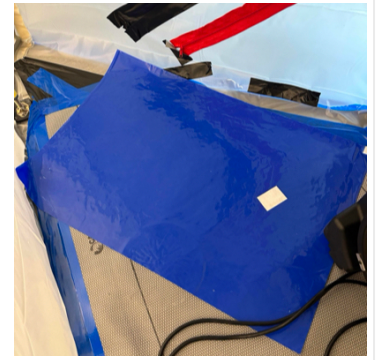
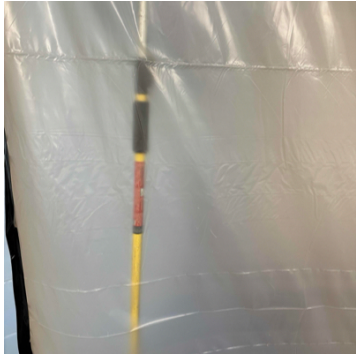
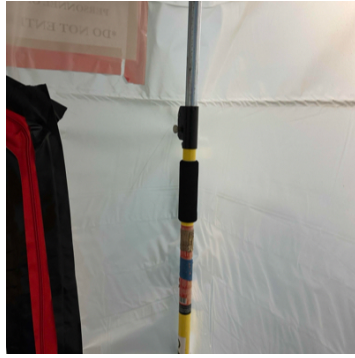
9. 305 Pioneer: Equipment On-site

- 4 - Zip Posts
- 2 - Air Scrubbers

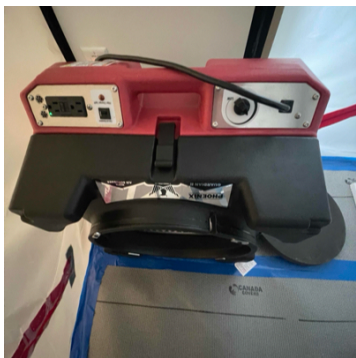
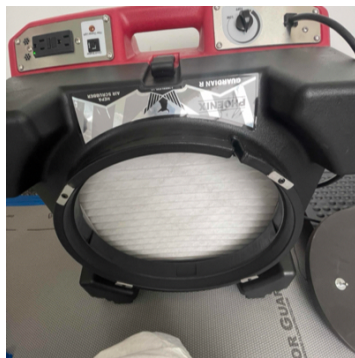
11. 311 Local History: Equipment On-site

2 - Air Scrubbers

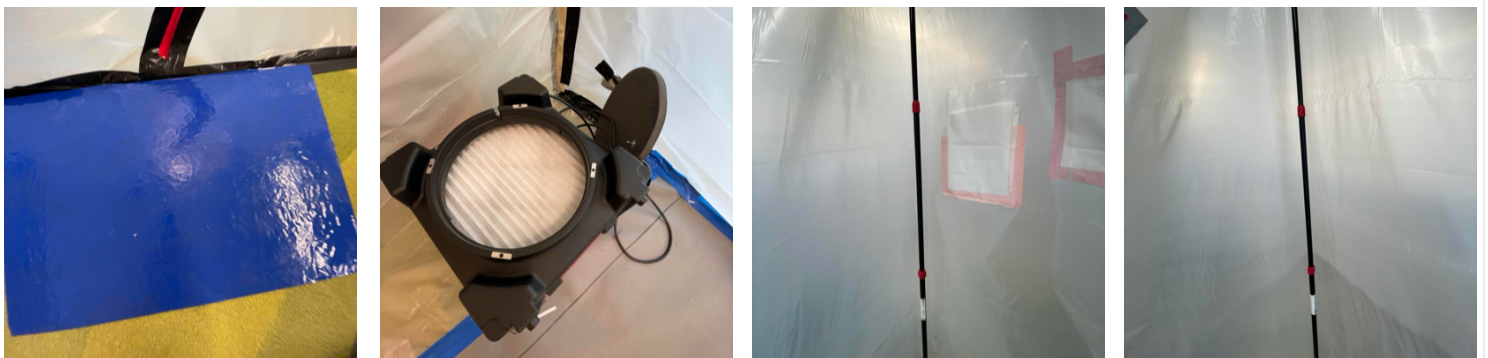
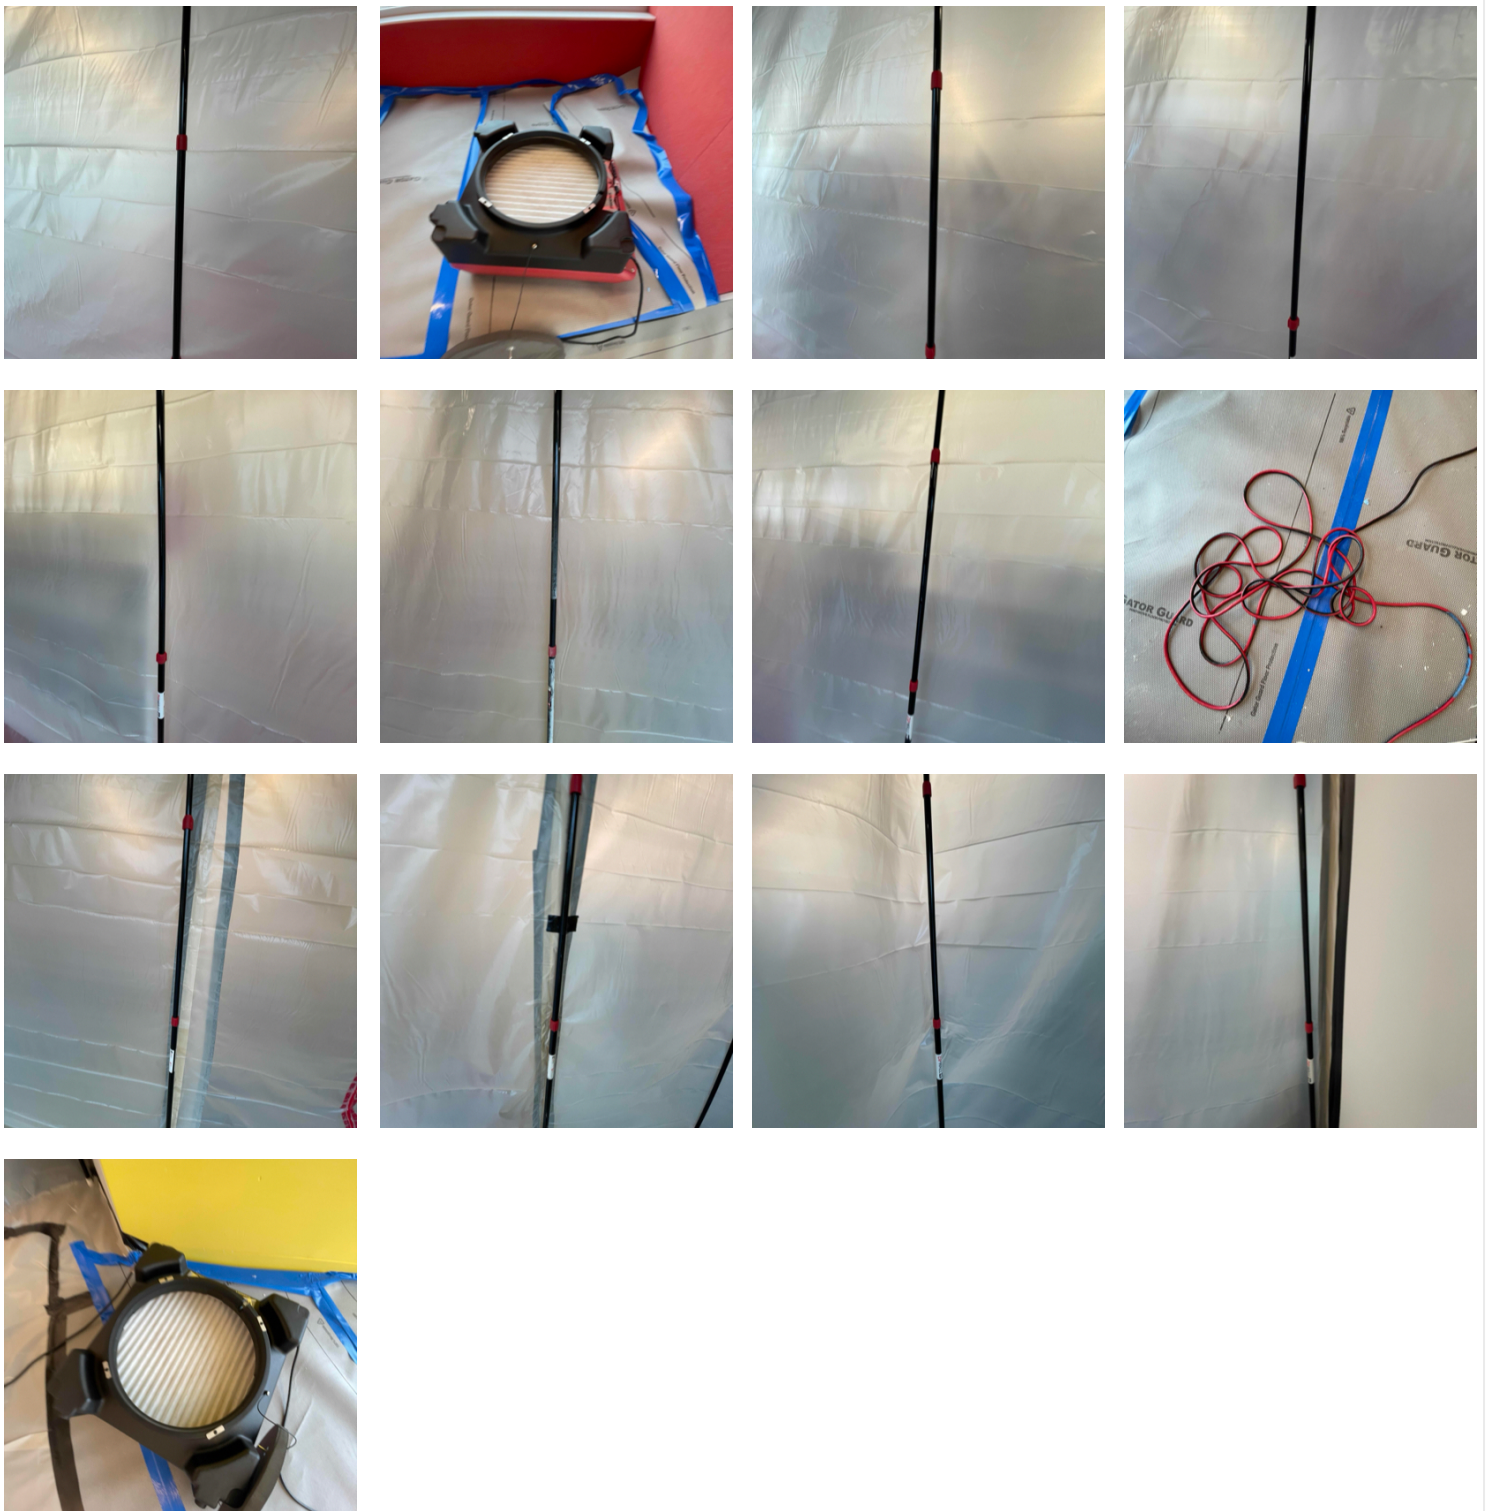
16. First Floor - Bay Windows (Children's Area): Equipment On-site

- 12 - Zip Posts
- 3 - Medium Air Scrubbers
- 1 - 50' extension cord

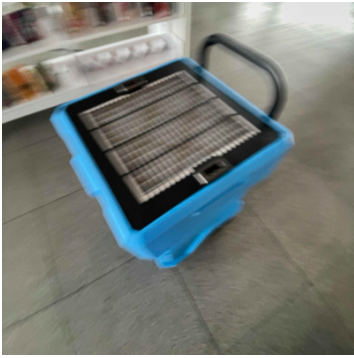
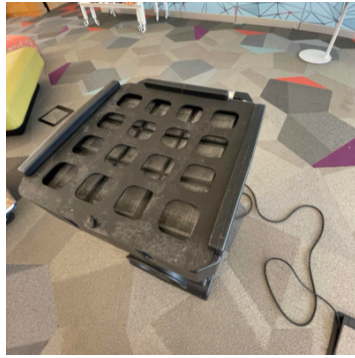
18. First Floor - Main Area: Equipment On-site

2 - Air Scrubbers

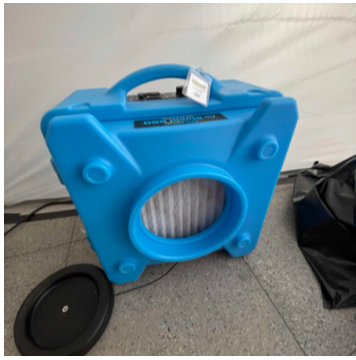
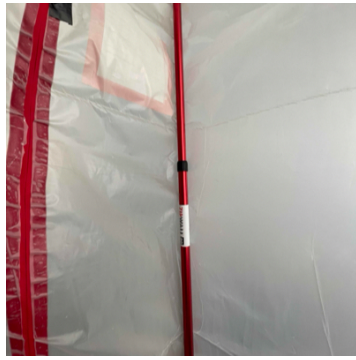
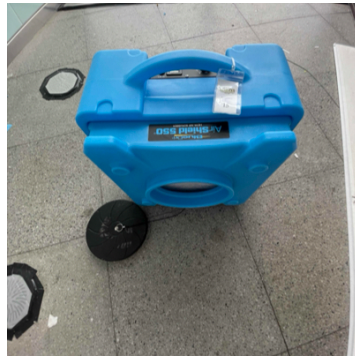
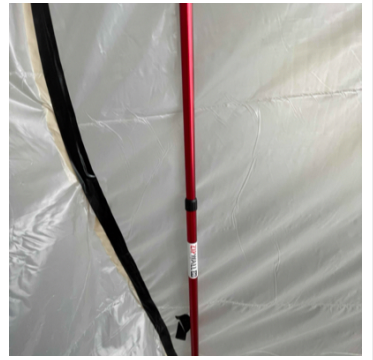
21. First Floor - Southwest Vestibule: Equipment On-site

2 - Air Scrubbers

2 - Zip Posts

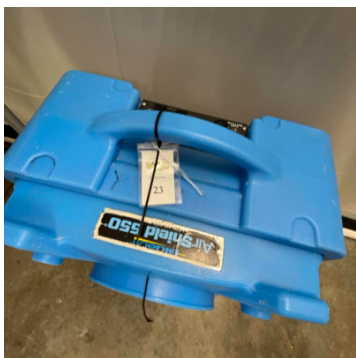
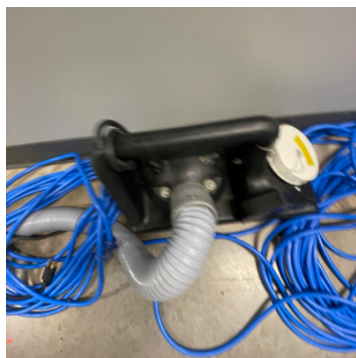
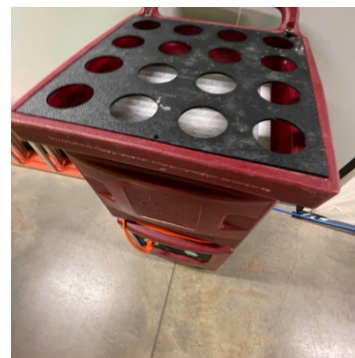
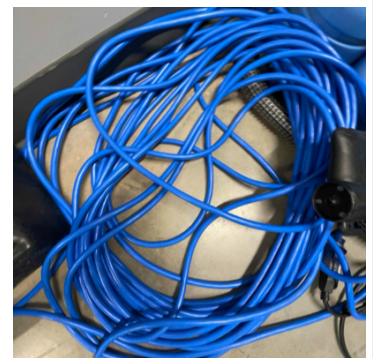
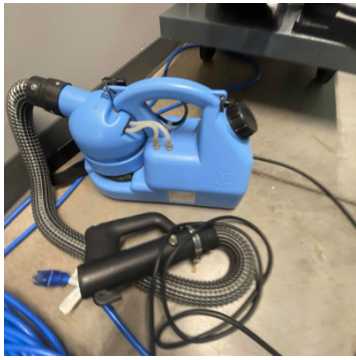
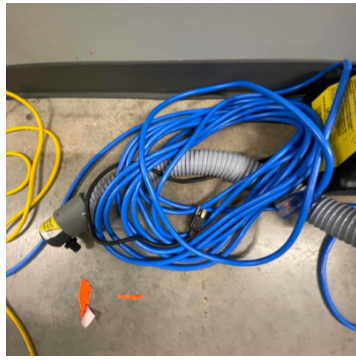
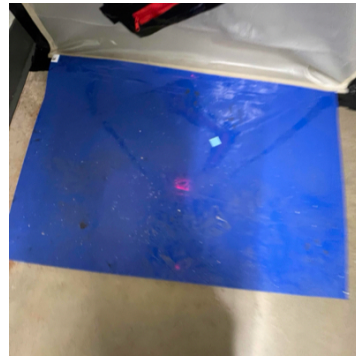
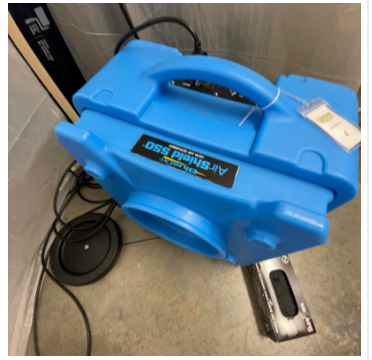
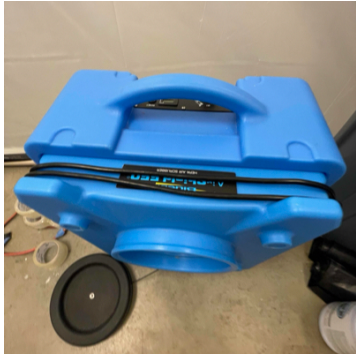
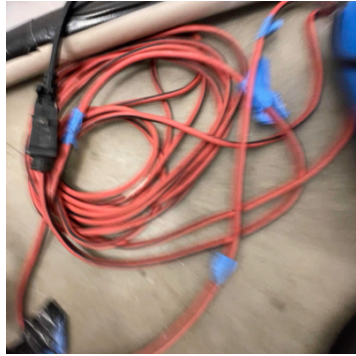
23. Garage: Equipment On-site

- 4 - Air Scrubbers
- 3 - 50' Extension Cord
- 1 - 25' Extension Cord

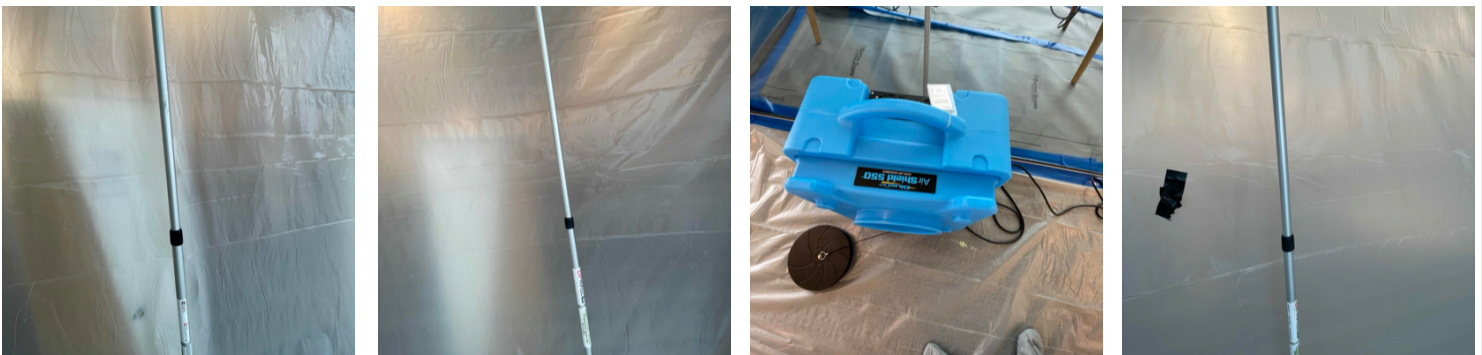
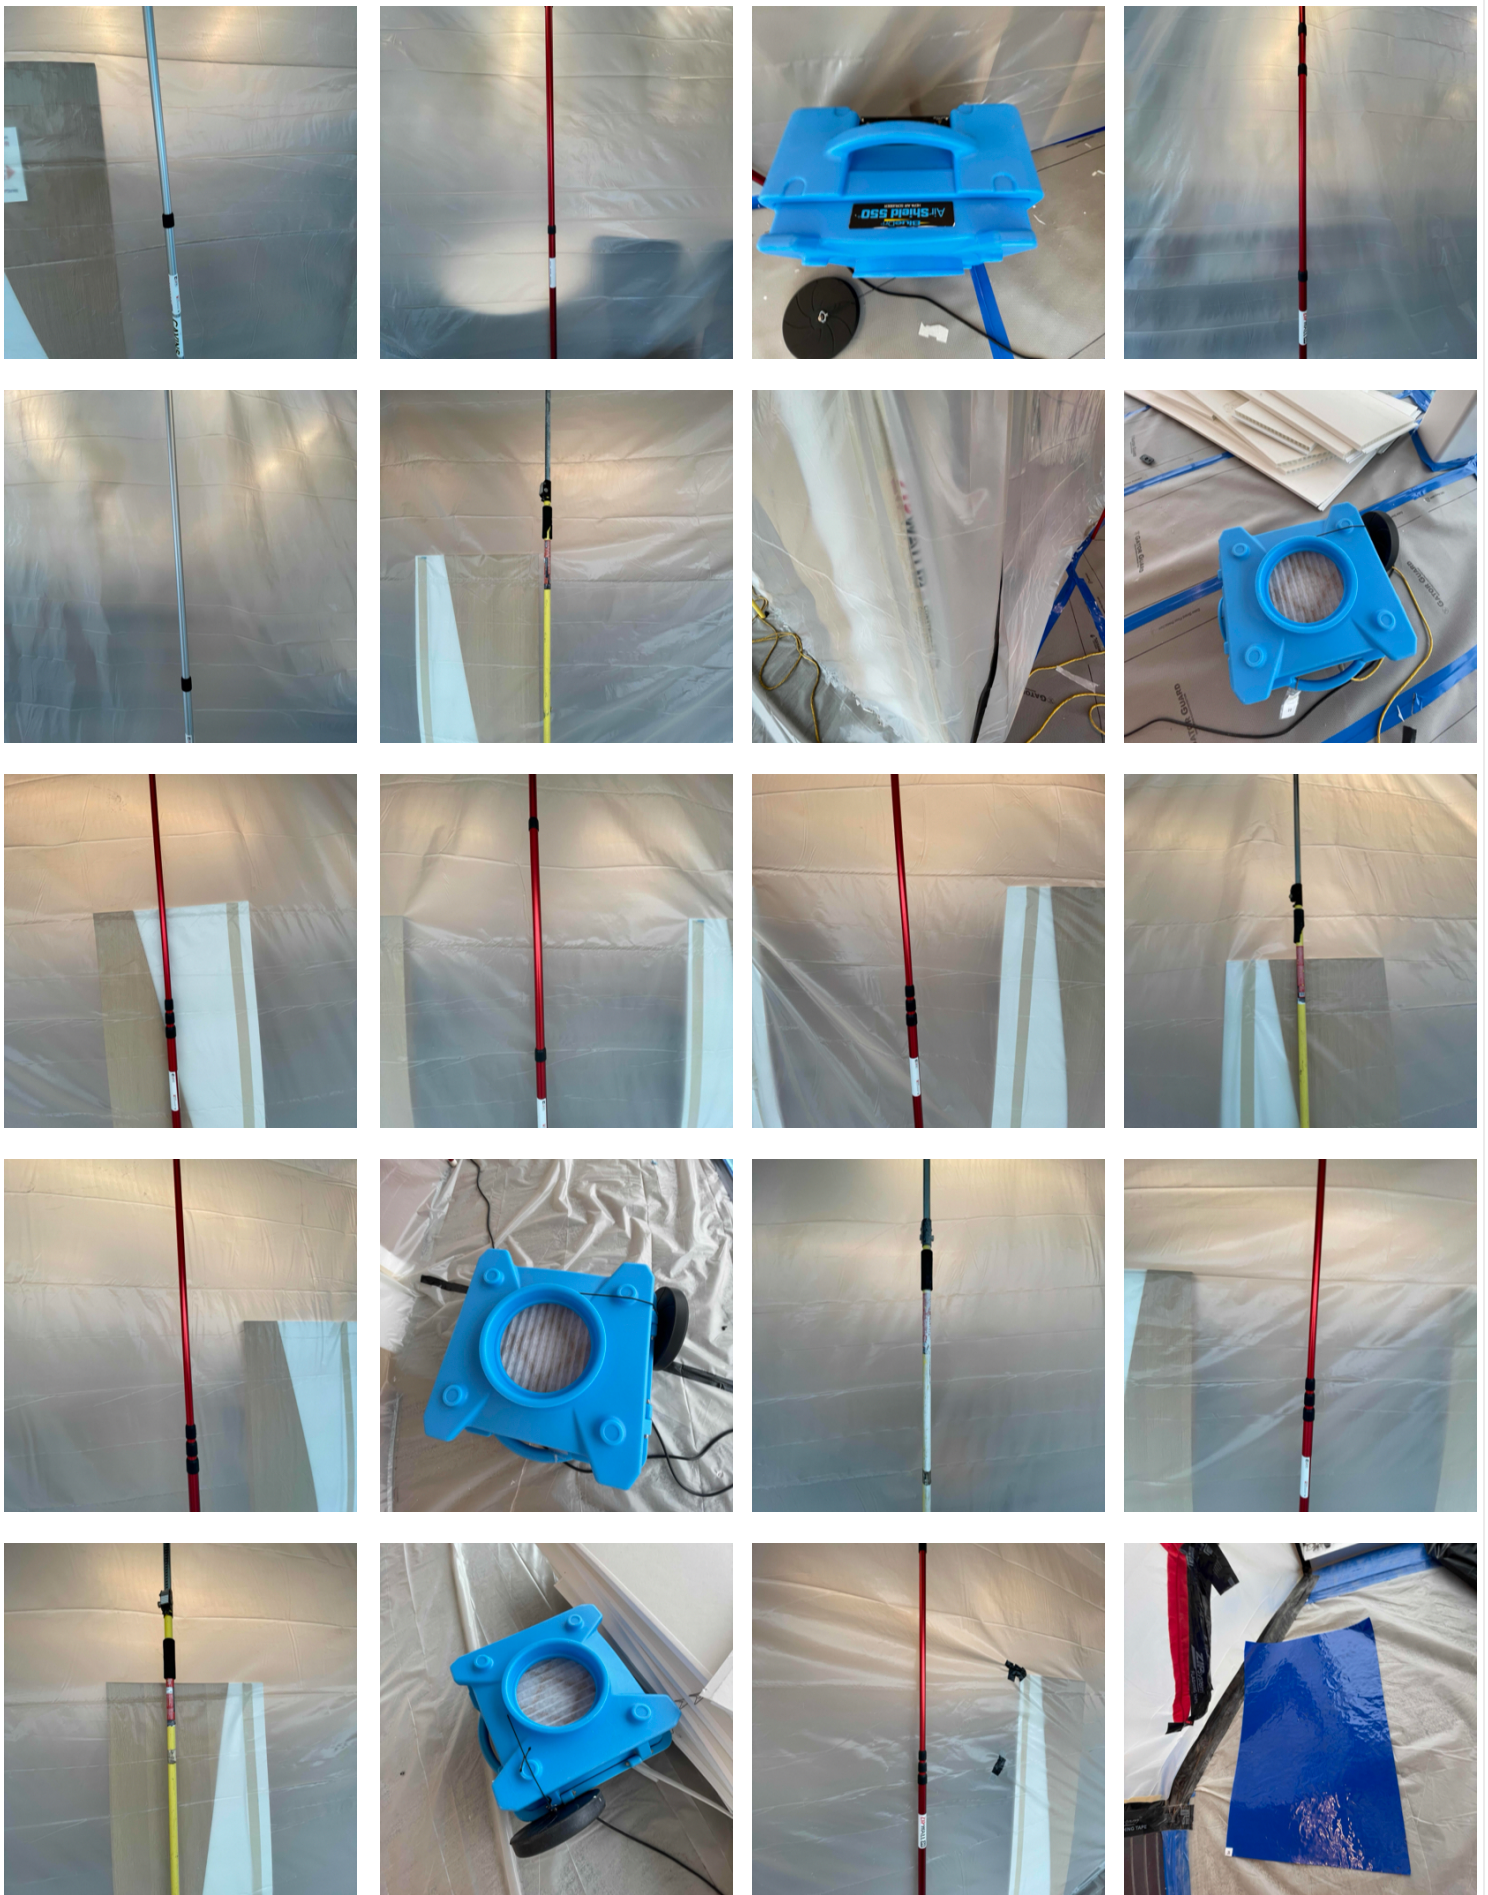
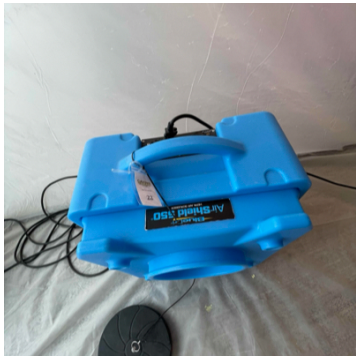
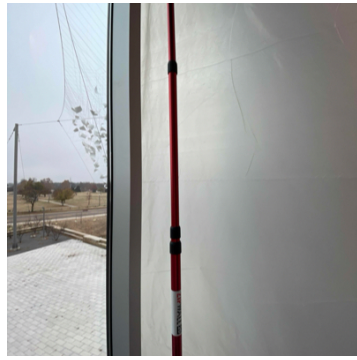
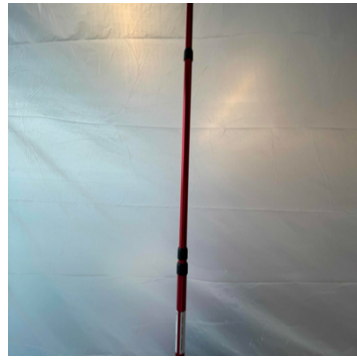
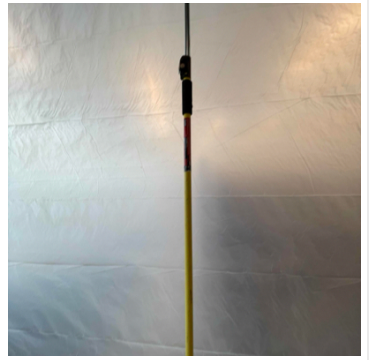
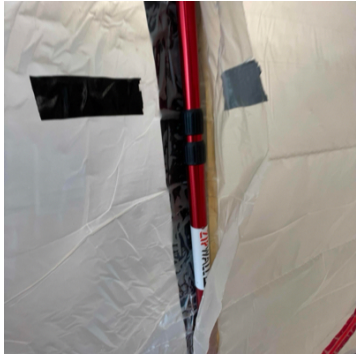
28. Second Floor - Southeast Corner: Equipment On-site

- 22 - Zip Posts
- 6 - Medium Air Scrubbers

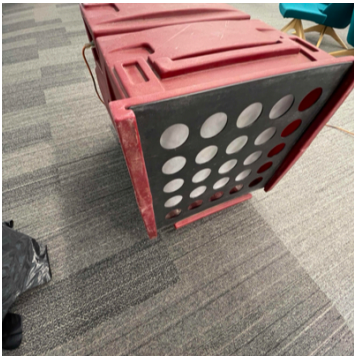
39. Second Floor - Main Area: Equipment On-site

1 - Air Scrubber
