# Norman Public Library Central - Mold

103 W Acres St Norman, OK 73069

Date Thu 01/11/2024

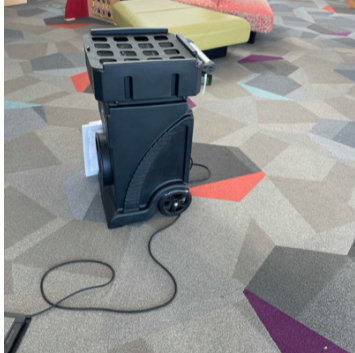
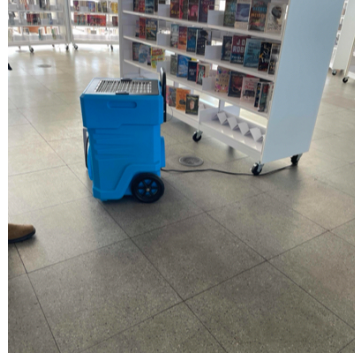
### 3. First Floor - Main Area: Equipment

#### 2 - Air Scrubbers

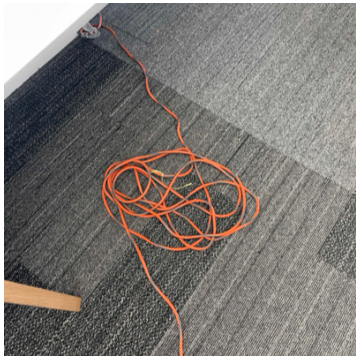
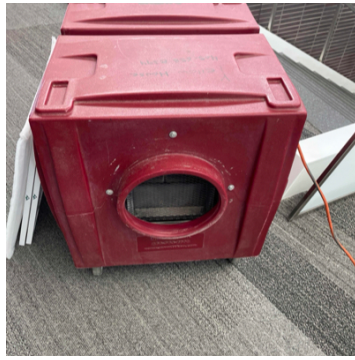
### 6. Third Floor - Main Area: Equipment

- 2 - Air Scrubbers
- 1 - 50' Extension Cord

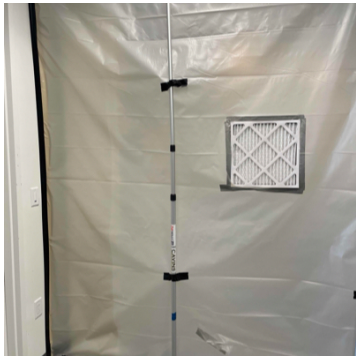
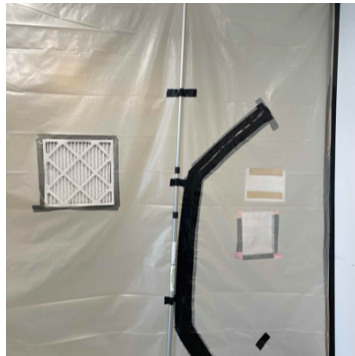
**7. 303 Storage: Equipment**

2 - Zip Post

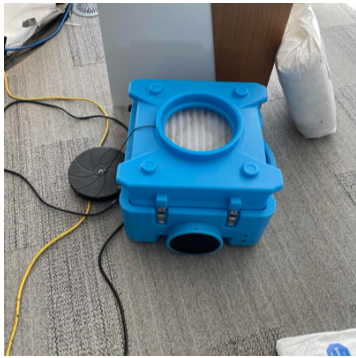
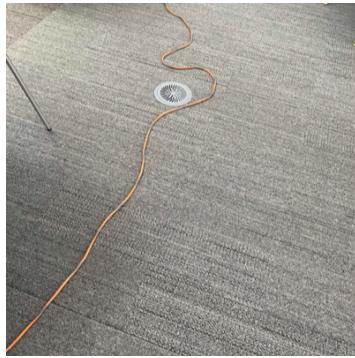
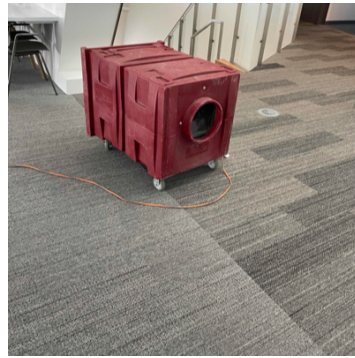
### 11. Second Floor - Main Area: Equipment

- 2 - Air Scrubbers
- 1 - 25' Extension Cord

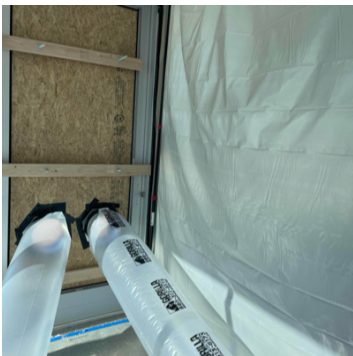
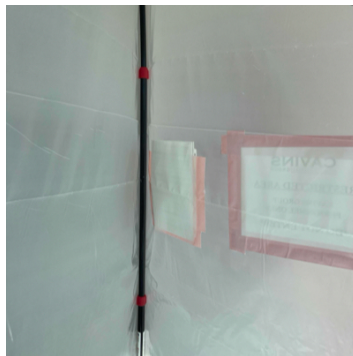
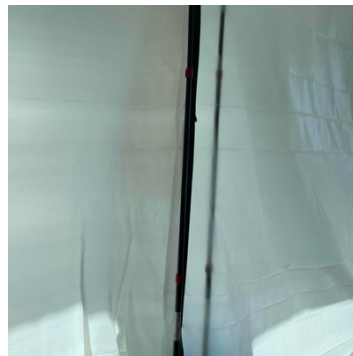
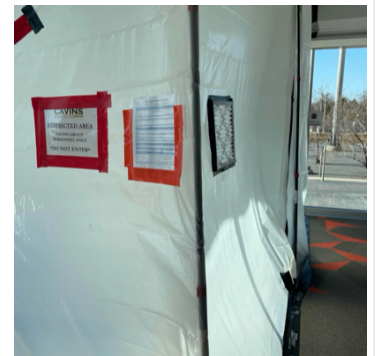
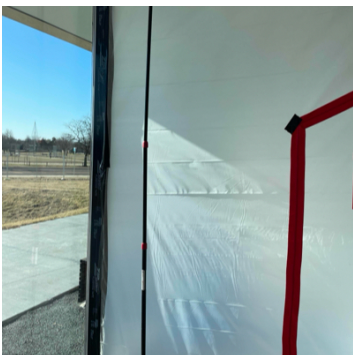
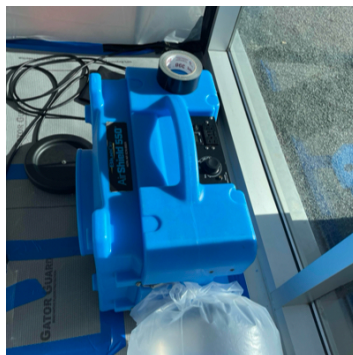
18. 149 Storytime: Equipment

- 5 - Zip Post
- 2 - Air Scrubbers

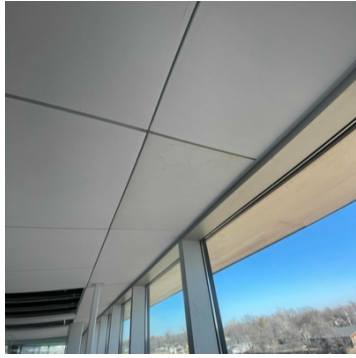
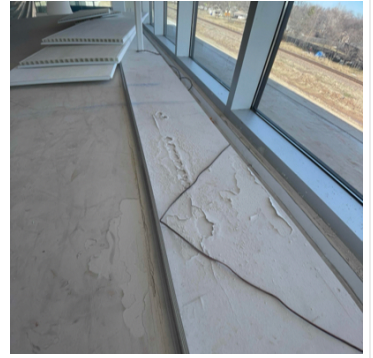
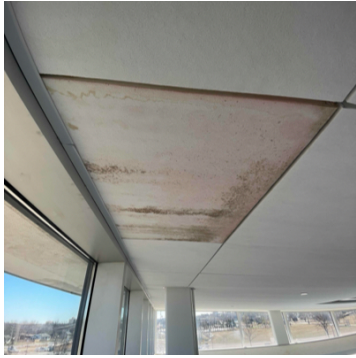
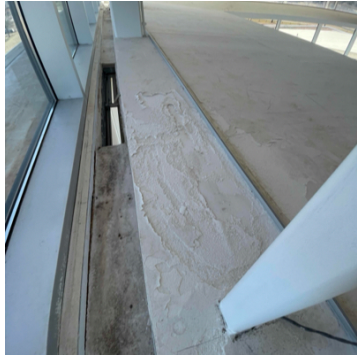
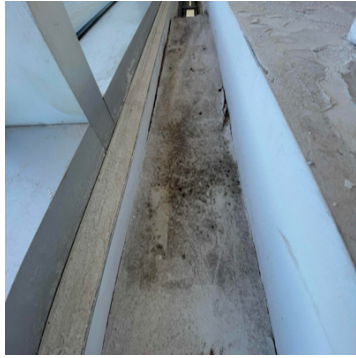
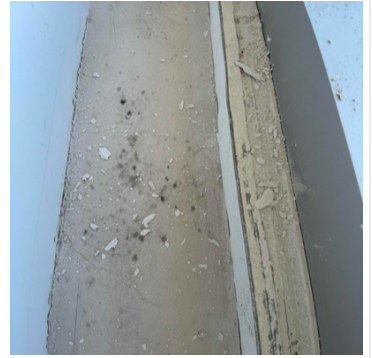
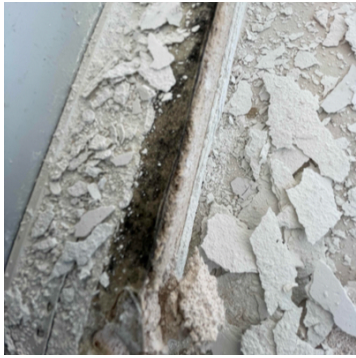
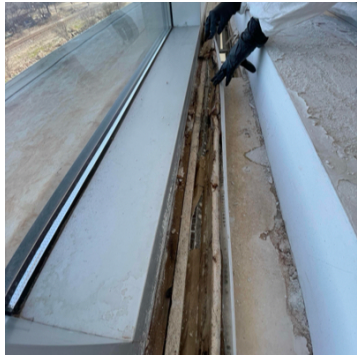
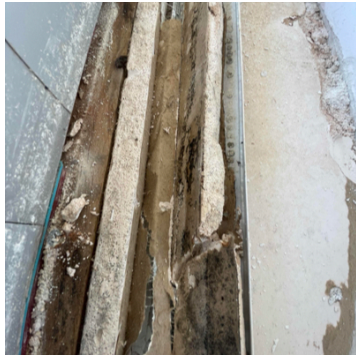
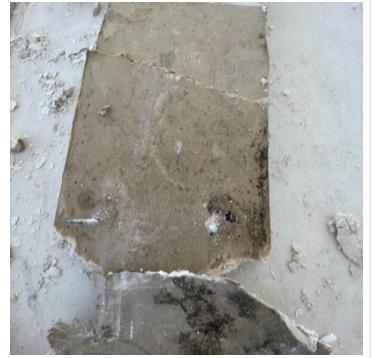
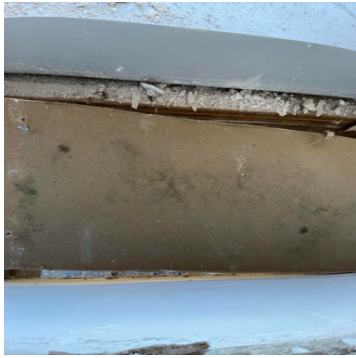
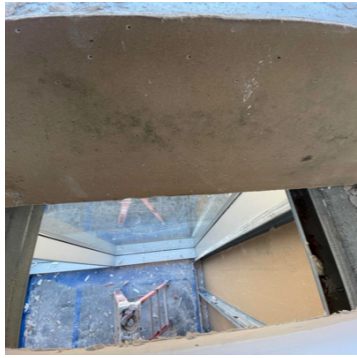
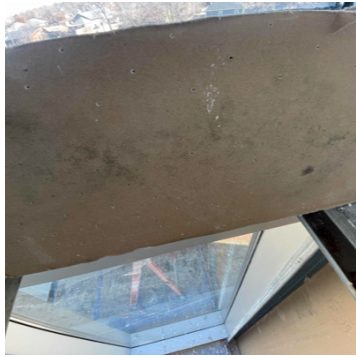
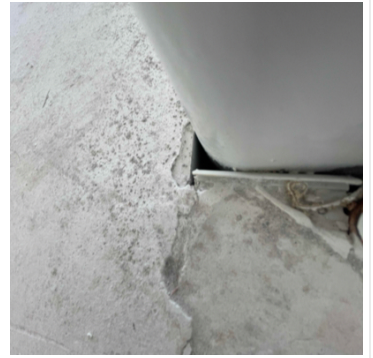
Water damage can be seen on the wall in the middle office, on the east side by the windows. After removing water damaged drywall, visible microbial growth can be seen on the upper left corner. Drywall on the ceiling needs to be removed in order to ensure there is no microbial growth. Visible microbial growth is seen on the back of the ceiling drywall and all affected areas were removed. Microbial growth spreads to the inside of the office ceiling and this was removed as well. On top of soffit (overhang) visible microbial growth can be seen where possible windows/exterior siding has been leaking, demo of affected areas were completed.

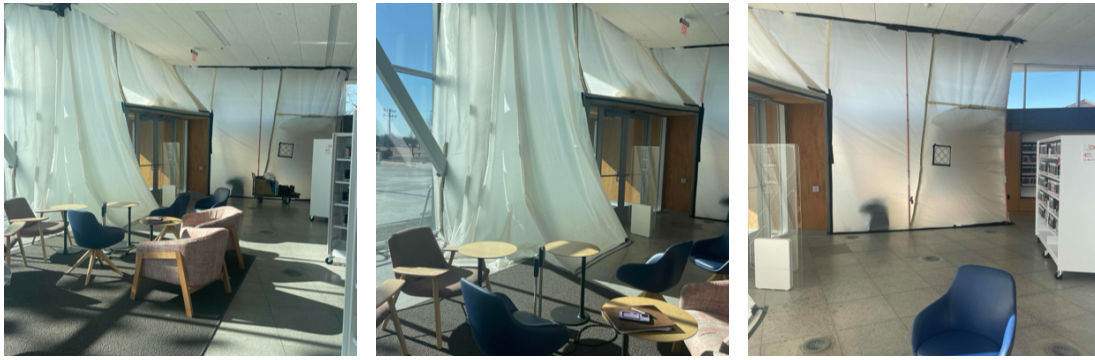
**27. First Floor - Southwest Vestibule: Equipment**

- 2 - Zip Post
- 2 - Air Scrubbers

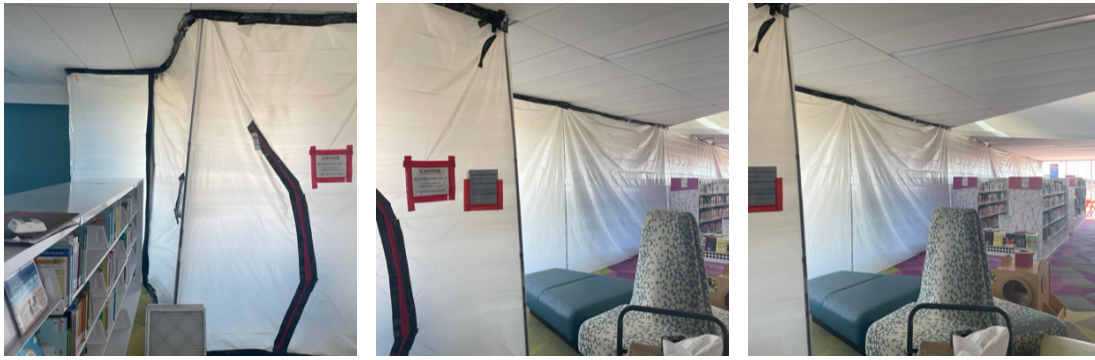
**31. First Floor - Bay Windows (Children's Area): Equipment**

- 12 - Zip Post
- 4 - Air Scrubbers
- 1 - 50' Extension Cord

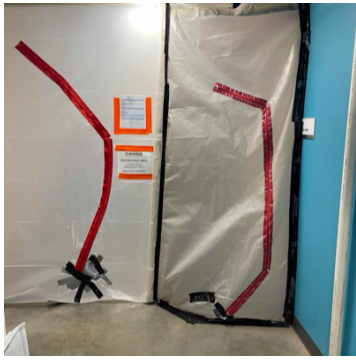
### 38. Garage: Equipment

- 4 - Air Scrubbers
- 2 - 50' Extension Cords
- 1 - 25' Extension Cord
- 2 - Foggers

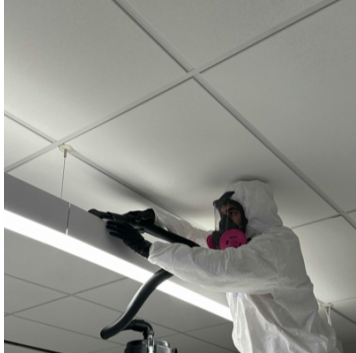
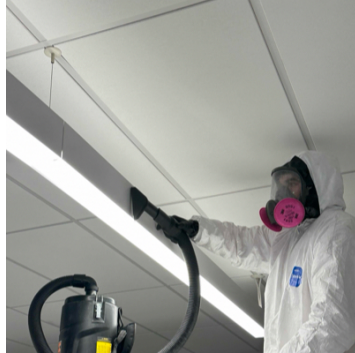
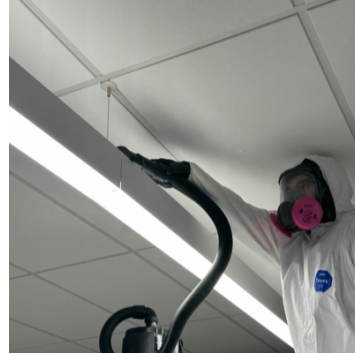
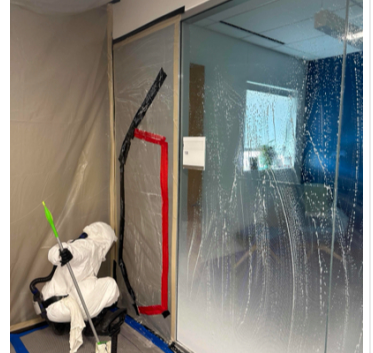
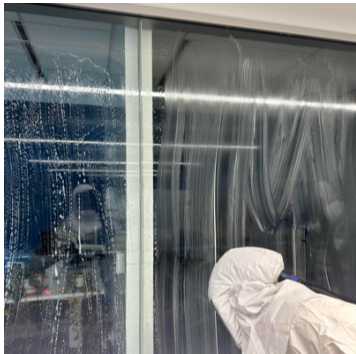
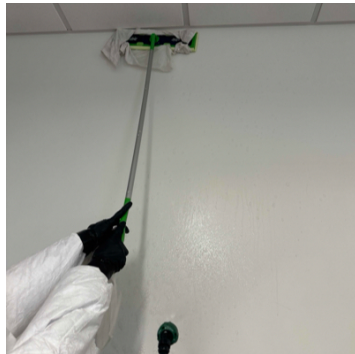
**43.** SO 115: Phase 2 cleaning  
Hepa vacuum ceiling, walls, & floors.  
Wipe ceiling, walls, & floors

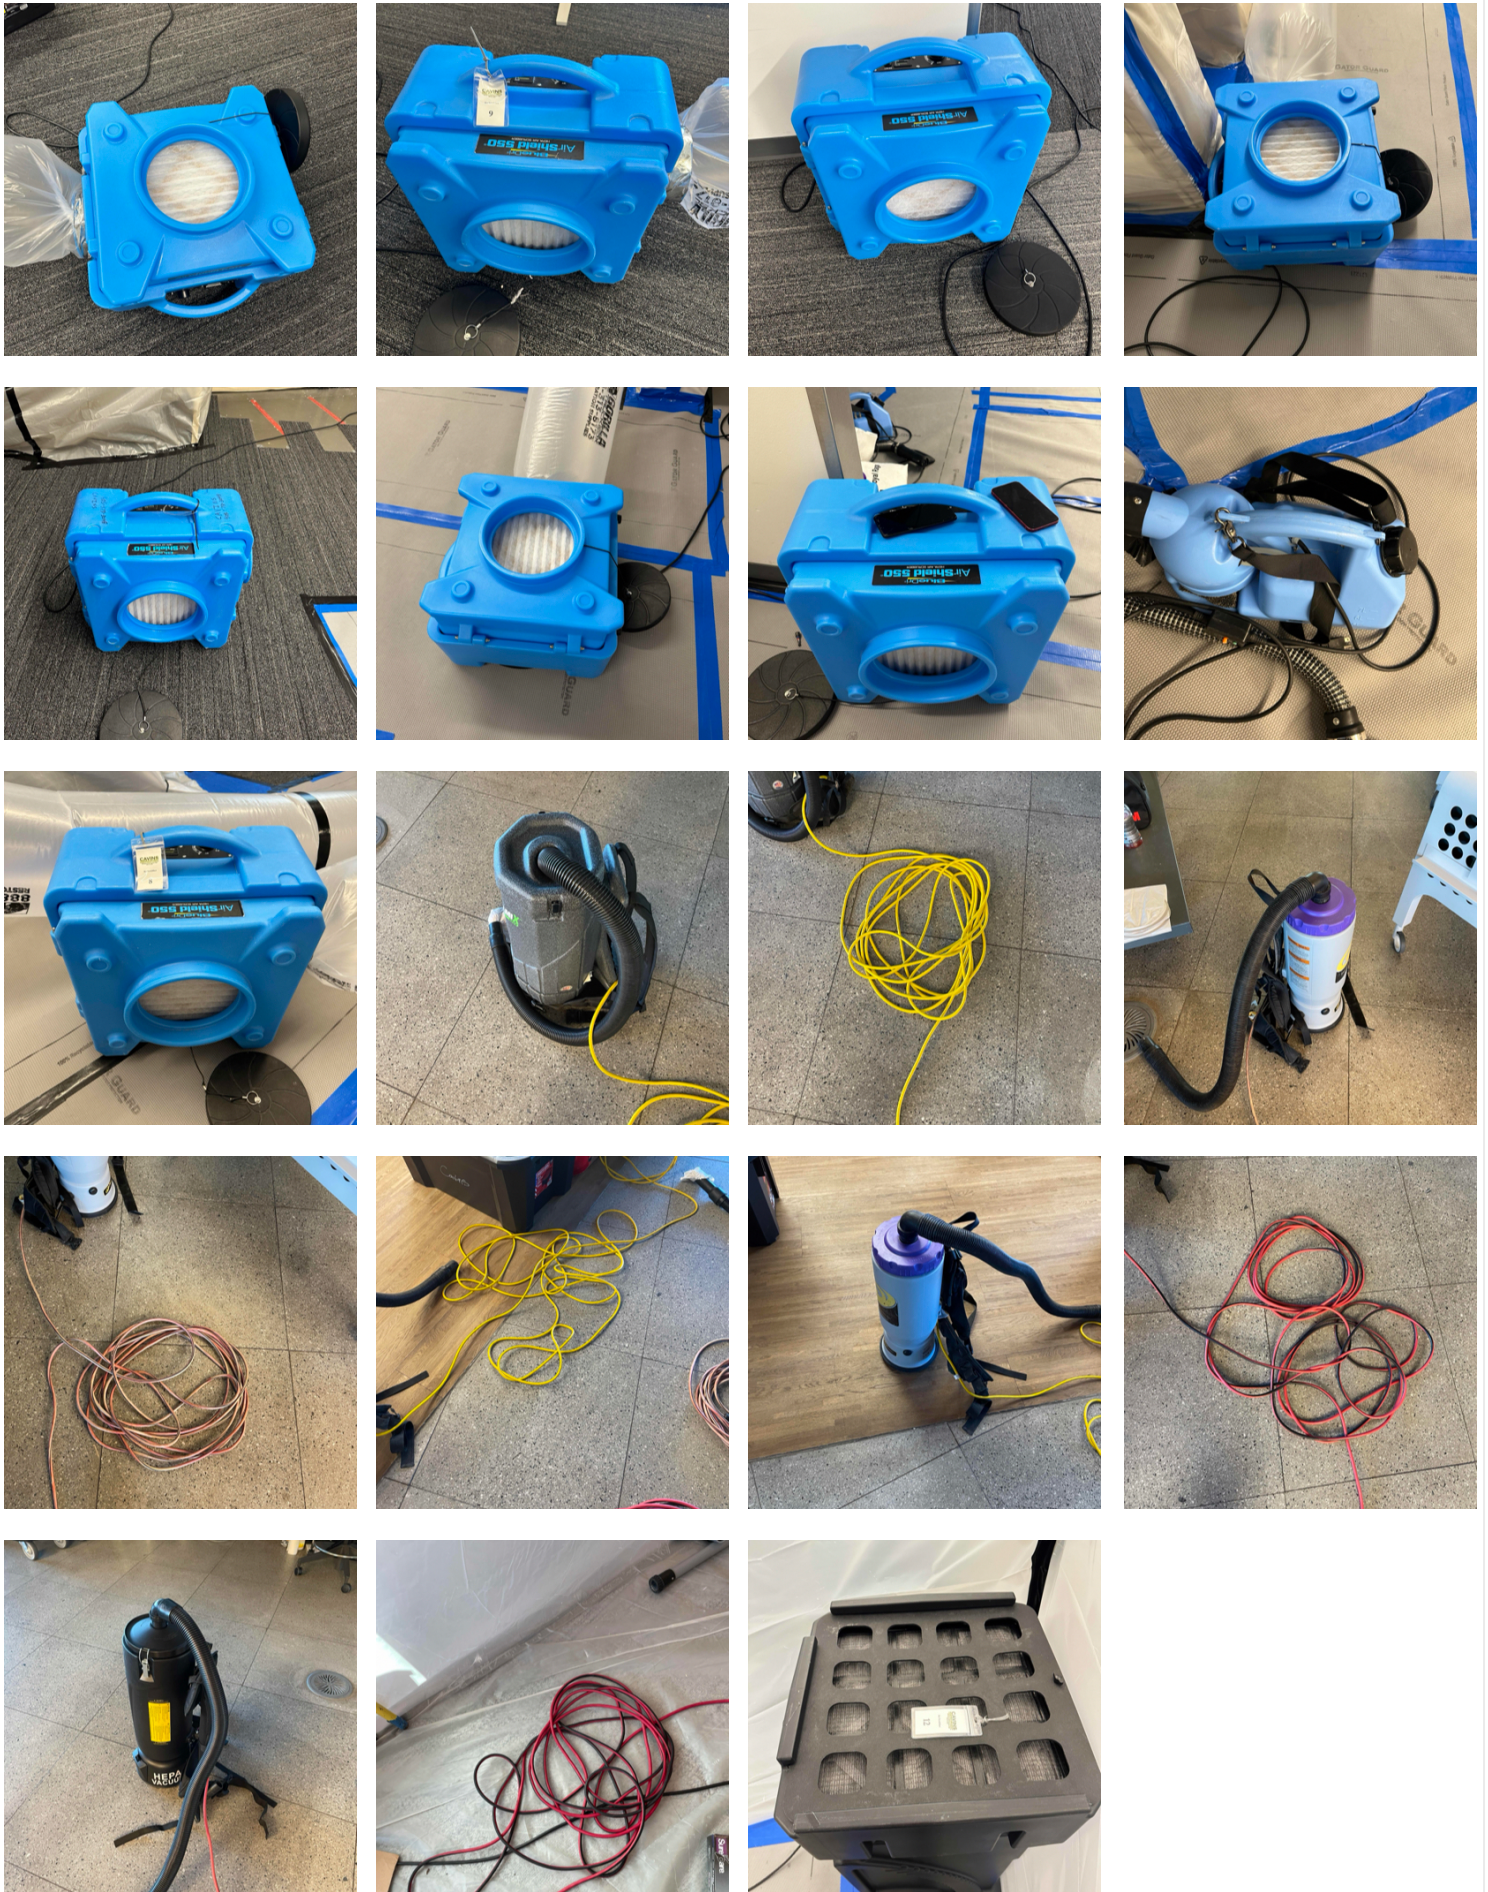
**44.** SO 115: equipment  
9 - Air Scrubbers  
5 - Hepa Vacuums  
8 - 50' Extension Cords  
1 - Fogger

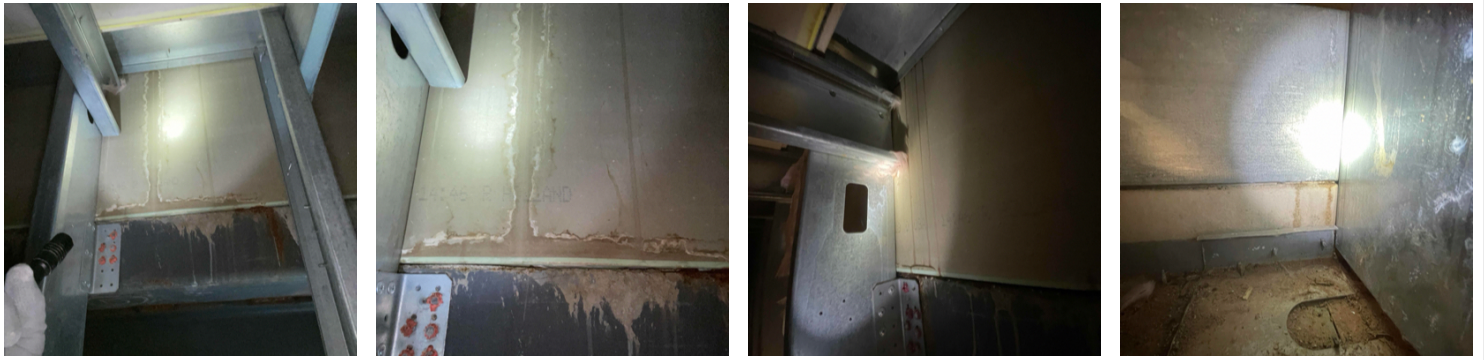
## 53. Water trails - Second floor Southeast Corner

Water marks can be seen on drywall above the support beam in the drop down ceiling from the second floor, inside the soffit area. Seems to be under the floor on the 3rd floor, east side under windows,.

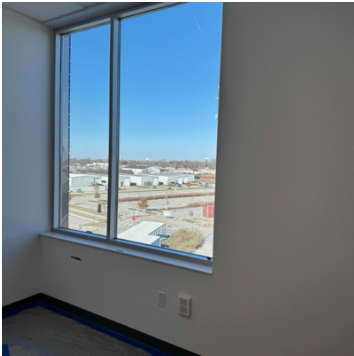
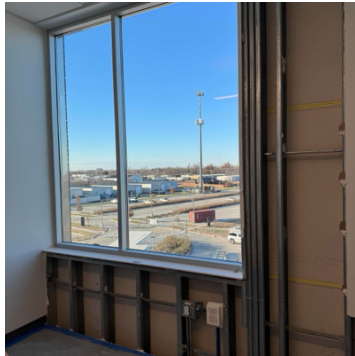
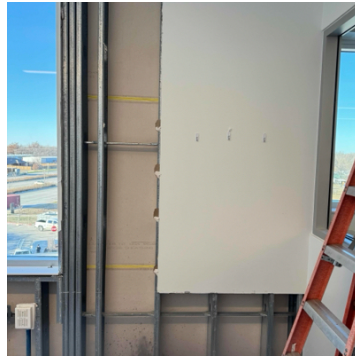
**58. 311 Local History: Selective demo for water intrusion investigation. Water intrusion appears to be from a former roof leak that may have already been repaired.**
